## CONDITION REPORT

Report No: 2016278730

DATE  
22/02/2024

Vehicle Type	PASSENGER VEHICLE	Registered Owner	MFC AUCTION HOUSE
Manufacturer	JEEP	Registration Number	CB86ZGGP
Model	COMPASS	Register Number	
VIN	1C4NJCDAA0CD606385	Date Of First Licensing	
Engine Number		Last COR	
Doors	5	License Expiry Date	30/11/2022
Color	WHITE	Power / Displacement	
Year Model		Paint Finish	TWO COAT METALLIC
Km Reading	156,976 KM	Fuel	PETROL
Cab / Body Type	STATION WAGON	Transmission	AUTOMATIC

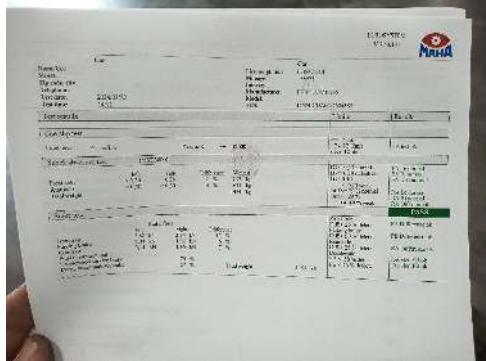
Brake test

Left	Right	Axle Weight [KG]	Deceleration [m/s <sup>2</sup> ]
	Braking Force [KN]	Braking Force [KN]		
Front	2.82	3.34	-	-
Rear	2.11	1.96	-	-
Emergency / Parking	2.04	1.92	-	-

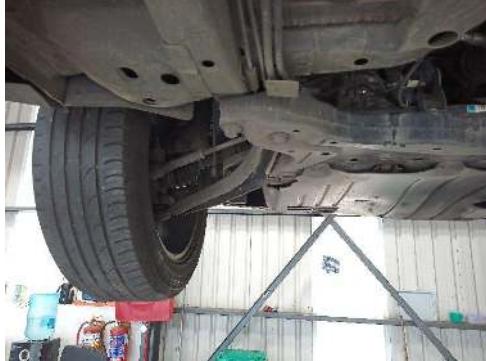
LF TYRE TREAD

Size	Load/Speed Index	Manufacture	Model	Type*	Production Date	Tread Depth (mm)
Front Left	215/55R18	99V	Continental	Contipremium	V	5218	0 mm
Front Right	215/55R18	99V	Continental	Contipremium	V	5218	0 mm
Rear Left	215/55R18	99V	Continental	Contipremium	V	5218	3 mm
Rear Right	215/55R18	99V	Continental	Contipremium	V	5218	3 mm

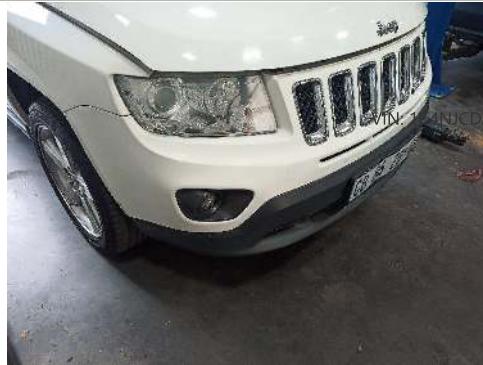
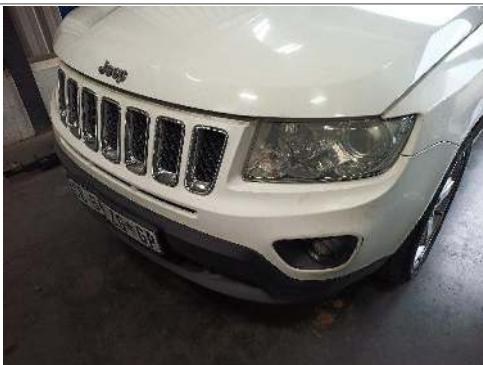
Damage	Repair Way
Engine Oil Leak	Repair
Engine Management Lights Set	Repair
Windscreen Wiper Damaged	Replace
Park Light Front Right Defective	Replace
Tail Light Right Damaged	Replace
Front Bumper Damaged	Repair
Bonnet Damaged	Repair
Front Fender Left Damaged	Repair
Front Fender Right Damaged	Repair
Rear Fender Left Damaged	Repair
Rear Fender Right Damaged	Repair
Door Front Left Damaged	Repair
Door Front Right Damaged	Repair
Door Rear Left Damaged	Repair
Door Rear Right Damaged	Repair
Boot Lid / Hatch door Damaged	Repair
Rear bumper Damaged	Repair
Shock Absorber Front Left Worn	Repair
Shock Absorber Front Right Worn	Replace
Shock Absorber Rear Left Worn	Repair
Shock Absorber Rear Right Worn	Replace
Tyre Front Left Worn	Replace
Tyre Front Right Worn	Replace
Engine Performance Insufficient	Repair
Body and exterior	Signs of repair work done to somebody panels.
Body and exterior	Minor dents and scratches and stone chips
