## CONDITION REPORT

Report No: 2016445842

MFC Auction House  
M57 Pretoria Rd, Glenmarais, KEMPTON PARK  
Gauteng

| Manufacturer | VOLKSWAGEN | Registration Number | ZLH924GP |

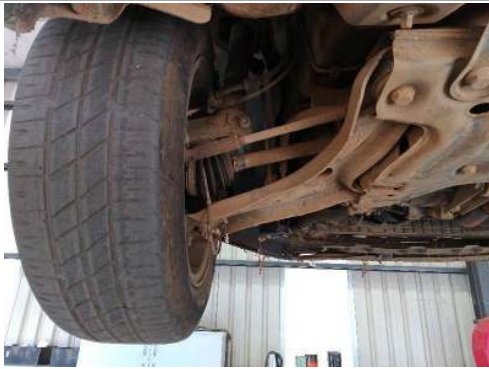
LF TYRE TREAD

| Damage | Repair Way |
|---|---|
| Tyre Front Left Damaged | Replace |

| | Size | Load/Speed Index | Manufacture | Model | Type* | Production Date | Tread Depth (mm) |
|---|---|---|---|---|---|---|---|
| Front Left | 185/60 R15 | 84H | Continental | Contipremuim | V | 1517 | 0 mm |

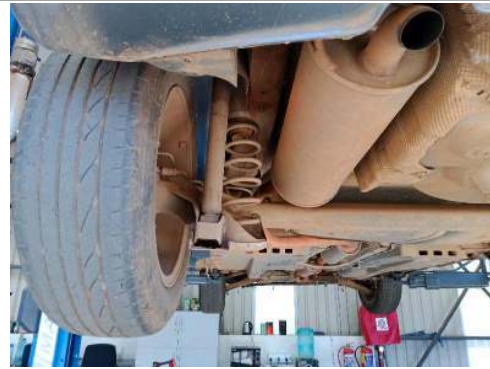
LR TYRE TREAD

| Damage | Repair Way |
|---|---|
| Tyre Rear Left Damaged | Replace |

| | Size | Load/Speed Index | Manufacture | Model | Type* | Production Date | Tread Depth (mm) |
|---|---|---|---|---|---|---|---|
| Rear Left | 185/60 R15 | 84H | Bridgestone | Turanza | V | 1918 | 1 mm |

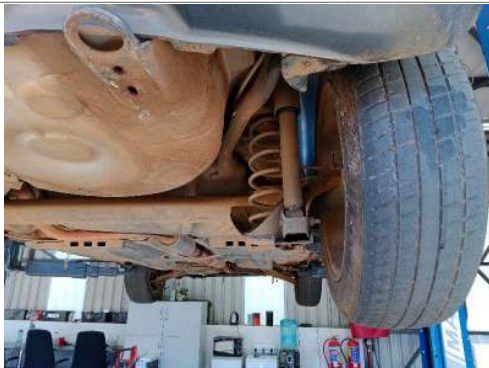
RR TYRE TREAD

| Damage | Repair Way |
|---|---|
| Tyre Rear Right Damaged | Replace |

| | Size | Load/Speed Index | Manufacture | Model | Type* | Production Date | Tread Depth (mm) |
|---|---|---|---|---|---|---|---|
| Rear Right | 185/60 R15 | 84H | Bridgestone | Potenza | V | 1915 | 0 mm |

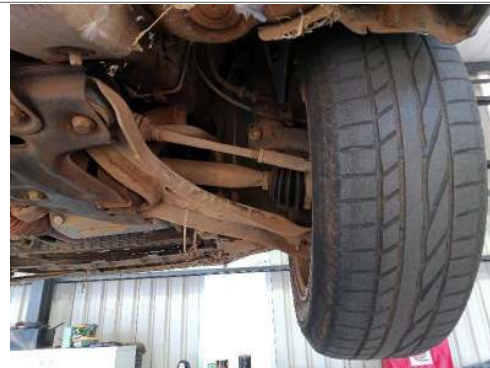
RF TYRE TREAD

| Damage | Repair Way |
|---|---|
| Tyre Front Right Damaged | Replace |

| | Size | Load/Speed Index | Manufacture | Model | Type* | Production Date | Tread Depth (mm) |
|---|---|---|---|---|---|---|---|
| Front Right | 185/60 R15 | 84H | Bridgestone | Turanza | V | 2917 | 0 mm |

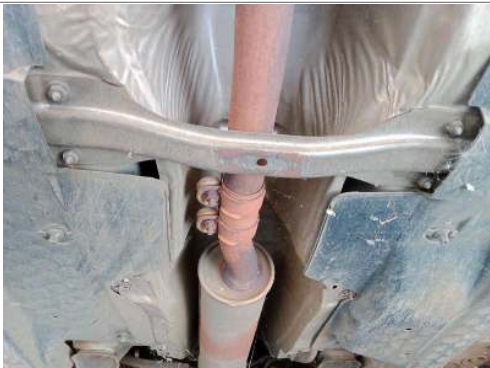
Center exhaust cross member br

| Damage | Repair Way |
|---|---|
| Undercarriage | Center exhaust cross member bracket dented |

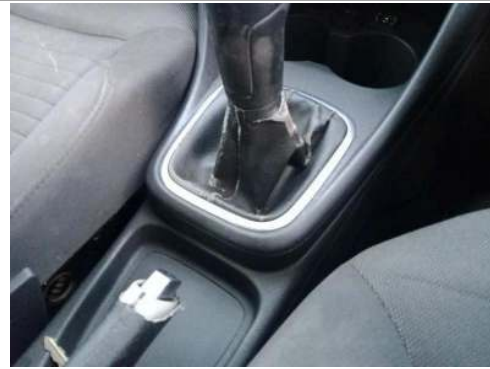
| Damage | Repair Way |
|---|---|
| Gear Lever Dust Boot Damaged | Repair |

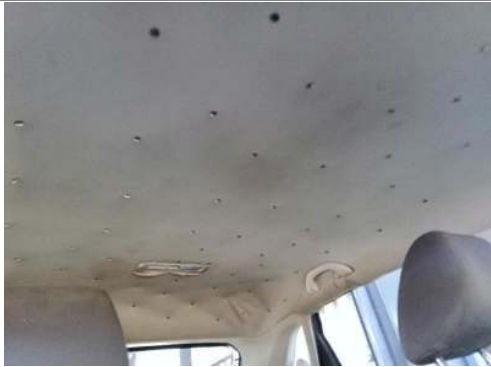
| Damage | Repair Way |
|---|---|
| Hood Lining Damaged | Replace |

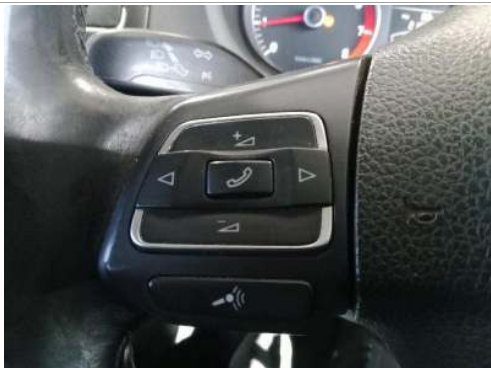
| Damage | Repair Way |
|---|---|
| Steering Wheel Trim Defective | Repair |

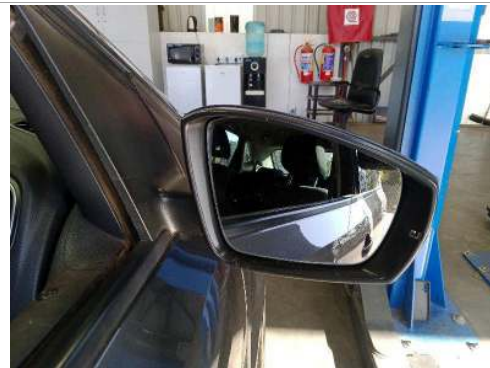
| Damage | Repair Way |
|---|---|
| Side Mirror Right Damaged | Repair |

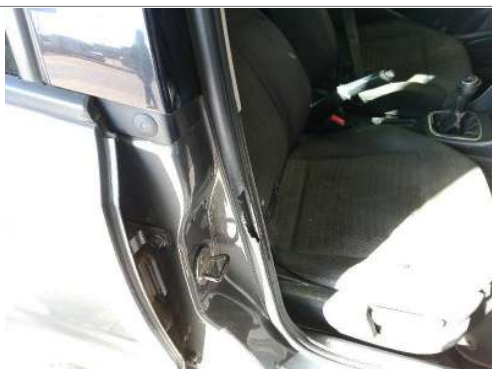
| Damage | Repair Way |
|---|---|
| Door Sealing Rubber Front Right Damaged | Replace |

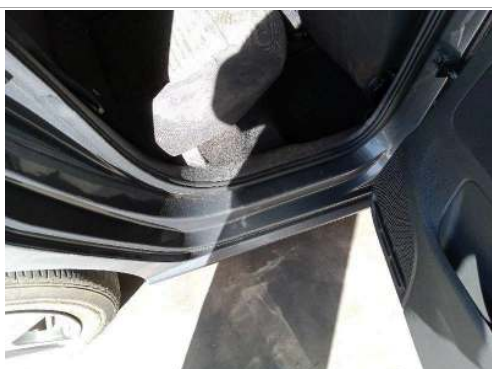
| Damage | Repair Way |
|---|---|
| Sill Panel Right Paintwork • Scratched | Repair |

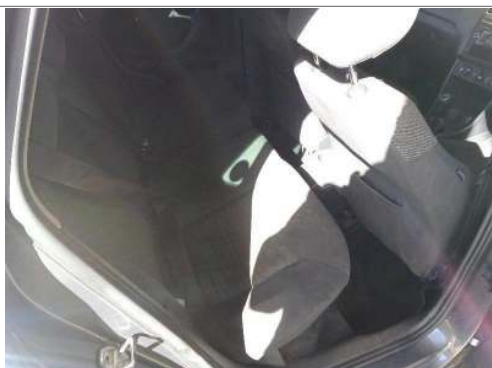
| Damage | Repair Way |
|---|---|
| Seat Rear Damaged | Repair |

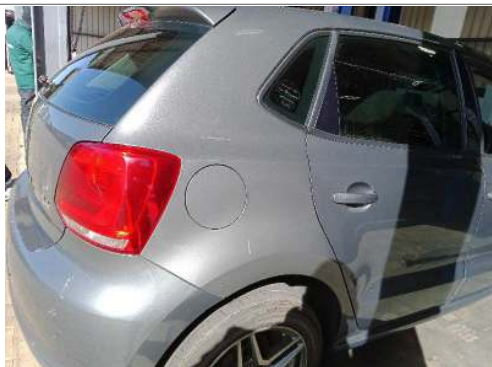
| Damage | Repair Way |
|---|---|
| Rear Fender Right Paintwork • Scratched | Repair |

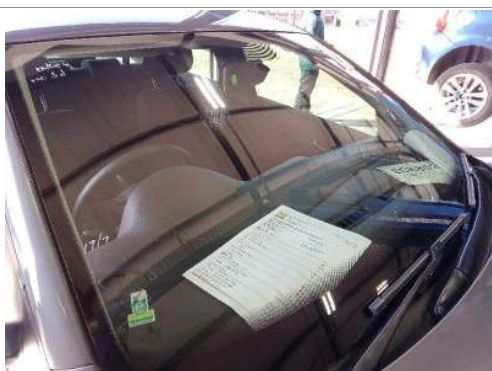
| Damage | Repair Way |
|---|---|
| Windscreen Cracked | Replace |

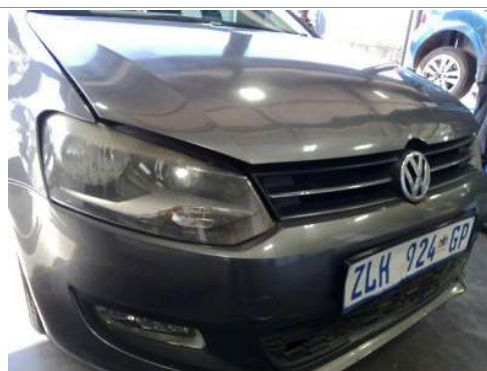
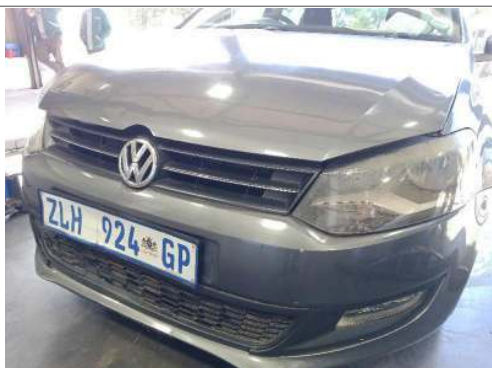
| Damage | Repair Way |
|---|---|
| Front Bumper Damaged | Repair |

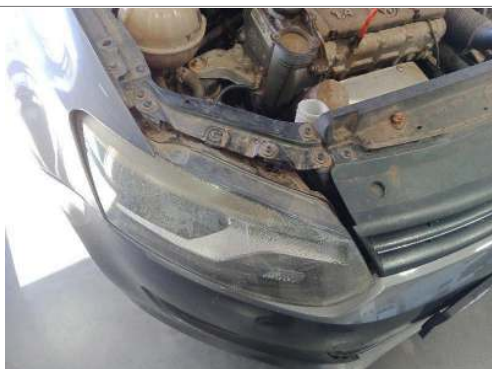
| Damage | Repair Way |
|---|---|
| Headlight Right Damaged | Replace |

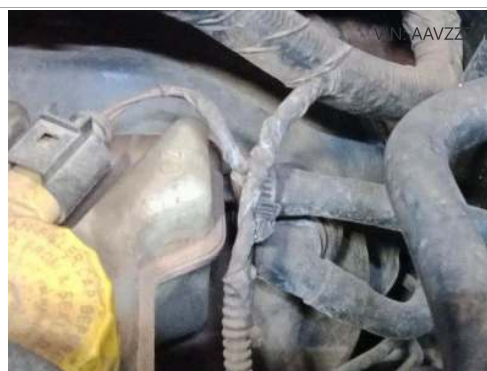
| Damage | Repair Way |
|---|---|
| Hoses Defective | Replace |

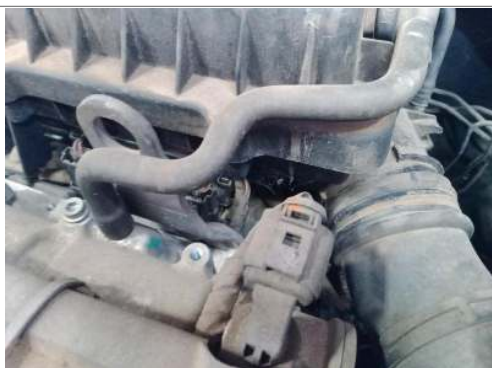
| Damage | Repair Way |
|---|---|
| Engine Wiring Defective | Repair |

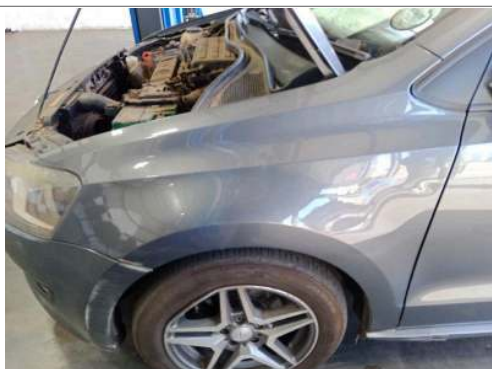
| Damage | Repair Way |
|---|---|
| Front Fender Left Damaged | Repair |

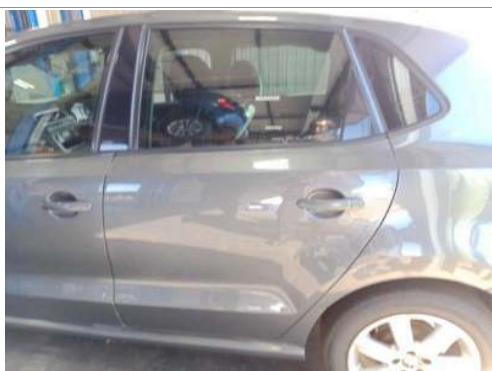
| Damage | Repair Way |
|---|---|
| Door Rear Left Paintwork • Scratched | Repair |

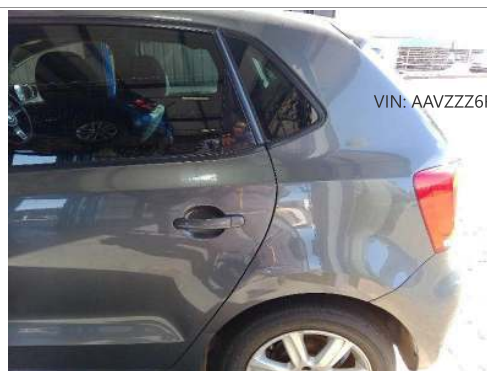
| Damage | Repair Way |
|---|---|
| Rear Fender Left Damaged | Repair |

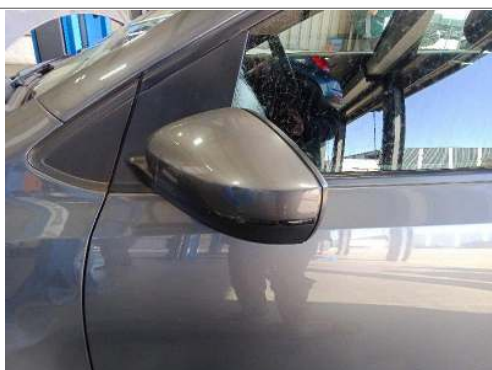
| Damage | Repair Way |
|---|---|
| Side Mirror Left Paintwork • Scratched | Repair |

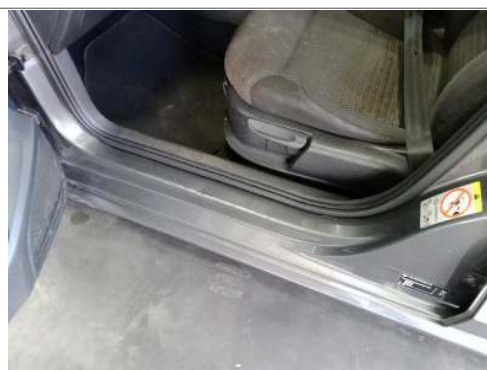
| Damage | Repair Way |
|---|---|
| Sill Panel Left Paintwork • Scratched | Repair |

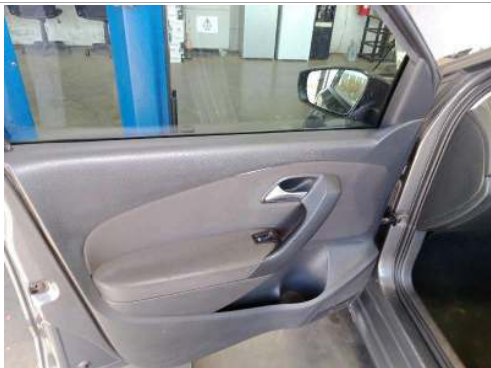
| Damage | Repair Way |
|---|---|
| Door Panel Front Left Defective | Repair |

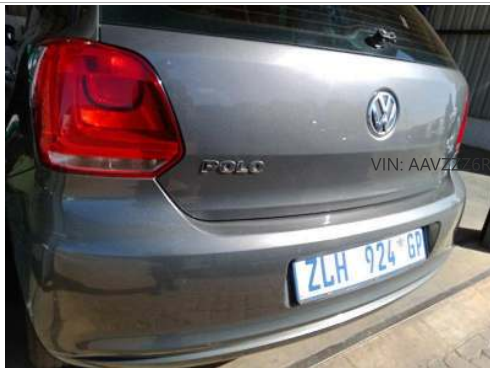
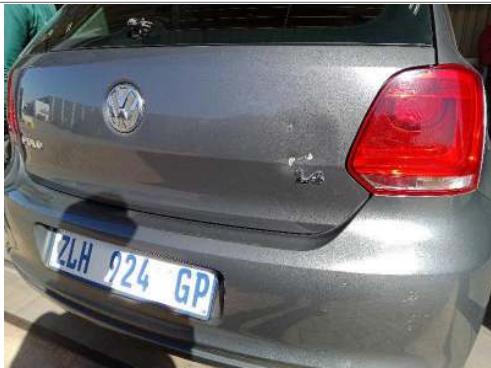
| Damage | Repair Way |
|---|---|
| Rear bumper Damaged | Repair |

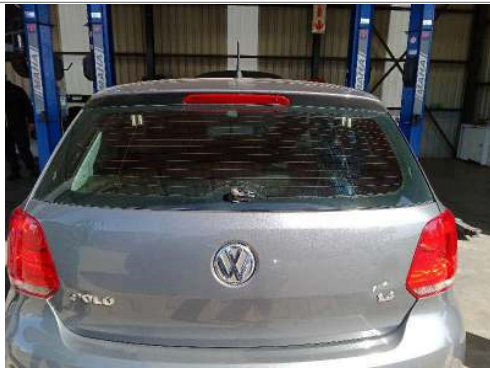
| Damage | Repair Way |
|---|---|
| Boot Lid / Hatch door Damaged | Repair |
| Body and Exterior | Boot does not open |

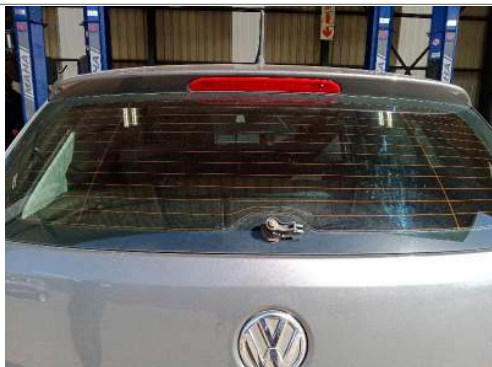
| Damage | Repair Way |
|---|---|
| Windscreen Wiper Missing | Replace |

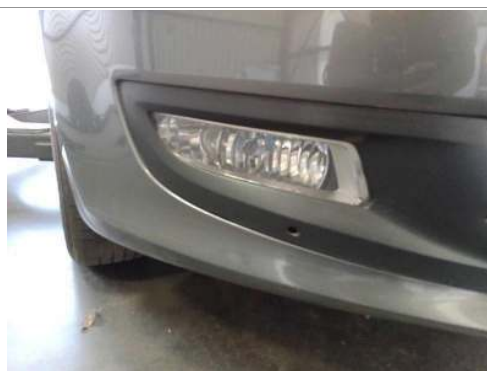
| Damage | Repair Way |
|---|---|
| Fog Light Front Right Defective | Replace |

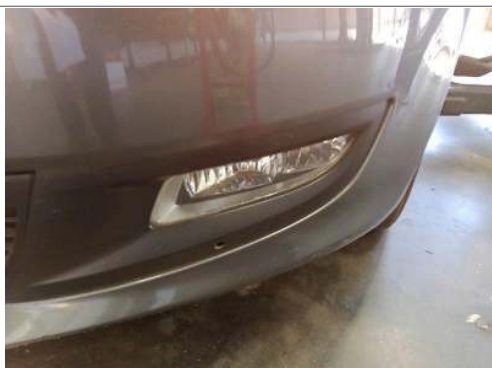
| Damage | Repair Way |
|---|---|
| Fog Light Front Left Defective | Replace |

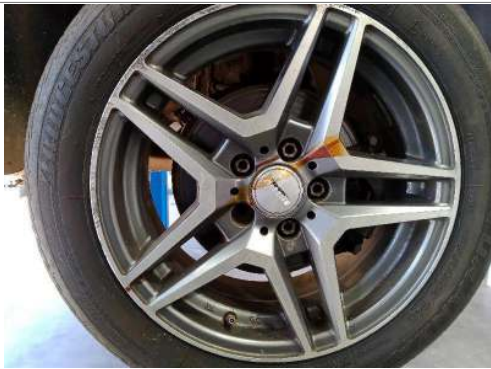
| Damage | Repair Way |
|---|---|
| Bolt(s) / Nut(s) Front Wheel Right Missing | Replace |

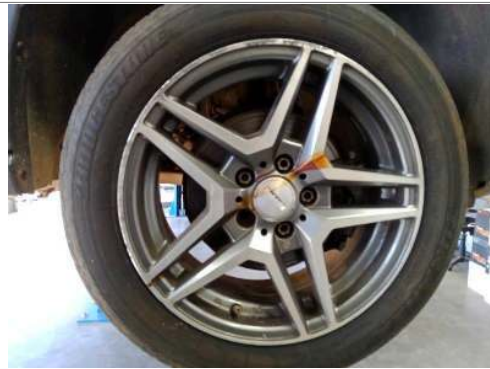
| Damage | Repair Way |
|---|---|
| Rim Front Right Defective | Repair |

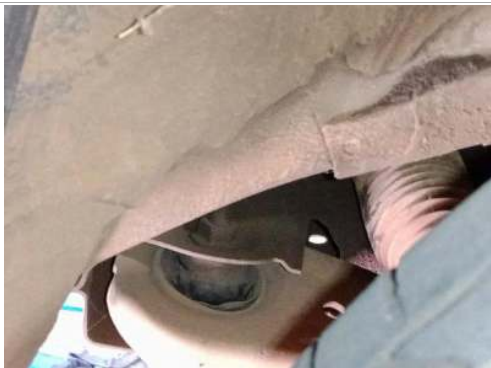
| Damage | Repair Way |
|---|---|
| Control Arm Bush(es) Front Axle Right Damaged | Replace |

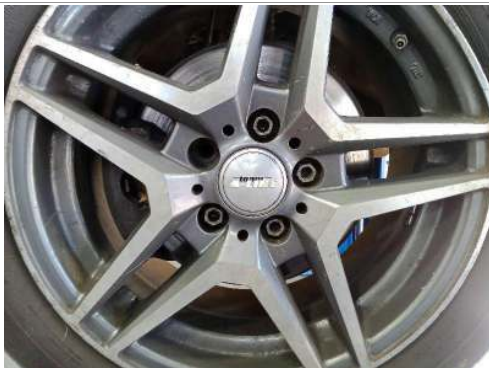
| Damage | Repair Way |
|---|---|
| Bolt(s) / Nut(s) Front Wheel Left Missing | Replace |

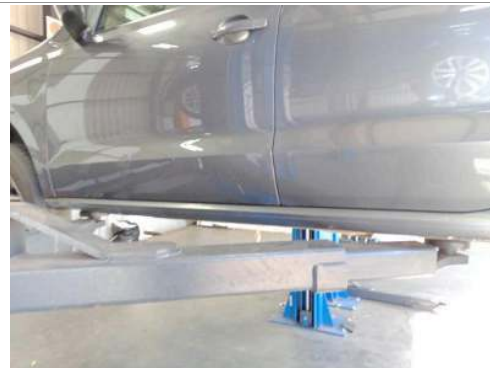
| Damage | Repair Way |
|---|---|
| Rocker Panel Left Damaged | Repair |

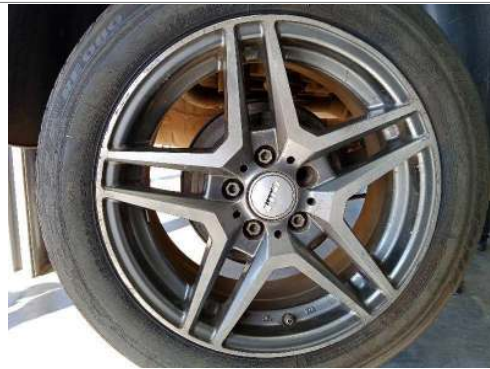
| Damage | Repair Way |
|---|---|
| Bolt(s) / Nut(s) Rear Wheel Right Missing | Replace |

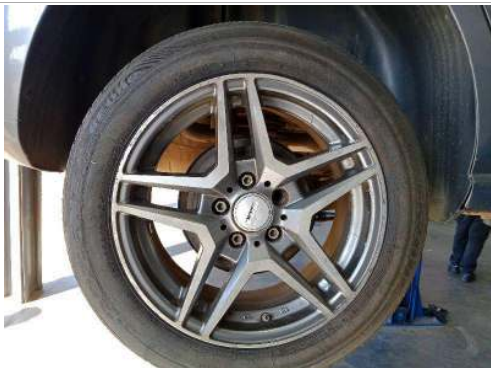
| Damage | Repair Way |
|---|---|
| Rim Rear Right Dented | Repair |

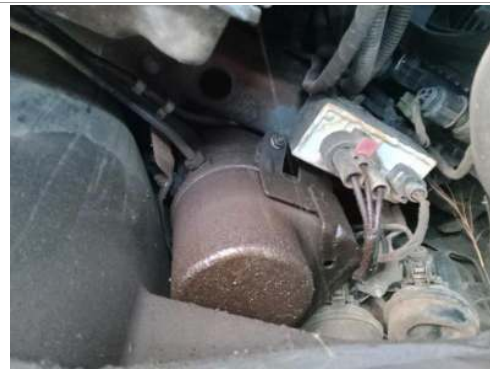
| Damage | Repair Way |
|---|---|
| Power Steering Pump / Electronic Unit Leak | Repair |

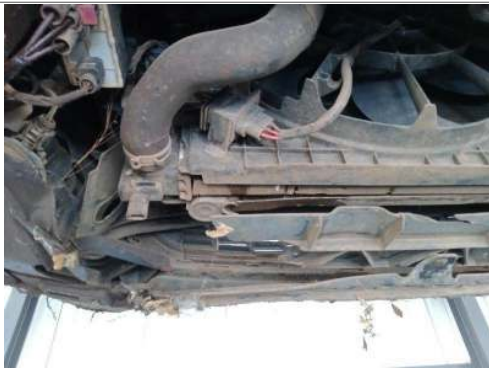
| Damage | Repair Way |
|---|---|
| Radiator Cradle Damaged | Replace |

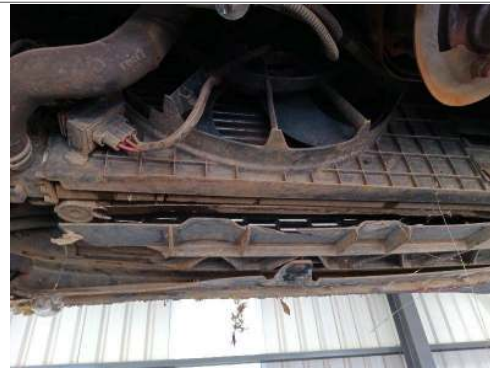
| Damage | Repair Way |
|---|---|
| Radiator Defective | Repair |

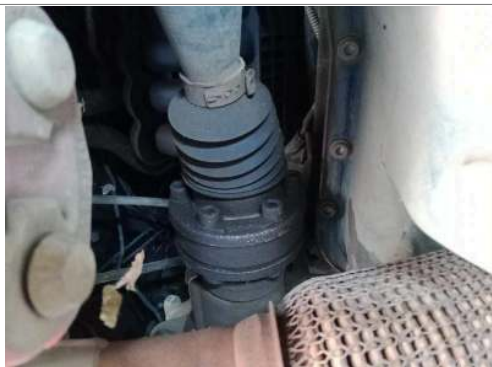
| Damage | Repair Way |
|---|---|
| CV Joint(s) Front Right (inner/outer) Defective | Repair |

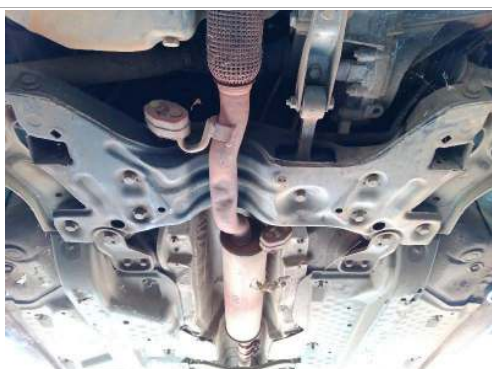
| Damage | Repair Way |
|---|---|
| Sub Frame Dented | Repair |

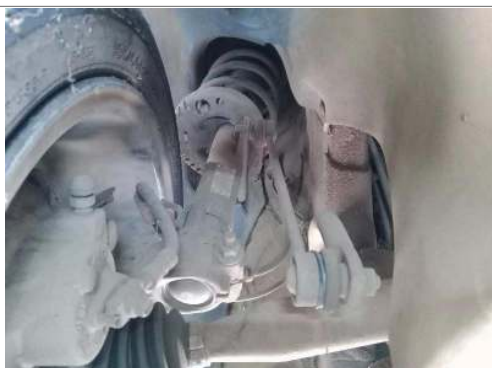
| Damage | Repair Way |
|---|---|
| Stabilizer Mounting Front Right Damaged | Replace |

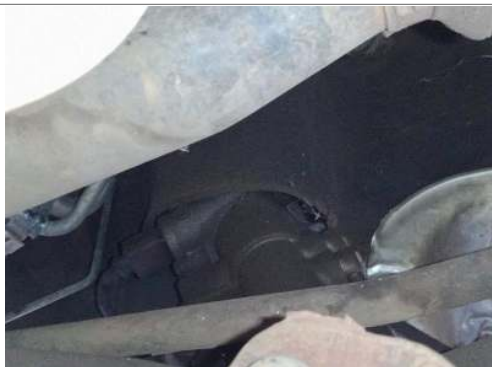
| Damage | Repair Way |
|---|---|
| Steering Rack Defective | Repair |

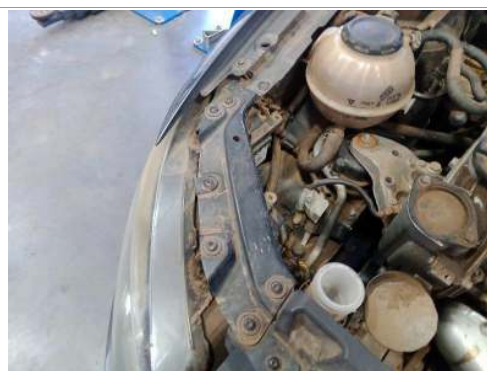
| Damage | Repair Way |
|---|---|
| Bonnet slam plate (Shock tower/ Inner tray) Dented | Repair |

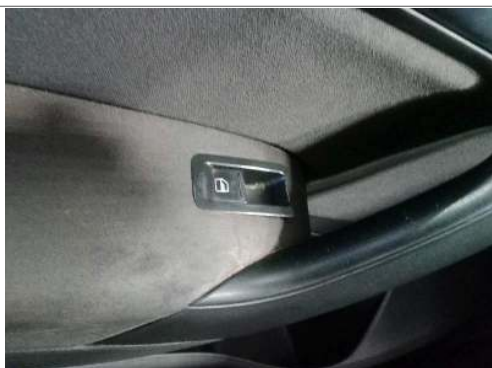
| Damage | Repair Way |
|---|---|
| Switch Electrical Window Winder front left Defective | Repair |

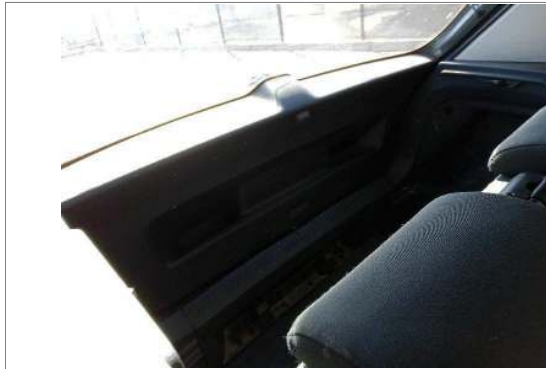
| Damage | Repair Way |
|---|---|
| Parcel Tray Missing | Replace |

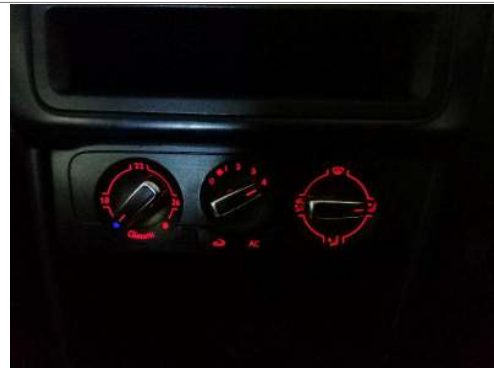
| Damage | Repair Way |
|---|---|
| Air Conditioner Insufficient | Replace |
