CONDITION REPORT

Report No: 2016865442

MFC Auction House
M57 Pretoria Rd, Glenmarais, KEMPTON PARK
Gauteng

Vehicle Type	PASSENGER VEHICLE	Registered Owner	
Manufacturer	VOLKSWAGEN	Registration Number	HC84JGGP
Model	POLO GP 1.2 TSI TRENDLINE 66KW 5-DR [2016-2018]	Register Number	
VIN	AAVZZZ6RZHU109170	Date Of First Licensing	
Engine Number		Last COR	
Doors	5	License Expiry Date	31/10/2025
Color	WHITE	Power / Displacement	
Year Model	2017	Paint Finish	C - COMMON
Km Reading	107,426 KM	Fuel	PETROL
Cab / Body Type	HATCHBACK	Transmission	MANUAL

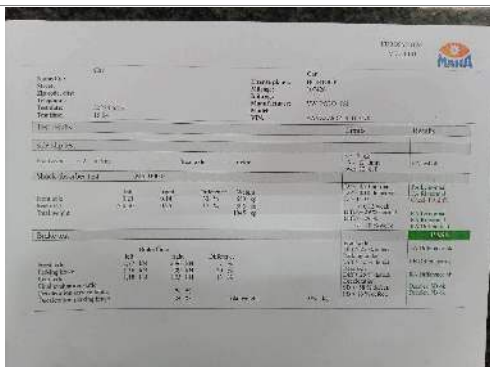
Shock and brake report

Left	Right		
	Braking Force [KN]	Braking Force [KN]	Axle Weight [KG]	Deceleration [m/s ²]
Front	2.7	2.9	-	
Rear	1.1	1.0	-	
Emergency / Parking	1.1	1	-

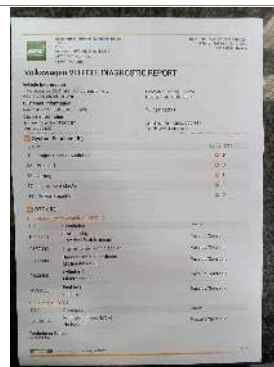
Diagnostic test

No	System	Code	Description	Status
1	ENGINE CONTROL MODULE	P308800	STARTER RELAY	
2	ENGINE CONTROL MODULE	P030000	RANDOM MULTIPLE CYLINDER MISFIRE DETECTED

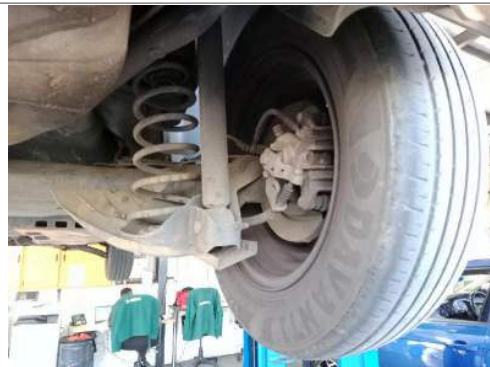
RR TYRE TREAD

Size	Load/Speed Index	Manufacture	Model	Type*	Production Date	Tread Depth (mm)
Front Left	175/70R14	84T	Continental	Control	V	3617	4 mm
Front Right	175/70R14	84T	Continental	Control	V	3617	3 mm
Rear Left	175/70R14	84T	Continental	Control	V	3617	3 mm
Rear Right	175/70R14	88T	Davanti	DX390	V	0820	0 mm
Spare	175/70R14	88T	Davanti	DX390	V	//////	1 mm

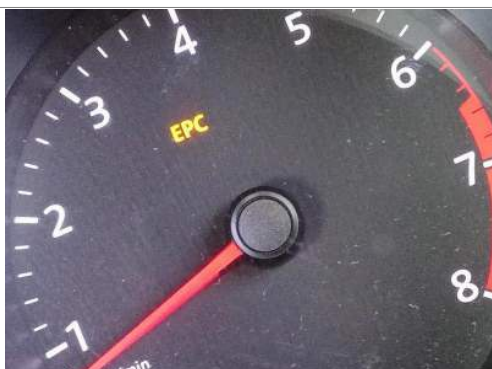
Tyre Rear Right Smooth
Gearbox Oil Sweat
Engine Performance Idling / Hunting
Warning lights illuminated

Replace
Repair
Repair
Repair
