## CONDITION REPORT

Report No: 2016194485

| Manufacturer | VOLKSWAGEN | Registration Number | FXF556L |
| Model | POLO VIVO | Register Number | |

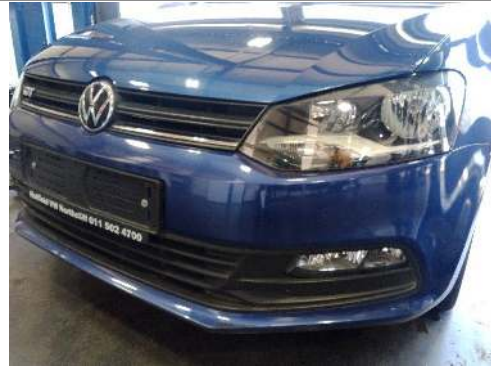
| Damage | Repair Way |
|---|---|
| Front Bumper Damaged | Repair |

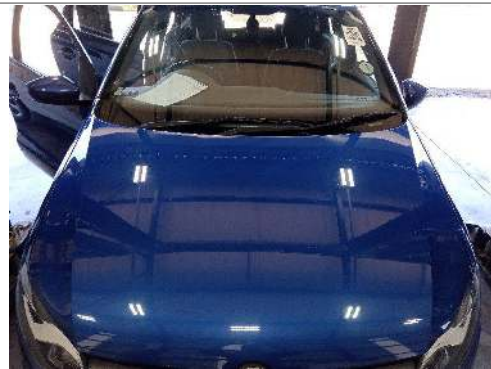
| Damage | Repair Way |
|---|---|
| Bonnet Dented | Repair |

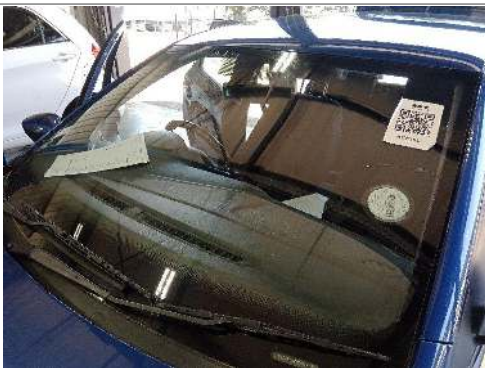
| Damage | Repair Way |
|---|---|
| Windscreen Cracked | Replace |

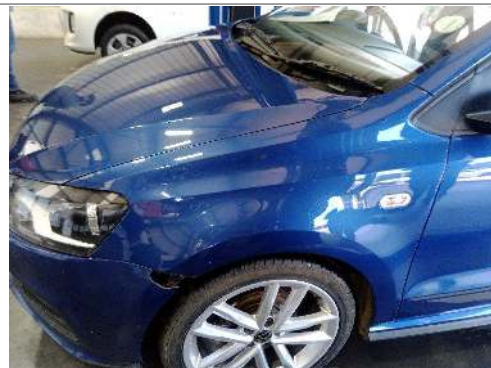
| Damage | Repair Way |
|---|---|
| Front Fender Left Defective | Repair |

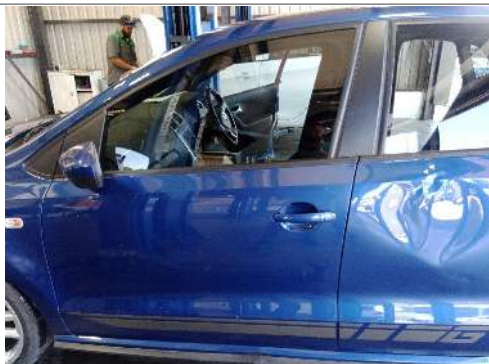
| Damage | Repair Way |
|---|---|
| Door Front Left Paintwork • Scratched | Repair |

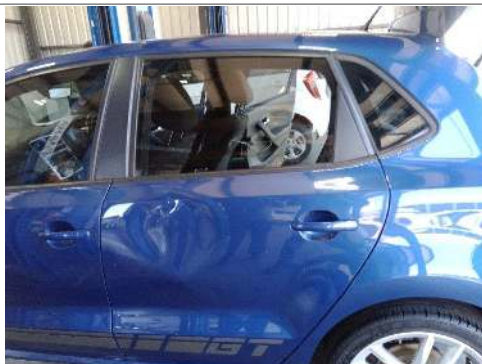
| Damage | Repair Way |
|---|---|
| Door Rear Left Damaged | Repair |

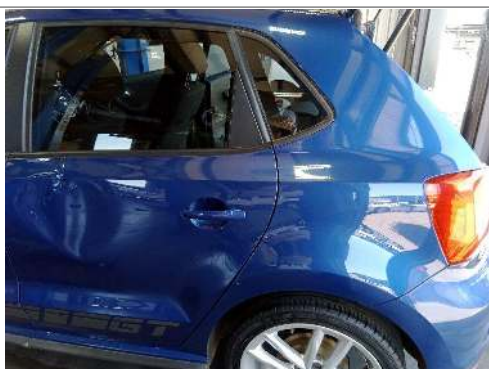
| Damage | Repair Way |
|---|---|
| Rear Fender Left Paintwork • Scratched | Repair |

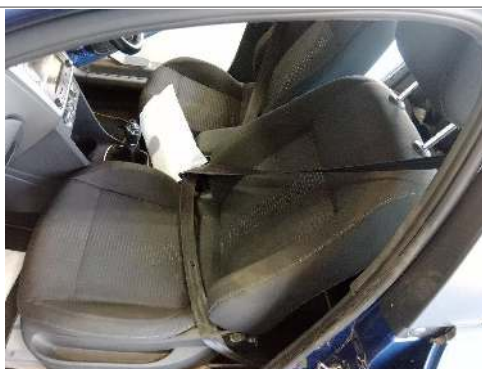
| Damage | Repair Way |
|---|---|
| Seat Front Left Dirty | Repair |

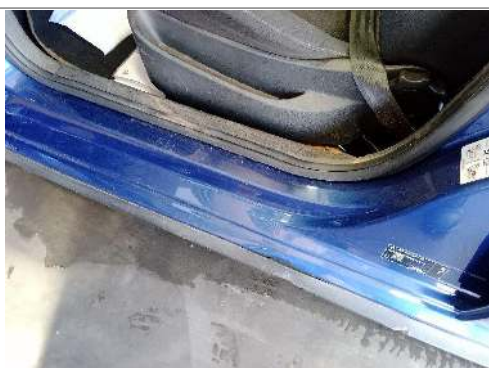
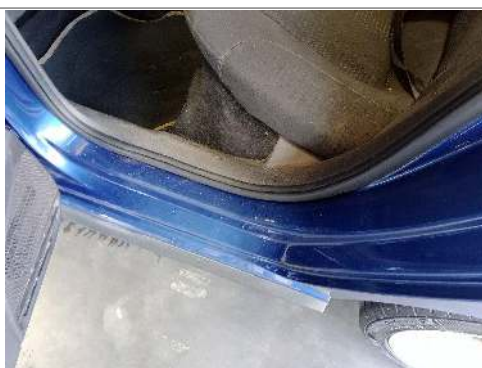
| Damage | Repair Way |
|---|---|
| Sill Panel Left Paintwork • Scratched | Repair |

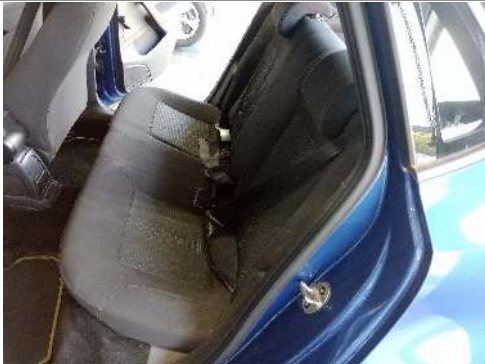
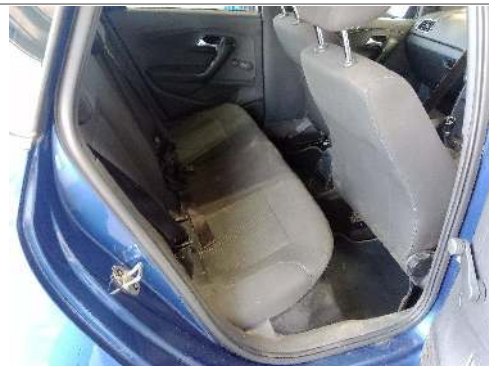
| Damage | Repair Way |
|---|---|
| Seat Rear Damaged | Repair |

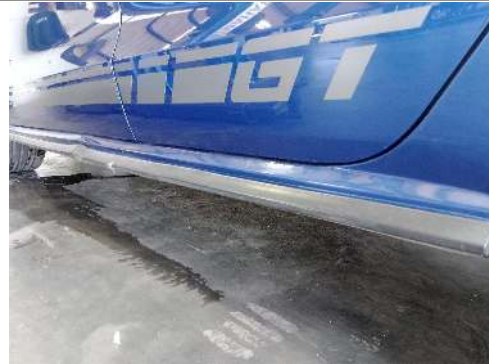
| Damage | Repair Way |
|---|---|
| Rocker Panel Left Damaged | Repair |

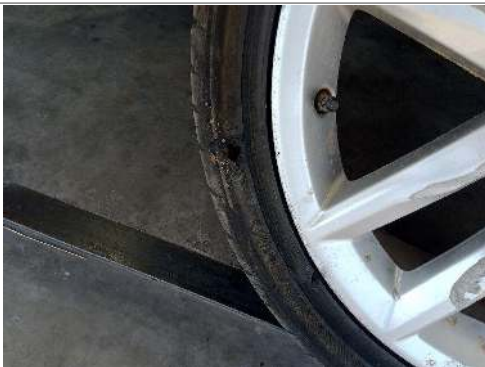
| Damage | Repair Way |
|---|---|
| Spare Tyre Damaged | Replace |

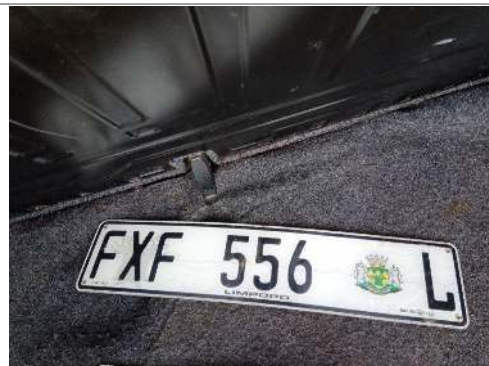
| Damage | Repair Way |
|---|---|
| Number Plate Front Defective | Repair |

General Comments: FRONT AND REAR NUMBER PLATES INSIDE BOOT OF VEHICLE.  
Engine Compartment: Engine bay dirty. Brake fluid level ok. Radiator dented.  
Interior: Vehicle interior dirty and some interior panels scratched.  
Body • Exterior: Dents and scratches on some body panels. Spray work on some body panels. Some body panels misaligned. Stone chips on some body panels.  
Signs of impact damage to front of vehicle.  
Brakes: Front right brake disk dust plate damaged.  
Axle and Suspension: Signs of new suspension parts fitted to front of vehicle. Excessive noise coming from front and rear suspension  
Tyres and Rims: Alloy rims scratched. Rear left and right tyre sizes different.  
Undercarriage: Vehicle undercarriage dirty. Center exhaust bracket dented. Fuel tank scratched. Exhaust heat shields dented.

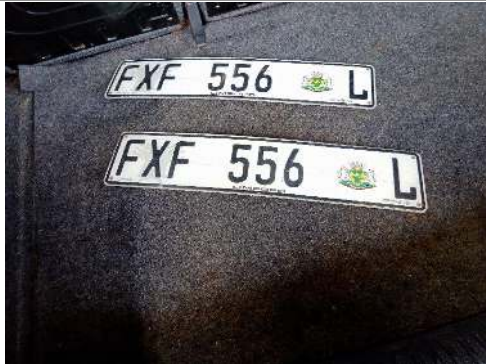
| Damage | Repair Way |
|---|---|
| Number Plate Rear Defective | Repair |

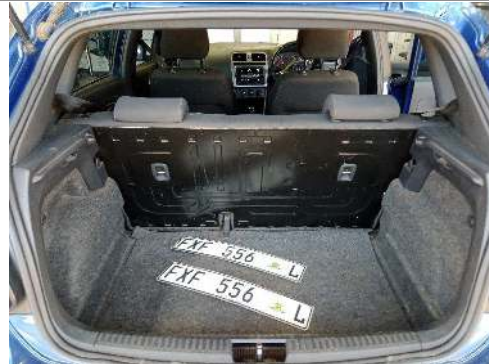
| Damage | Repair Way |
|---|---|
| Parcel Tray Missing | Replace |

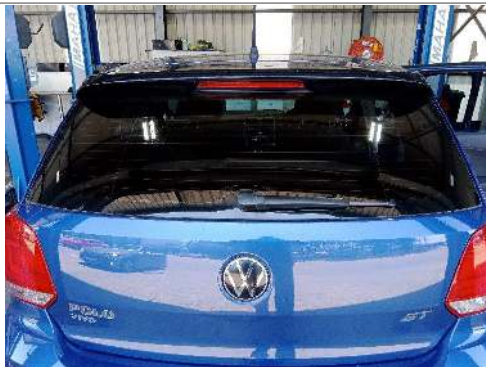
| Damage | Repair Way |
|---|---|
| Boot Lid / Hatch door Paintwork • Scratched | Repair |

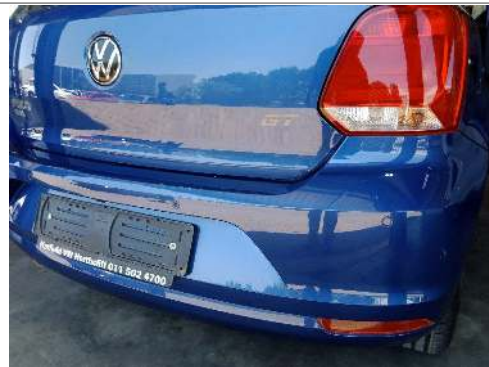
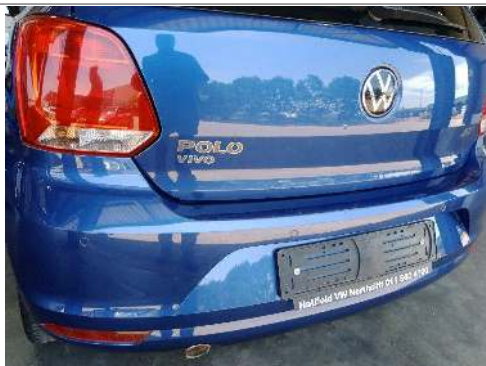
| Damage | Repair Way |
|---|---|
| Rear bumper Paintwork • Scratched | Repair |

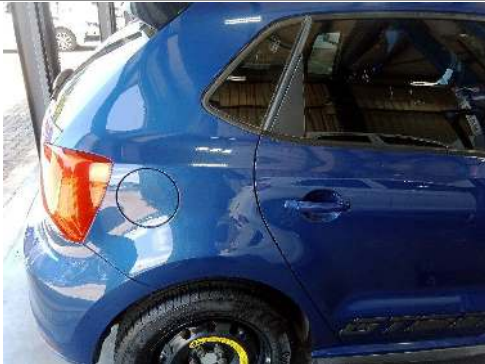
| Damage | Repair Way |
|---|---|
| Rear Fender Right Paintwork • Scratched | Repair |

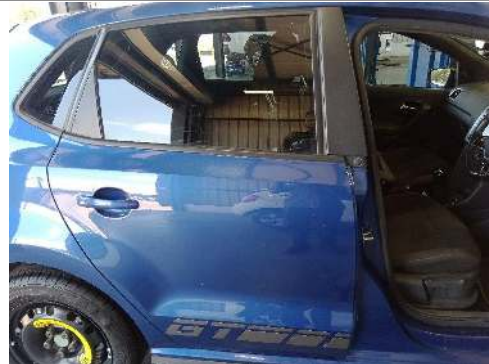
| Damage | Repair Way |
|---|---|
| Door Rear Right Paintwork • Scratched | Repair |

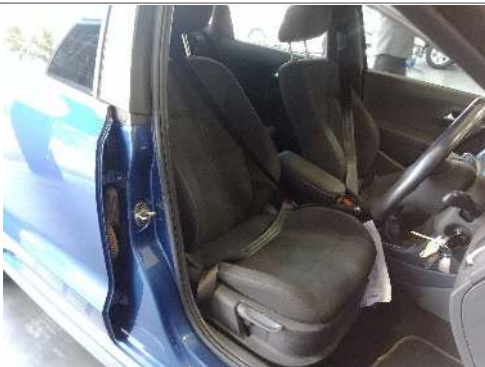
| Damage | Repair Way |
|---|---|
| Seat Front Right Damaged | Repair |

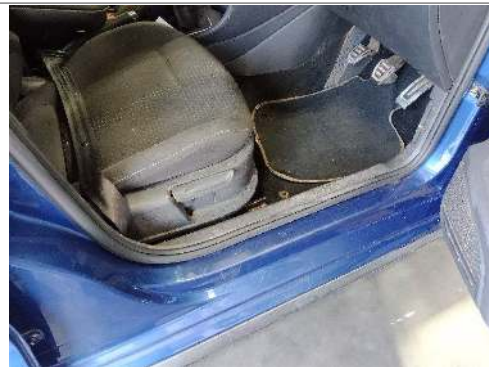
| Damage | Repair Way |
|---|---|
| Sill Panel Right Paintwork • Scratched | Repair |

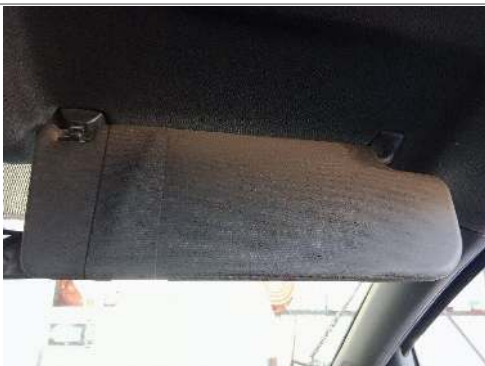
| Damage | Repair Way |
|---|---|
| Sun Visor Right Dirty | Repair |

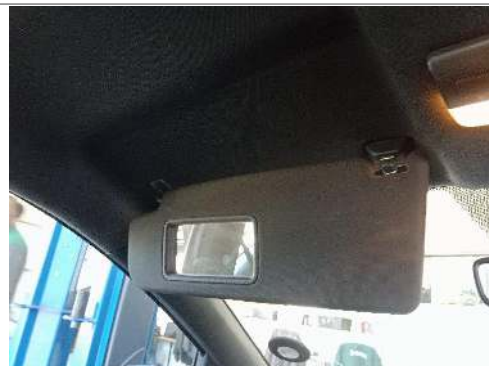
| Damage | Repair Way |
|---|---|
| Sun Visor Left Dirty | Repair |

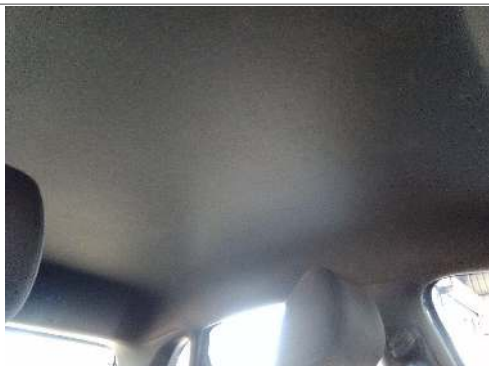
| Damage | Repair Way |
|---|---|
| Hood Lining Dirty | Repair |

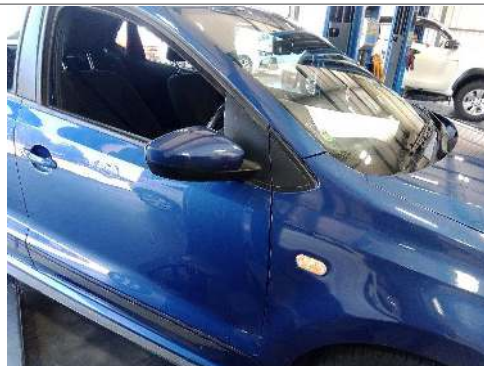
| Damage | Repair Way |
|---|---|
| Door Front Right Dented | Repair |

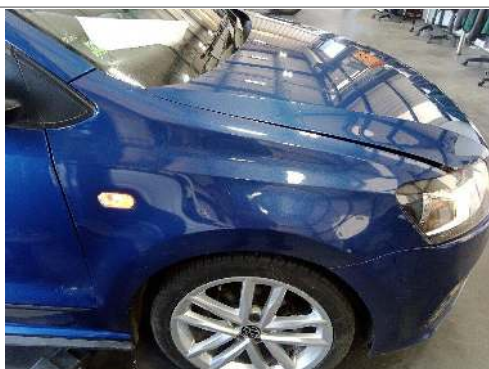
| Damage | Repair Way |
|---|---|
| Front Fender Right Dented | Repair |

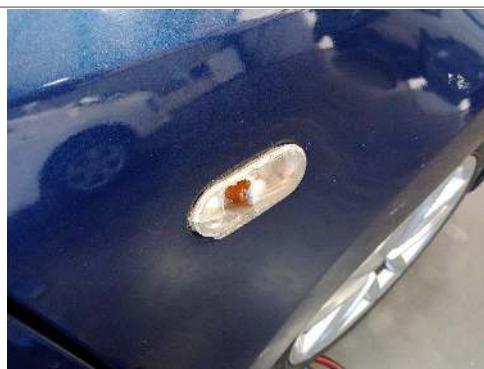
| Damage | Repair Way |
|---|---|
| Indicator Light Front Right Damaged | Replace |

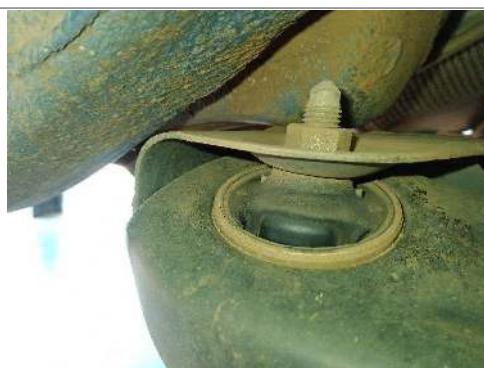
| Damage | Repair Way |
|---|---|
| Control Arm Bush(es) Front Axle Right Cracked | Replace |

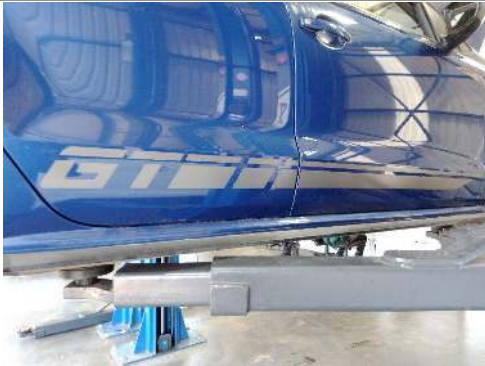
| Damage | Repair Way |
|---|---|
| Rocker Panel Right Damaged | Repair |

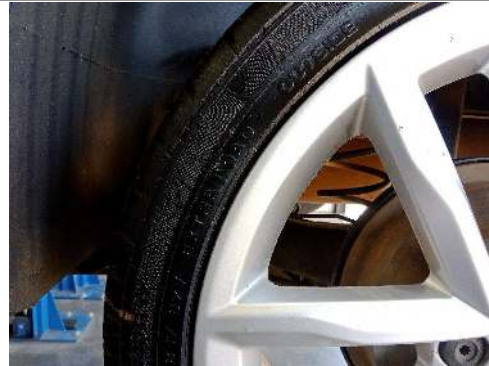
| Damage | Repair Way |
|---|---|
| Tyre Rear Left Torn / Cut | Replace |

| | Size | Load/Speed Index | Manufacture | Model | Type* | Production Date | Tread Depth (mm) |
|---|---|---|---|---|---|---|---|
| Rear Left | 215/40 R17 | 87V | Continental | Contipremuim | V | 2422 | 3 mm |

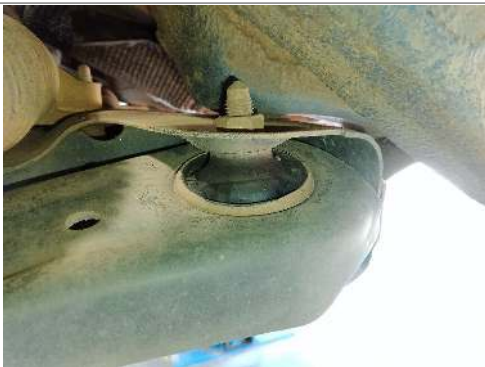
| Damage | Repair Way |
|---|---|
| Control Arm Bush(es) Front Axle Left Cracked | Replace |

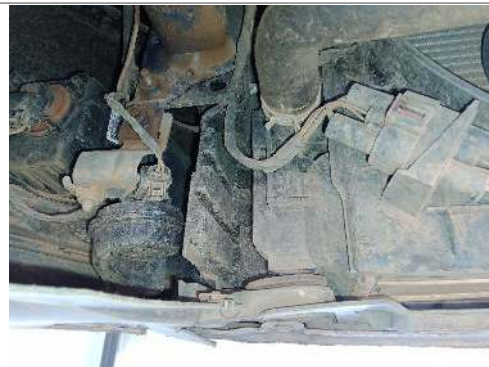
| Damage | Repair Way |
|---|---|
| Radiator Cradle Damaged | Replace |

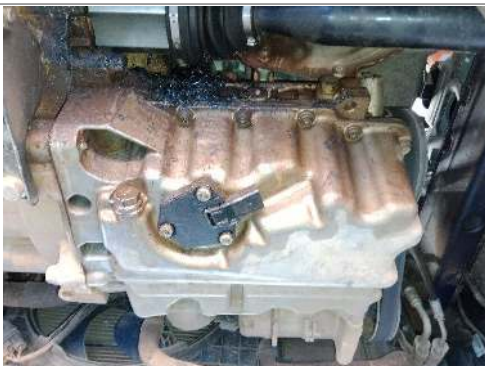
| Damage | Repair Way |
|---|---|
| Engine Oil Leak | Repair |

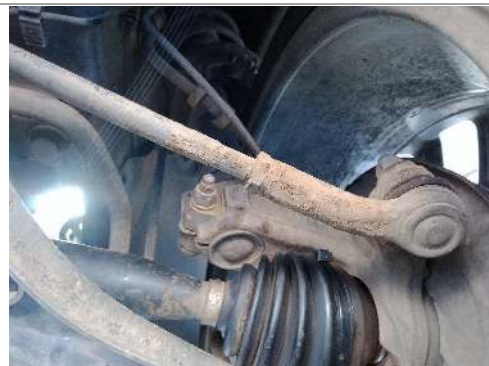
Tie Rod End right VIN: AAVZZZ6RZNU017670

| Damage | Repair Way |
|---|---|
| Tie Rod End right Defective | Replace |

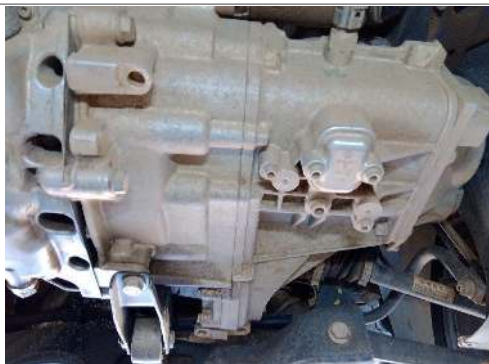
| Damage | Repair Way |
|---|---|
| Gearbox Oil Sweat | Repair |

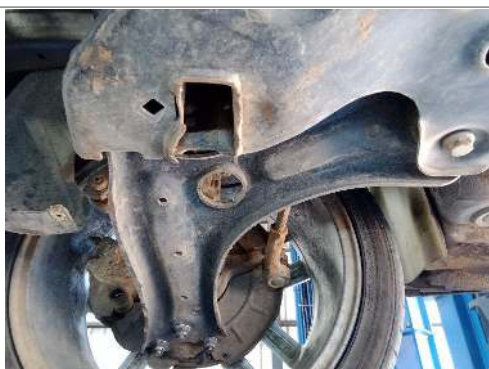
| Damage | Repair Way |
|---|---|
| Control Arm(s) Front Axle Right Defective | Replace |

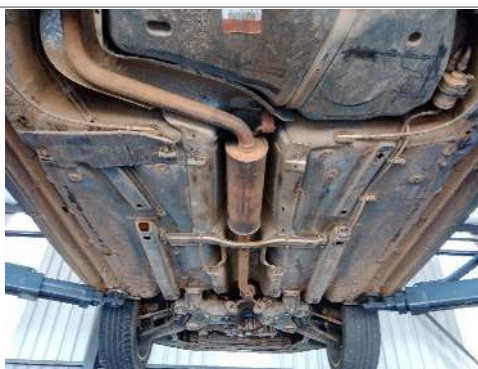
| Damage | Repair Way |
|---|---|
| Chassis Damaged | Repair |

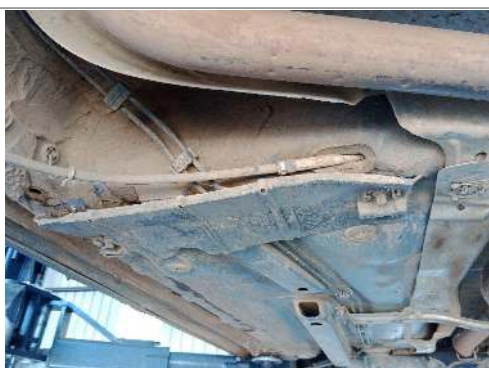
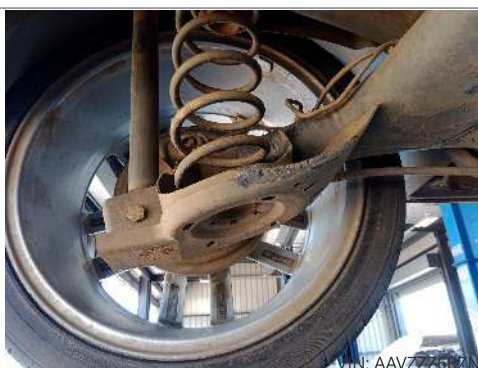
| Damage | Repair Way |
|---|---|
| Belly plates Damaged | Replace |

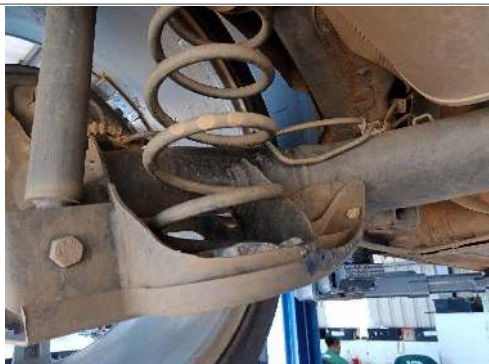
| Damage | Repair Way |
|---|---|
| Rear Axle Defective | Repair |

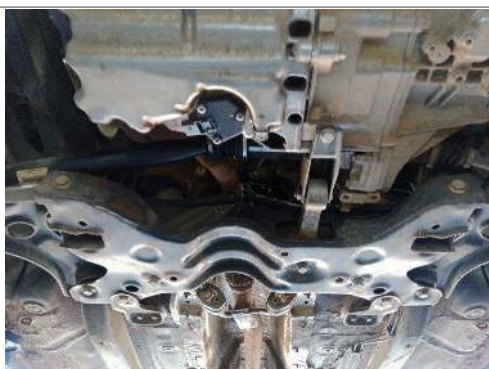
| Damage | Repair Way |
|---|---|
| Sub Frame Dented | Repair |

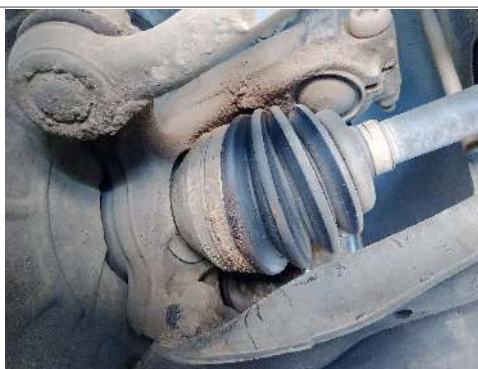
| Damage | Repair Way |
|---|---|
| CV Joint(s) Boot(s) Front Left (inner/outer) Defective | Replace |

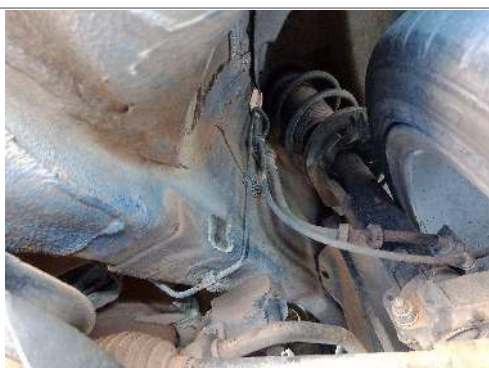
| Damage | Repair Way |
|---|---|
| Front Fender Right / Inner Tray Paintwork • Scratched | Repair |

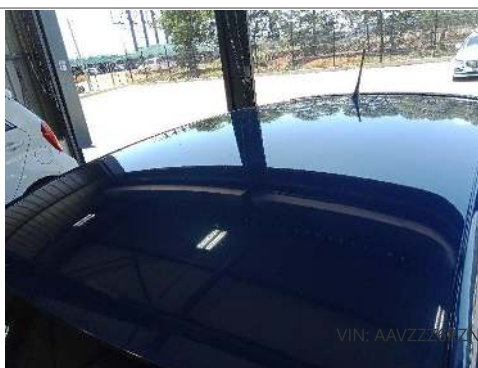
| Damage | Repair Way |
|---|---|
| Roof Paintwork • Chipmarks | Repair |

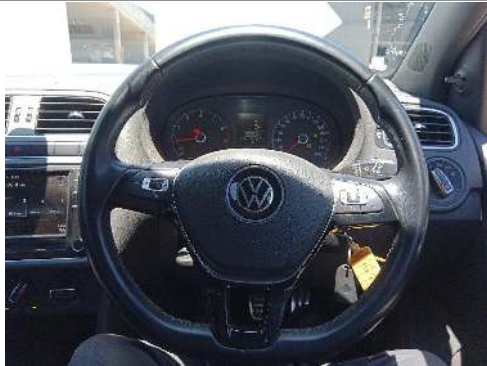
| Damage | Repair Way |
|---|---|
| Steering Wheel Trim Defective | Repair |
