MFC Auction House  
M57 Pretoria Rd, Glenmarais, KEMPTON PARK  
Gauteng

DEKRA MFC  
M57 Pretoria Rd - 1619  
KEMPTON PARK - GT  
08610 33572

## Assignment

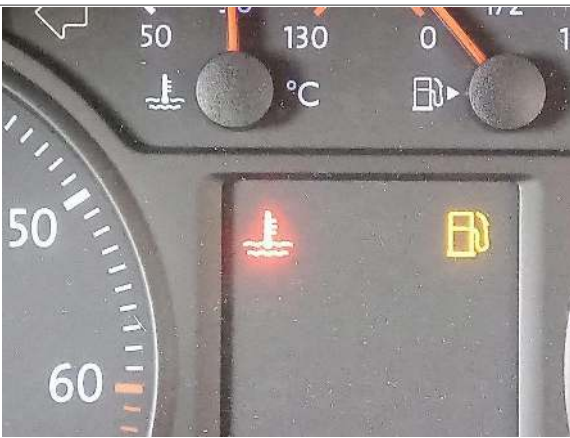
| | Damage | Repair Way |
|---|---|---|
| | Warning light illuminated | Repair |

Warning light illuminated

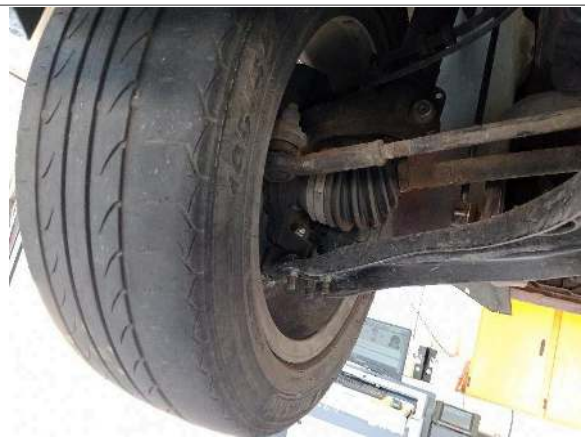
LF TYRE TREAD

| | Damage | Repair Way |
|---|---|---|
| | Tyre Front Left Smooth | Replace |

| | Size | Load/Speed Index | Manufacture | Model | Type* | Production Date | Tread Depth (mm) |
|---|---|---|---|---|---|---|---|
| Front Left | 195/55R15 | 85V | Landsail | LS388 | V | 2017 | 0 mm |

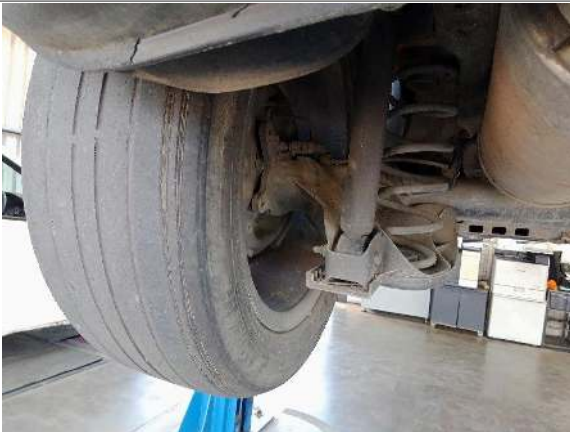
LR TYRE TREAD

| | Damage | Repair Way |
|---|---|---|
| | Tyre Rear Left Excessive Wear & Tear | Replace |

| | Size | Load/Speed Index | Manufacture | Model | Type* | Production Date | Tread Depth (mm) |
|---|---|---|---|---|---|---|---|
| Rear Left | 195/55R15 | 85V | Landsail | LS388 | V | 0000 | 0 mm |

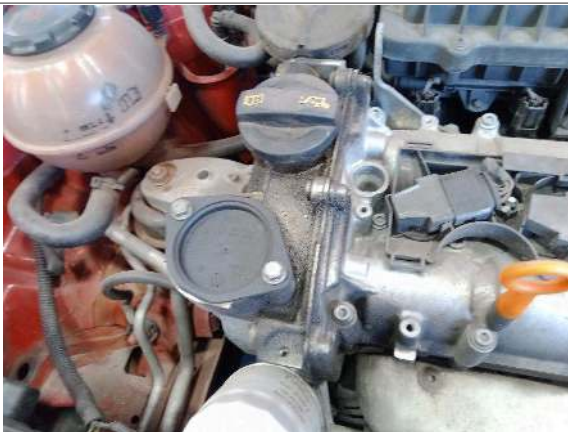
| | Damage | Repair Way |
|---|---|---|
| | Engine Leak | Repair |
| | Engine Noise Excessive | Repair |

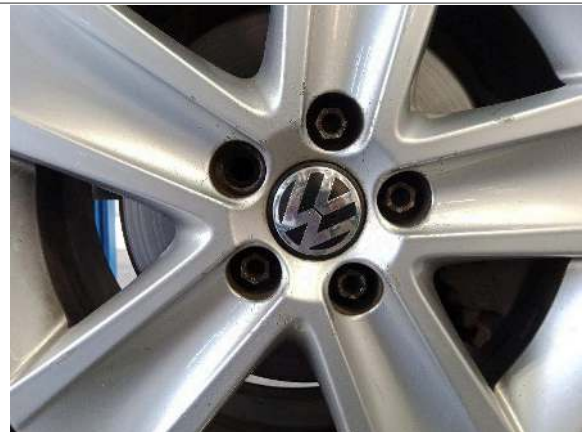
| | Damage | Repair Way |
|---|---|---|
| | Bolt(s) / Nut(s) Front Wheel Right Missing | Replace |

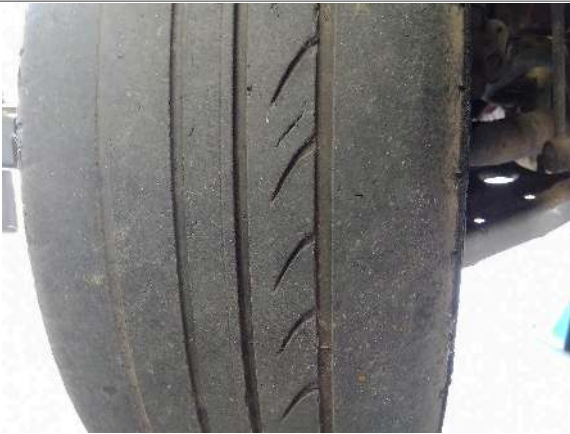
| | Damage | Repair Way |
|---|---|---|
| | Tyre Front Right Smooth | Replace |

| | Size | Load/Speed Index | Manufacture | Model | Type* | Production Date | Tread Depth (mm) |
|---|---|---|---|---|---|---|---|
| Front Right | 195/55R15 | 85V | Landsail | LS388 | V | 2017 | 0 mm |

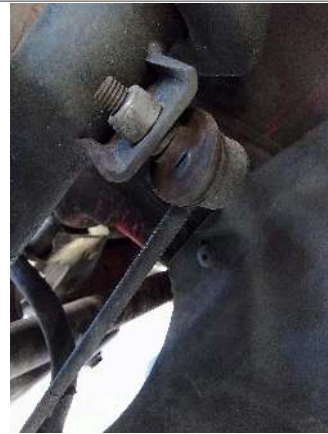
| | Damage | Repair Way |
|---|---|---|
| | Stabilizer Mounting Front Right Damaged | Replace |

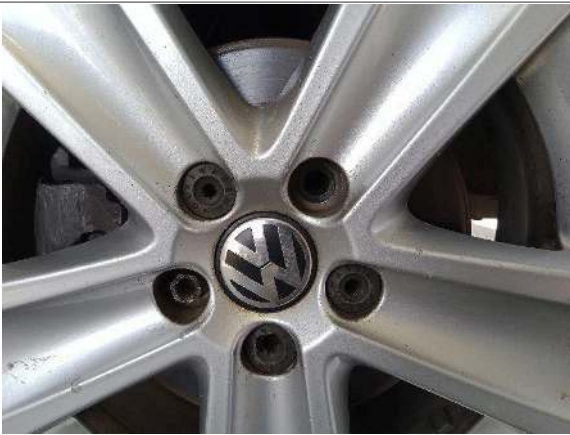
| | Damage | Repair Way |
|---|---|---|
| | Bolt(s) / Nut(s) Front Wheel Left Missing | Replace |

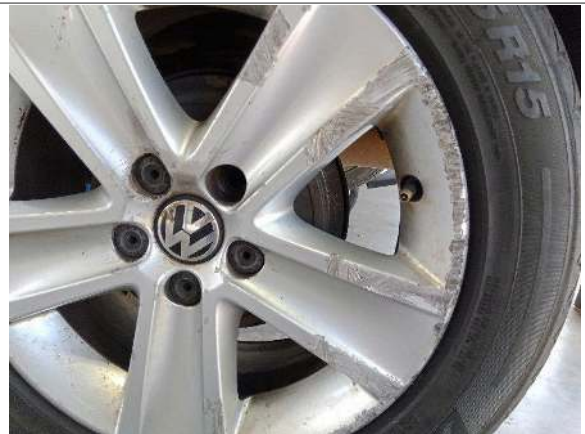
| | Damage | Repair Way |
|---|---|---|
| | Rim Rear Left Scratched | Replace |

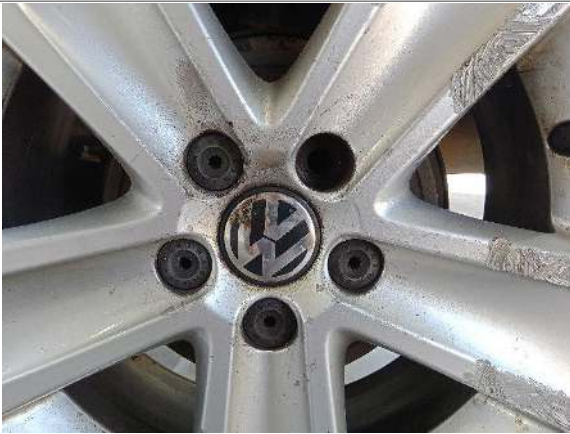
| | Damage | Repair Way |
|---|---|---|
| | Bolt(s) / Nut(s) Rear Wheel Left Missing | Replace |

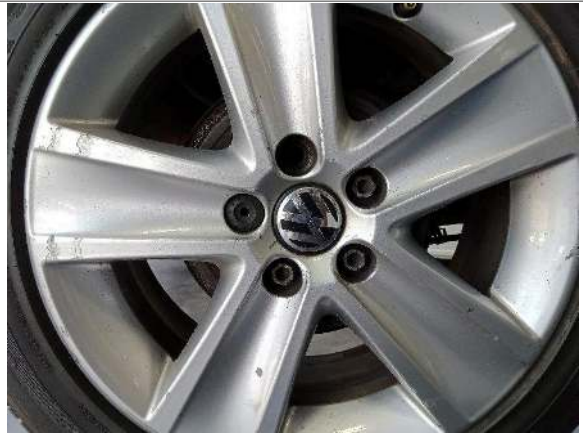
| | Damage | Repair Way |
|---|---|---|
| | Bolt(s) / Nut(s) Rear Wheel Right Missing | Replace |

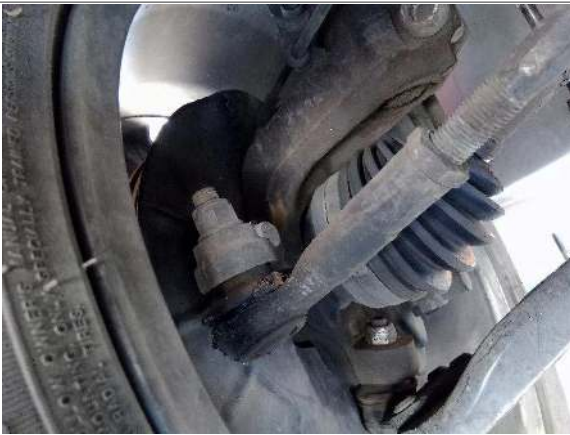
| | Damage | Repair Way |
|---|---|---|
| | Tie Rod End left Damaged | Replace |

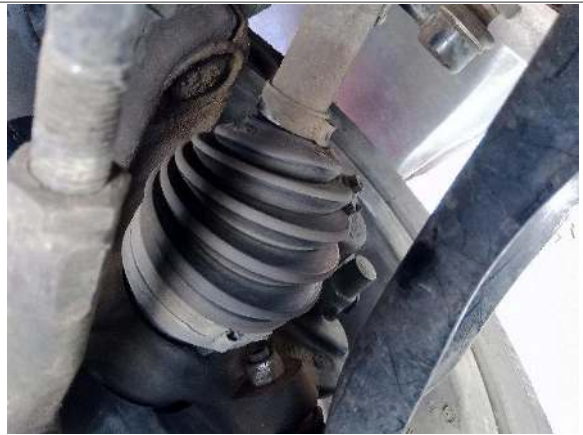
| | Damage | Repair Way |
|---|---|---|
| | CV Joint(s) Boot(s) Front Left (inner/outer) Damaged | Replace |

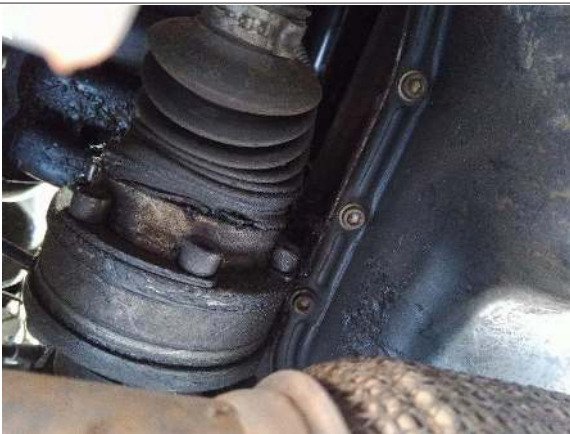
| | Damage | Repair Way |
|---|---|---|
| | CV Joint(s) Boot(s) Front Right (inner/outer) Damaged | Replace |

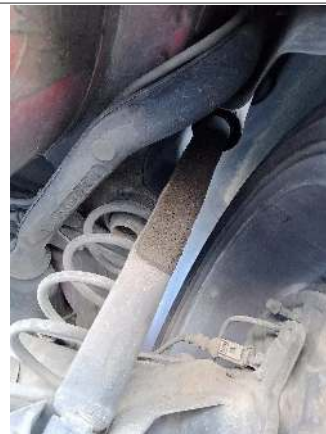
| | Damage | Repair Way |
|---|---|---|
| | Shock Absorber Rear Right Sweat | Replace |

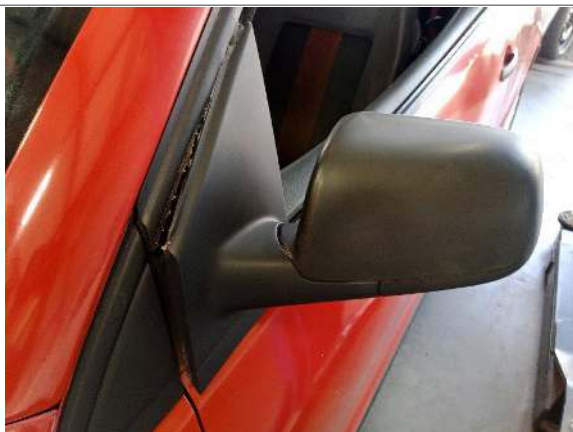
| | Damage | Repair Way |
|---|---|---|
| | Side Mirror Left Damaged | Repair |

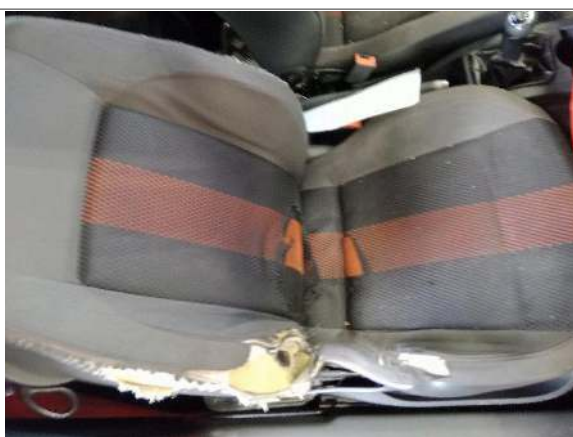
| | Damage | Repair Way |
|---|---|---|
| | Seat Front Right Torn / Cut | Repair |

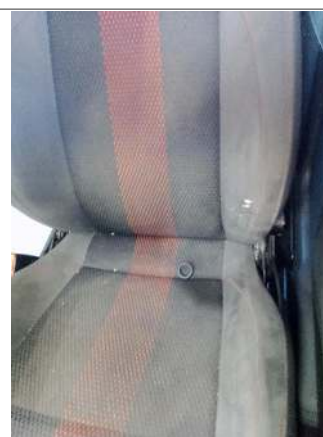
| | Damage | Repair Way |
|---|---|---|
| | Seat Front Left Torn / Cut | Repair |

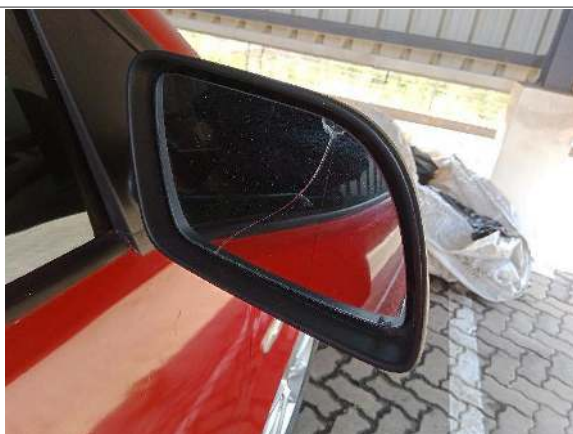
| | Damage | Repair Way |
|---|---|---|
| | Side Mirror Right Damaged | Replace |
