## CONDITION REPORT

Report No:  
2016999506  
DATE  
02/09/2025

MFC Auction House  
M57 Pretoria Rd, Glenmarais, KEMPTON PARK  
Gauteng

Vehicle Type	PASSENGER VEHICLE	Registered Owner	MFC
Manufacturer	VOLKSWAGEN	Registration Number	HVG956MP
Model	POLO VIVO GP 1.6 77KW MAXX 5-DR [2014-2016]	Register Number	
VIN	AAVZZZ6SZFU008157	Date Of First Licensing	
Engine Number		Last COR	
Doors	5	License Expiry Date	31/01/2025
Color	SILVER	Power / Displacement	
Year Model	2014	Paint Finish	TWO COAT METALLIC
Km Reading	207,985 KM	Fuel	PETROL
Cab / Body Type	HATCHBACK	Transmission	MANUAL

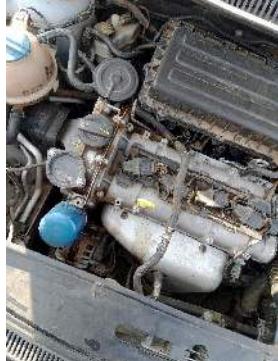
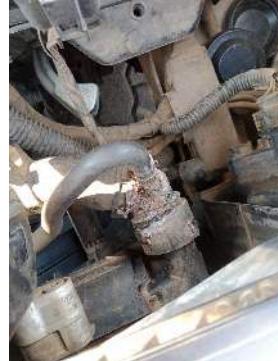
Damage	Repair Way
Engine Damaged	Replace
Hoses Damaged	Replace
Radio/CD/USB Damaged	Replace
Headlight Left Damaged	Repair
Headlight Right Damaged	Repair
Seat Front Left Damaged	Repair
Seat Front Right Damaged	Repair
Seat Rear Damaged	Repair
Sun Visor Right Damaged	Repair
Parcel Tray Damaged	Repair
Side Mirror Right Damaged	Repair
Front Bumper Damaged	Repair
Bonnet Damaged	Repair
Front Fender Left Damaged	Repair
Front Fender Right Damaged	Repair
Rear Fender Left Damaged	Repair
Rear Fender Right Damaged	Repair
Door Front Right Damaged	Repair
Door Rear Right Damaged	Repair
Boot Lid / Hatch door Damaged	Repair
Rear bumper Damaged	Repair
Shock Absorber Front Right Damaged	Replace
Tyre Front Left Worn	Replace
Tyre Front Right Worn	Replace
Tyre Rear Left Worn	Replace
Sub Frame Damaged	Repair
Engine to silencer pipe Welded	Replace
Silencer Missing	Repair
CV Joint(s) Boot(s) Front Left (inner/outer) Damaged	Replace
CV Joint(s) Boot(s) Front Right (inner/outer) Damaged	Replace

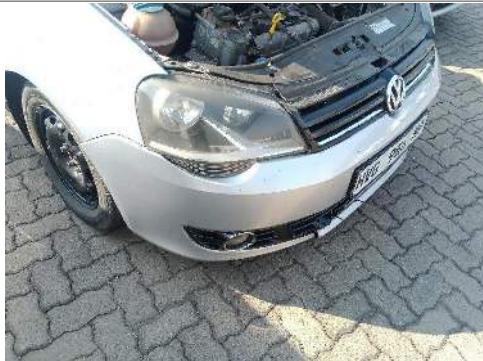
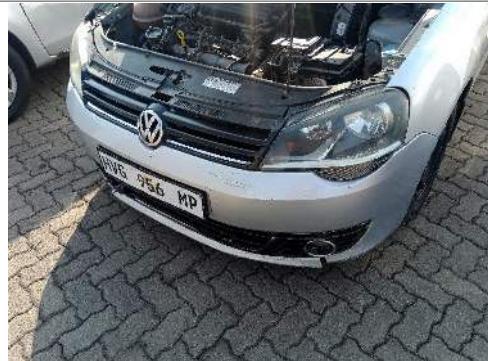
Front Bumper

General Comments: ACCORDING TO THE AGE AND MILEAGE OF THE VEHICLE, NORMAL WEAR AND TEAR MARKS ARE VISIBLE ON THE INTERIOR, EXTERIOR, ELECTRICAL AND MECHANICAL PARTS. Body • Exterior: Minor dents and scratches and stone chips to some body panels. Signs of repair work done to somebody panels. Poor alignment to somebody panels. Signs of impact damage to front of vehicle.

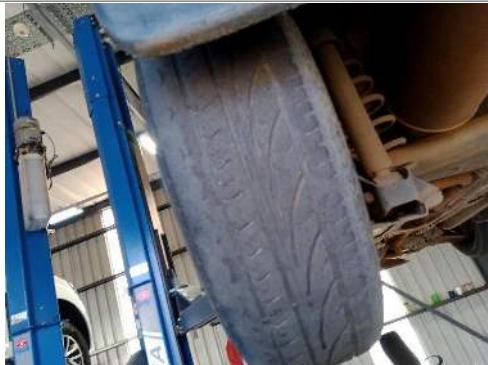
Tyre Rear Left

Size	Load/Speed Index	Manufacture	Model	Type*	Production Date	Tread Depth (mm)
Front Left	165/70R14	81S	Bridgestone	Radial	V	3617	0 mm
Front Right	175/65R14	82T	Bridgestone	Radial	V	1516	0 mm
Rear Left	175/65R14	86H	Radar	Radial	V	1123	0 mm
Rear Right	215/40R17	87V	Continental	Contipremiu	V	2217	1 mm

Brakes: rear tire sizes do not match.

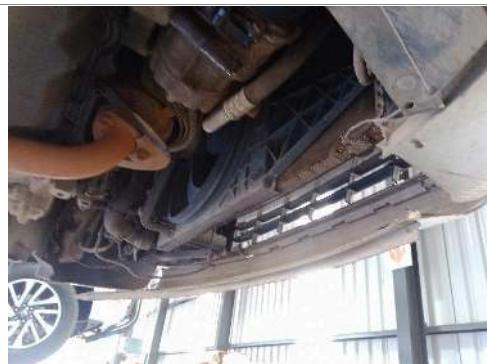
Radiator Cradle Damaged	Replace
Warning light illuminated	Repair
