CONDITION REPORT

Report No:  
2016904811  
DATE  
06/06/2025

| Manufacturer | VOLKSWAGEN | Registration Number | KVM657NW |
| Model | POLO VIVO GP 1.4 55KW CONCEPTLINE 5-DR [2016-2018] | Register Number | |

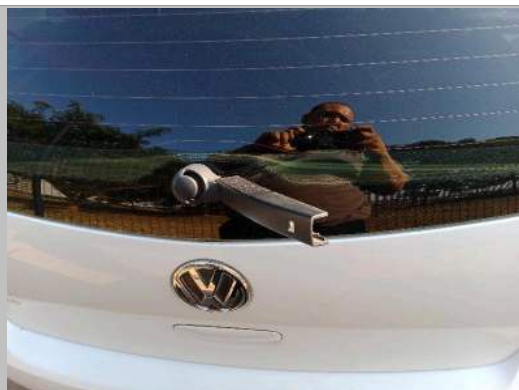
| Damage | Repair Way |
|---|---|
| Windscreen Wiper Missing | Replace |

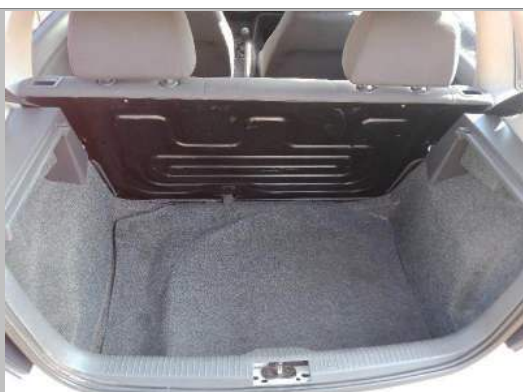
| Damage | Repair Way |
|---|---|
| Parcel Tray Missing | Replace |

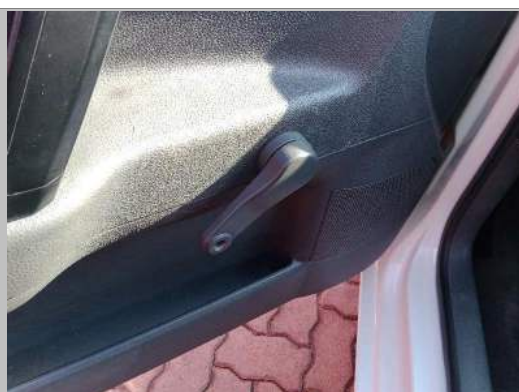
| Damage | Repair Way |
|---|---|
| Window Winder front left Defective | Repair |

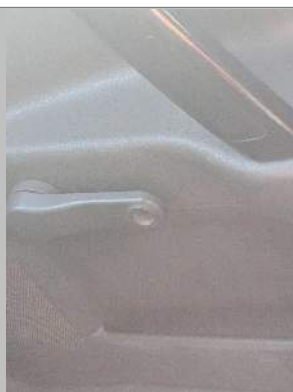
| Damage | Repair Way |
|---|---|
| Window Winder front right Defective | Repair |

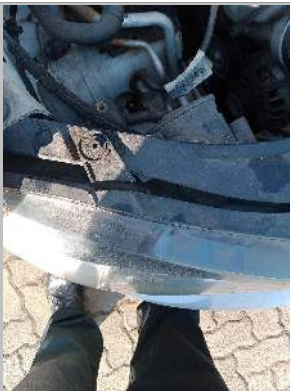
| Damage | Repair Way |
|---|---|
| Headlight Right Damaged | Repair |

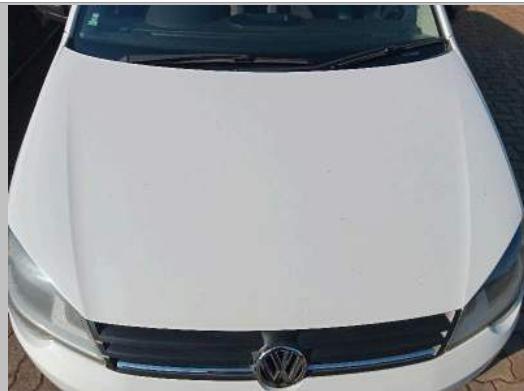
| Damage | Repair Way |
|---|---|
| Bonnet Paintwork • Chipmarks | Repair |

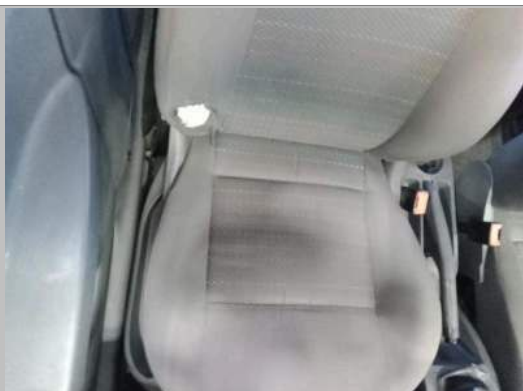
| Damage | Repair Way |
|---|---|
| Seat Front Right Torn / Cut | Repair |

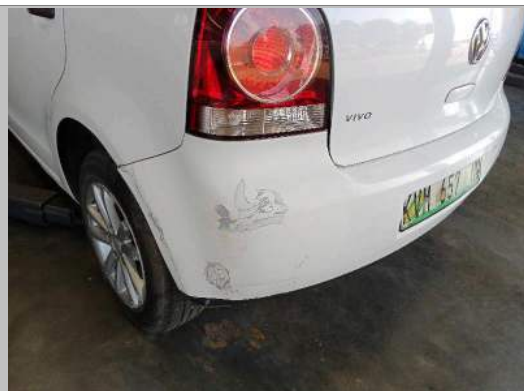
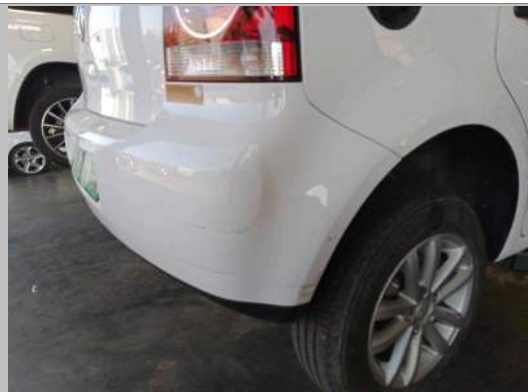
| Damage | Repair Way |
|---|---|
| Rear bumper Residual Traces of Repair | Repair |

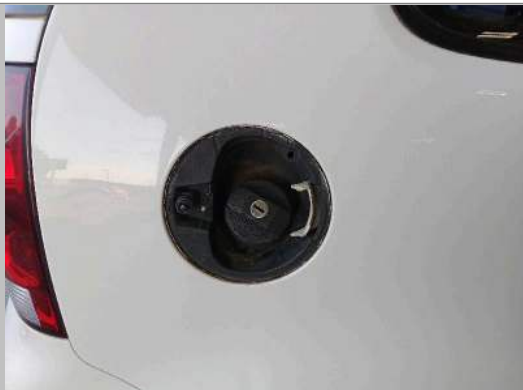
| Damage | Repair Way |
|---|---|
| Fuel Flap Damaged | Repair |

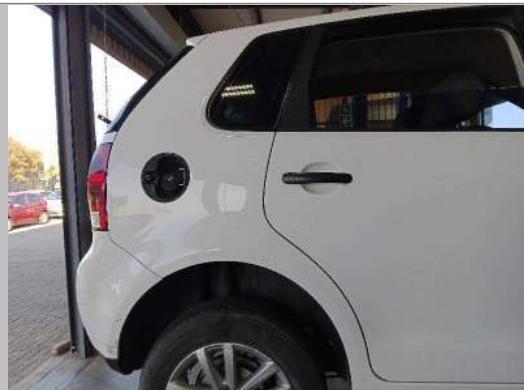
| Damage | Repair Way |
|---|---|
| Rear Fender Right Paintwork • Scratched | Repair |

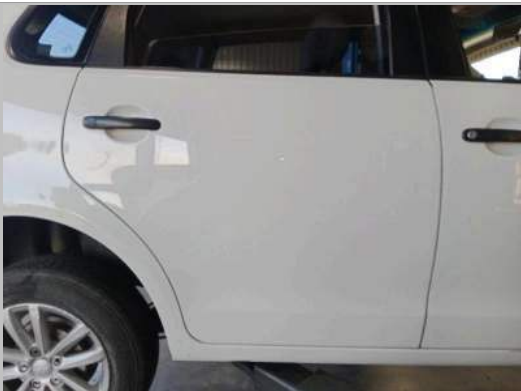
| Damage | Repair Way |
|---|---|
| Door Rear Right Paintwork • Scratched | Repair |

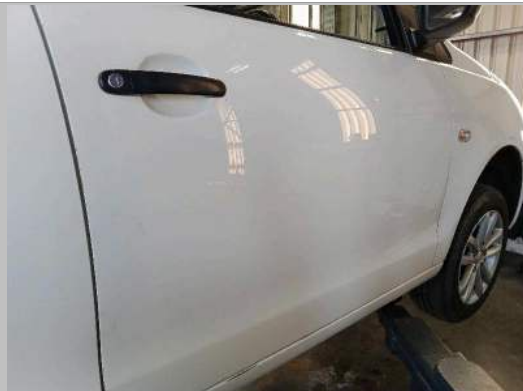
| Damage | Repair Way |
|---|---|
| Door Front Right Paintwork • Scratched | Repair |

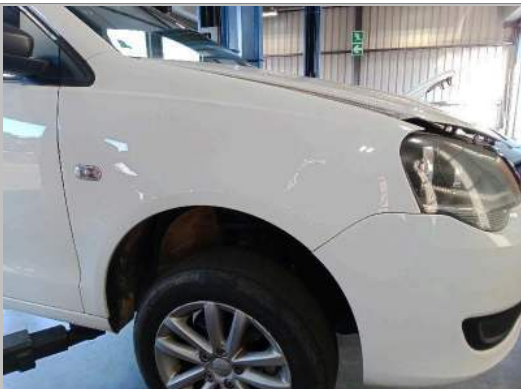
| Damage | Repair Way |
|---|---|
| Front Fender Right Paintwork • Scratched | Repair |

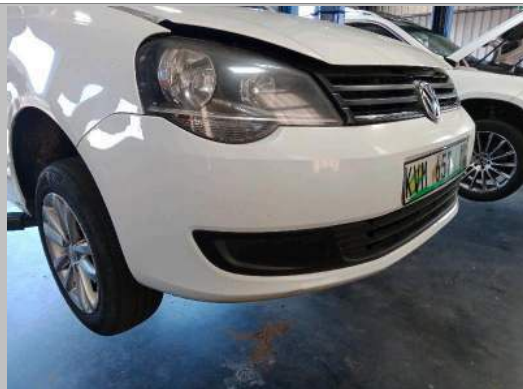
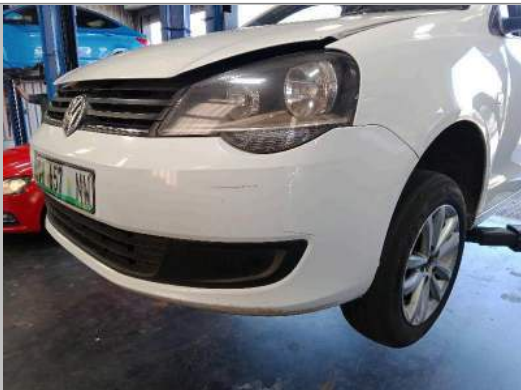
| Damage | Repair Way |
|---|---|
| Front Bumper Paintwork • Scratched | Repair |

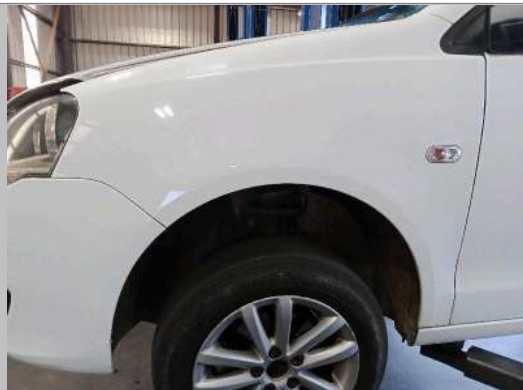
| Damage | Repair Way |
|---|---|
| Front Fender Left Paintwork • Scratched | Repair |

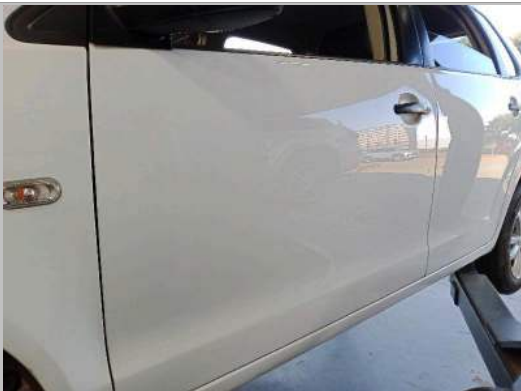
| Damage | Repair Way |
|---|---|
| Door Front Left Dented | Repair |

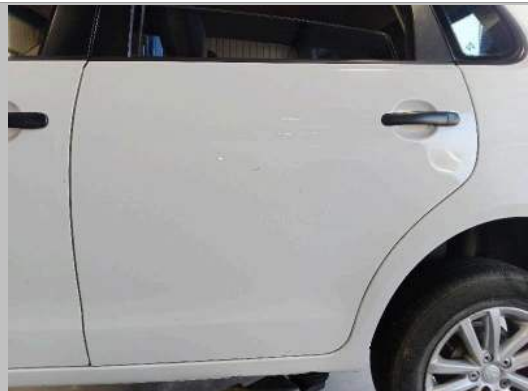
| Damage | Repair Way |
|---|---|
| Door Rear Left Paintwork • Scratched | Repair |

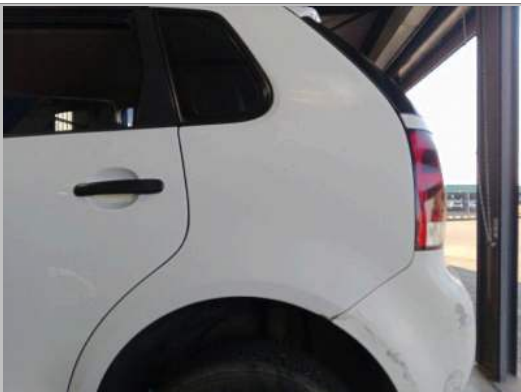
| Damage | Repair Way |
|---|---|
| Rear Fender Left Paintwork • Scratched | Repair |

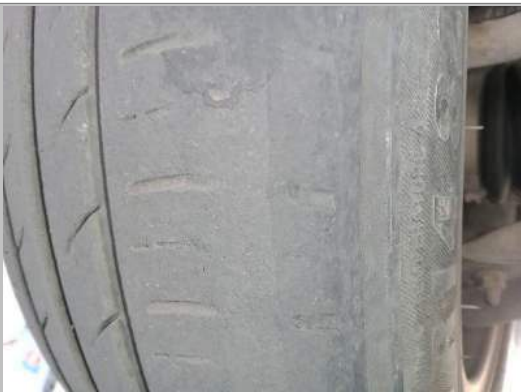
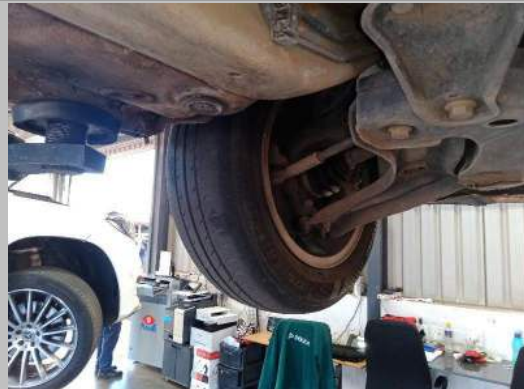
| Damage | Repair Way |
|---|---|
| Tyre Front Left Smooth | Replace |

| | Size | Load/Speed Index | Manufacture | Model | Type* | Production Date | Tread Depth (mm) |
|---|---|---|---|---|---|---|---|
| Front Left | 175/65R14 | 82T | Kumho | Ecowing | V | 1622 | 0 mm |

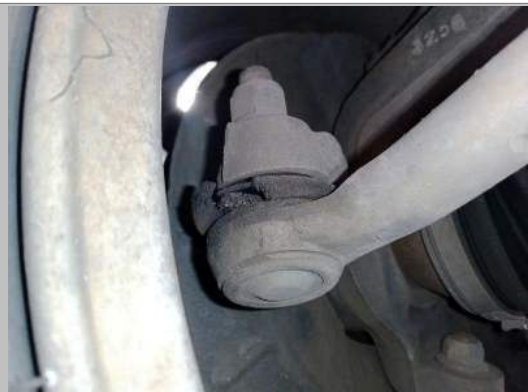
| Damage | Repair Way |
|---|---|
| Tie Rod End left Damaged | Replace |

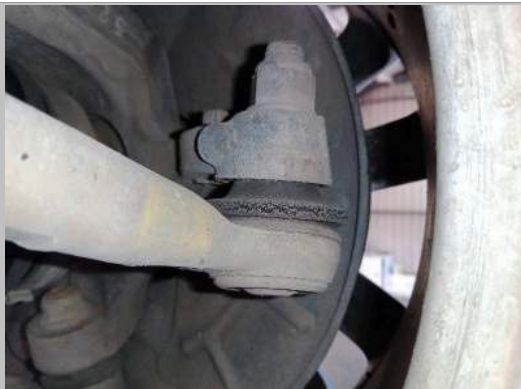
| Damage | Repair Way |
|---|---|
| Tie Rod End right Cracked | Replace |

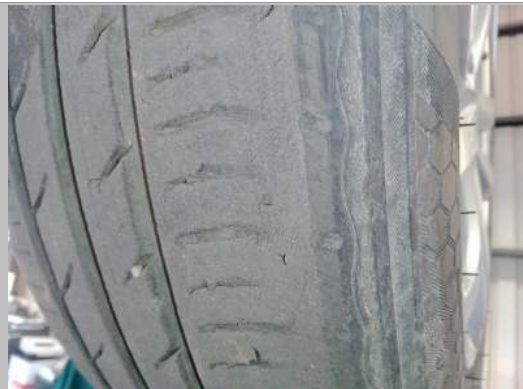
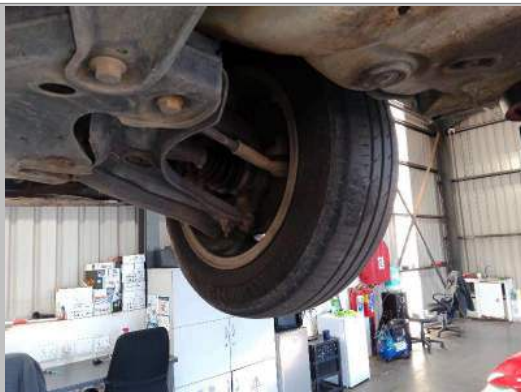
| Damage | Repair Way |
|---|---|
| Tyre Front Right Smooth | Replace |

| | Size | Load/Speed Index | Manufacture | Model | Type* | Production Date | Tread Depth (mm) |
|---|---|---|---|---|---|---|---|
| Front Right | 175/65R14 | 82T | Kumho | Ecowing | V | 1622 | 0 mm |

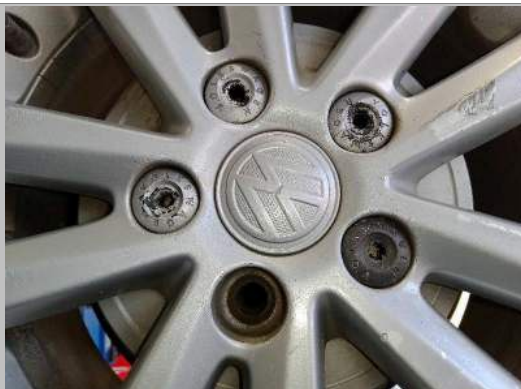
| Damage | Repair Way |
|---|---|
| Bolt(s) / Nut(s) Rear Wheel Left Missing | Replace |

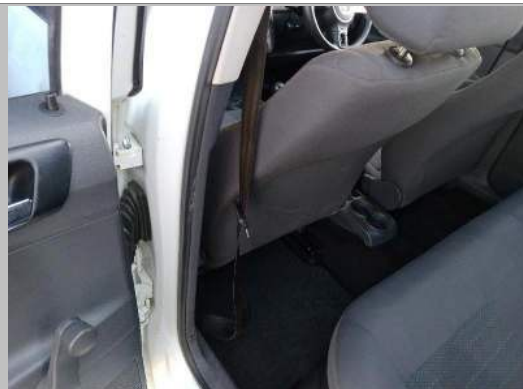
| Damage | Repair Way |
|---|---|
| Seat Belt Front Left Defective | Repair |
