CONDITION REPORT

Report No: 2016223324

MFC Auction House
M57 Pretoria Rd, Glenmarais, KEMPTON PARK
Gauteng

Vehicle Type	PASSENGER VEHICLE	Registered Owner	MFC
Manufacturer	VOLKSWAGEN	Registration Number	KPW468NW
Model	POLO TSI	Register Number	
VIN	AAVZZAWZJU071493	Date Of First Licensing	
Engine Number		Last COR	
Doors	5	License Expiry Date	31/01/2024
Color	GREY	Power / Displacement	
Year Model		Paint Finish	TWO COAT UNI
Km Reading	126,006 KM	Fuel	PETROL
Cab / Body Type	HATCHBACK	Transmission	MANUAL

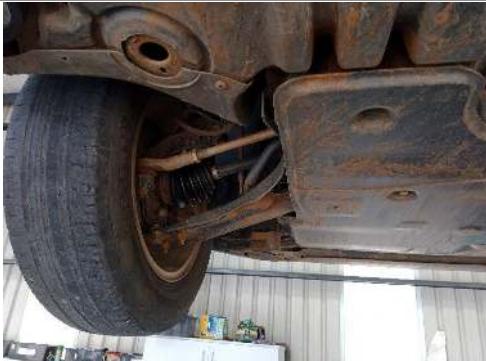
LF TYRE TREAD

Size	Load/Speed Index	Manufacture	Model	Type*	Production Date	Tread Depth (mm)
Front Left	185/65 R15	88H	Continental	Contipremium	V	1421	0 mm
Front Right	185/65 R15	88H	Continental	Contipremium	V	1421	4 mm
Rear Left	185/65 R15	88H	Continental	Contipremium	V	1421	3 mm
Rear Right	185/65 R15	88H	Continental	Contipremium	V	1421	4 mm
Spare	185/70 R14	88H	Falken	Sincera	V	3118	1 mm

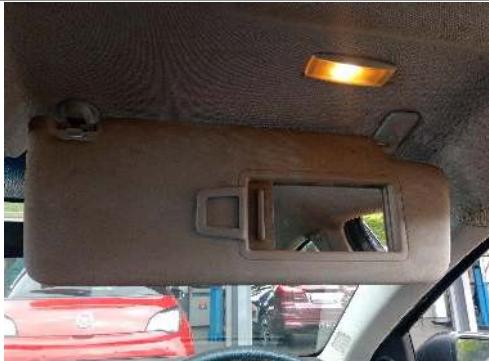
Damage	Repair Way
Engine Oil Leak	Repair
Seat Front Left Dirty	Repair
Seat Front Right Damaged	Repair
Seat Rear Dirty	Repair
Sun Visor Right Dirty	Repair
Hood Lining Defective	Repair
Side Mirror Left Paintwork • Scratched	Repair
Front Bumper Paintwork • Scratched	Repair
Bonnet Paintwork • Scratched	Repair
Front Fender Right Dented	Repair
Rear Fender Right Dented	Repair
Door Front Left Paintwork • Scratched	Repair
Door Front Right Paintwork • Scratched	Repair
Door Rear Right Paintwork • Scratched	Repair
Boot Lid / Hatch door Paintwork • Scratched	Repair
Rear bumper Paintwork • Scratched	Repair
Inner Boot Floor Pan and Spare Wheel Well Paintwork • Scratched	Repair
Rocker Panel Left Dented	Repair
Rocker Panel Right Dented	Repair
Roof Paintwork • Scratched	Repair
Windscreen Chipped	Replace
Parking Brake Performance Left / Right Difference out of legal range	Repair
Tie Rod End left Damaged	Replace
Tie Rod End right Damaged	Replace

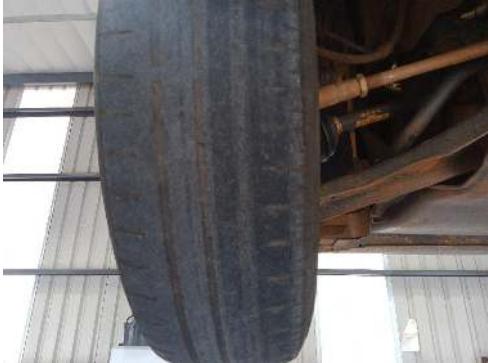
Tyre Front Left Worn	Replace
Belly plates Defective	Repair
Brakes Noisy	Repair
