## CONDITION REPORT

Report No: 2016222756

MFC Auction House  
M57 Pretoria Rd, Glenmarais, KEMPTON PARK  
Gauteng

Vehicle Type	PASSENGER VEHICLE	Registered Owner	MFC
Manufacturer	VOLKSWAGEN	Registration Number	LH00VTGP
Model	POLO TSI	Register Number	
VIN	AAVZZZAWZMU056005	Date Of First Licensing	
Engine Number		Last COR	
Doors	5	License Expiry Date	31/07/2024
Color	WHITE	Power / Displacement	
Year Model		Paint Finish	TWO COAT UNI
Km Reading	62,675 KM	Fuel	PETROL
Cab / Body Type	HATCHBACK	Transmission	AUTOMATIC

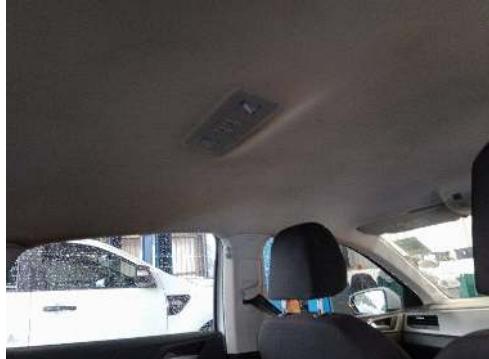
Damage	Repair Way
Engine Oil Sweat	Repair
Seat Front Left Dirty	Repair
Hood Lining Dirty	Repair
Bonnet Paintwork • Chipmarks	Repair
Front Fender Left Dented	Repair
Rear Fender Left Paintwork • Scratched	Repair
Rear Fender Right Dented	Repair
Door Front Left Paintwork • Scratched	Repair
Door Front Right Paintwork • Scratched	Repair
Door Rear Left Paintwork • Scratched	Repair
Door Rear Right Paintwork • Scratched	Repair
Boot Lid / Hatch door Paintwork • Scratched	Repair
Rear bumper Damaged	Repair
Inner Boot Floor Pan and Spare Wheel Well Dented	Repair
Sill Panel Left Paintwork • Scratched	Repair
Sill Panel Right Paintwork • Scratched	Repair
Windscreen Chipped	Repair
Brake disc 1. Axle right Defective	Replace
Parking Brake Performance Left / Right Difference out of legal range	Repair
Shock Absorber Front Left Sweat	Replace
Belly plates Defective	Repair

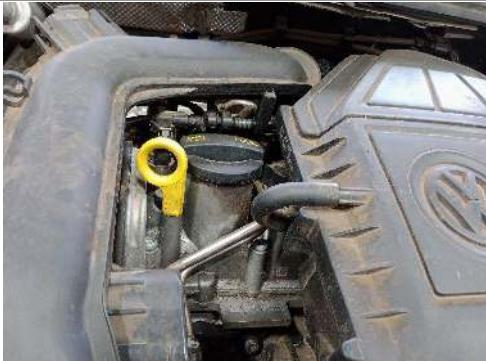
General Comments: ACCORDING TO AGE AND MILEAGE OF VEHICLE NORMAL WEAR AND TEAR ON INTERIOR, EXTERIOR, ELECTRICAL AND MECHANICAL PARTS. Engine Compartment: Engine bay dirty. Brake fluid level ok. Signs of rodent in engine bay.
