## CONDITION REPORT

Report No: 2016331658

| Manufacturer | ISUZU | Registration Number | FVG261L |
| Model | D-MAX | Register Number | |

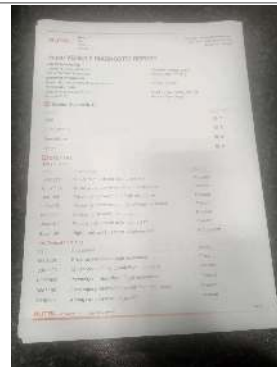
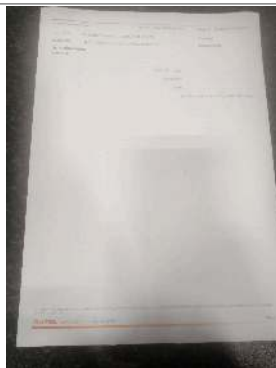
Diagnostic report

| No | System | Code | Description | Status |
|---|---|---|---|---|
| 1 | | B005200 | AIRBAG CIRCUIT ACTIVATED (CRASH) | PRESENT |

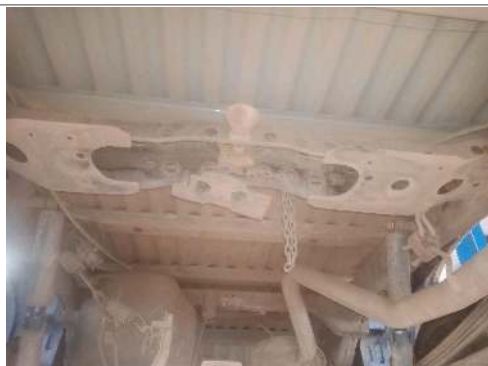
No spare wheel

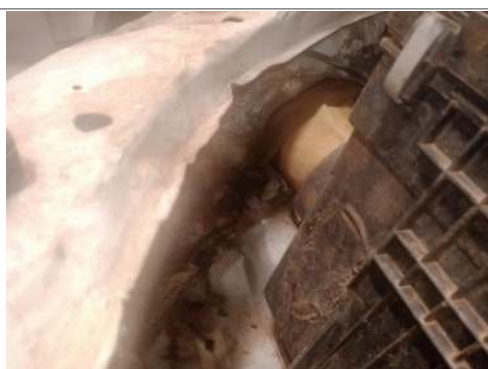
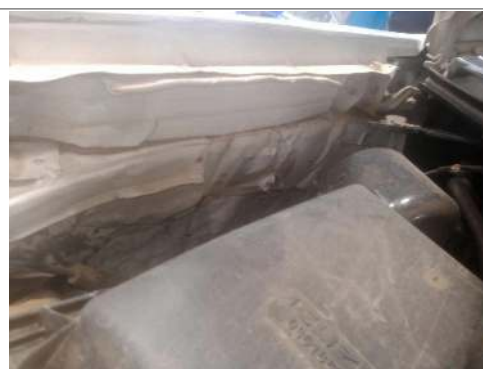
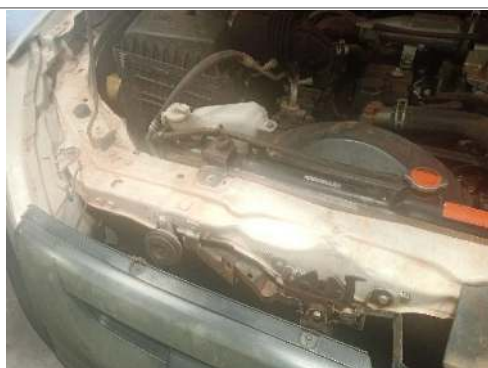
| Damage | Repair Way |
|---|---|
| Bonnet slam plate (Shock tower/ Inner tray) Welded | Repair |

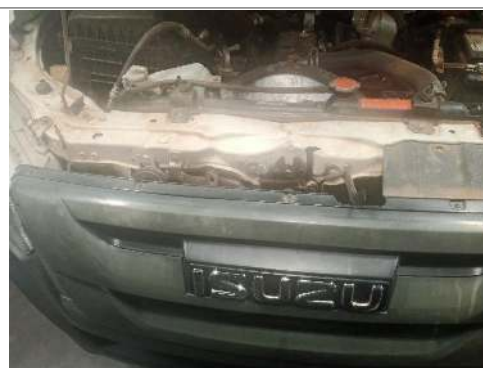
| Damage | Repair Way |
|---|---|
| Grill Damaged | Replace |

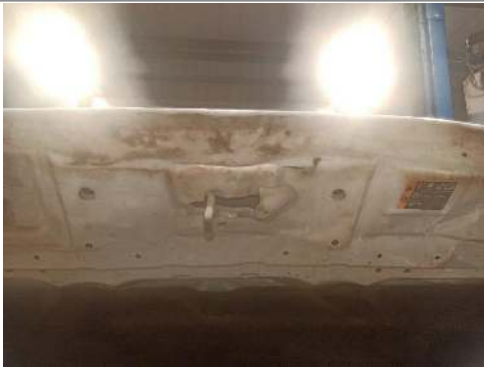
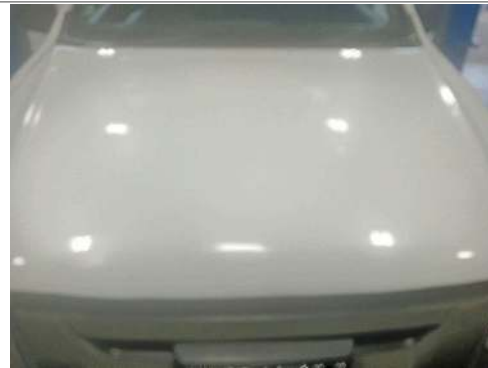
| Damage | Repair Way |
|---|---|
| Bonnet Residual Traces of Repair | Repair |

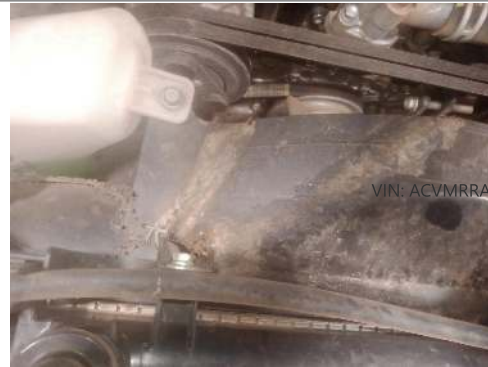
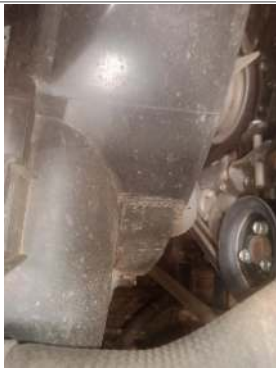
| Damage | Repair Way |
|---|---|
| Fan Damaged | Replace |

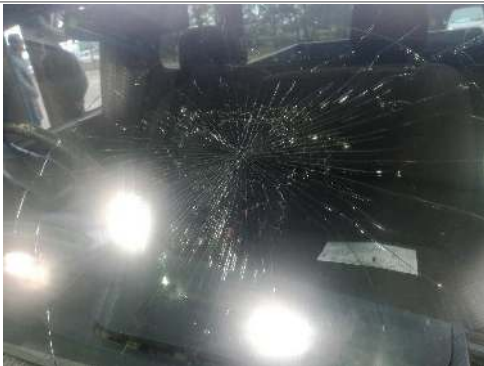
| Damage | Repair Way |
|---|---|
| Windscreen Cracked | Replace |

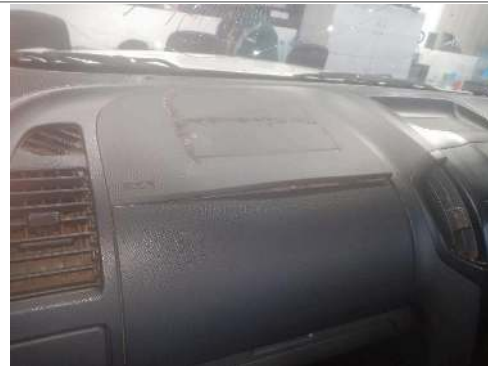
| Damage | Repair Way |
|---|---|
| Dash Padding Damaged | Repair |

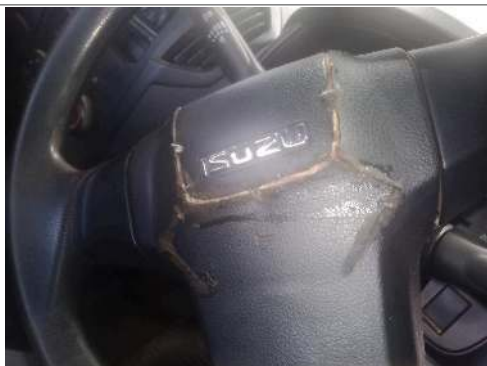
| Damage | Repair Way |
|---|---|
| Steering Wheel Trim Damaged | Repair |

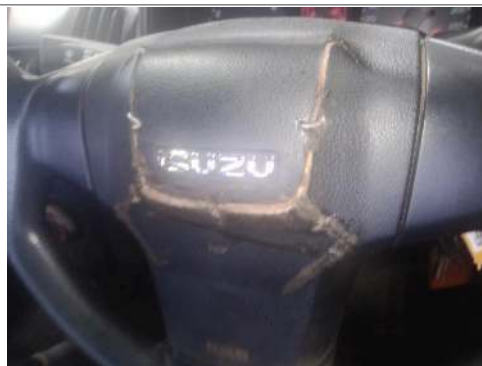
| Damage | Repair Way |
|---|---|
| Hooter Defective | Repair |

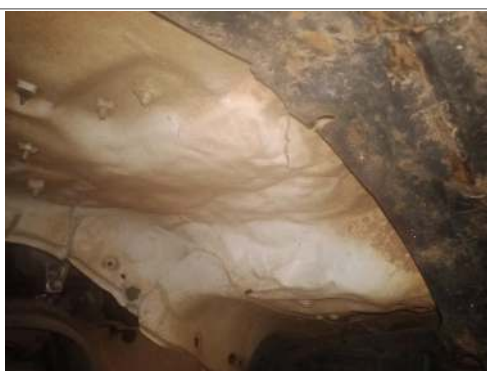
| Damage | Repair Way |
|---|---|
| Front Fender Right / Inner Tray Dented | Repair |

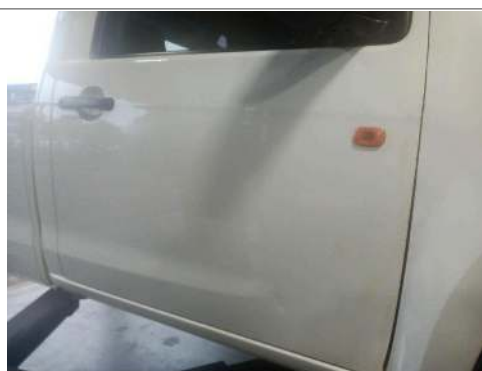
| Damage | Repair Way |
|---|---|
| Door Front Right Dented | Repair |

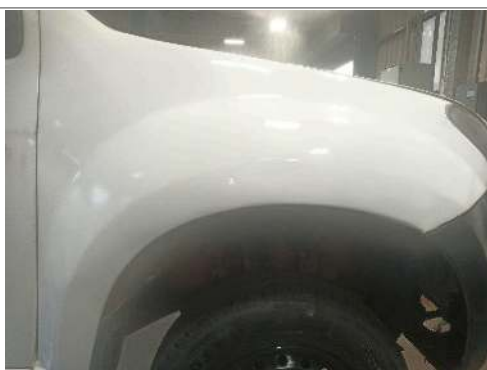
| Damage | Repair Way |
|---|---|
| Front Fender Right Paintwork • Pitmarks | Repair |

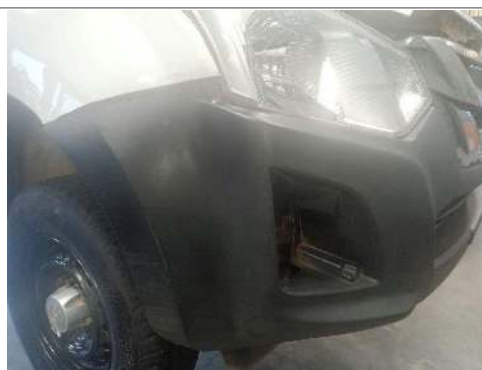
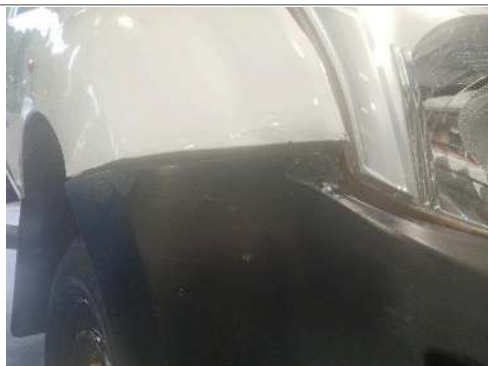
| Damage | Repair Way |
|---|---|
| Front Bumper Damaged | Repair |

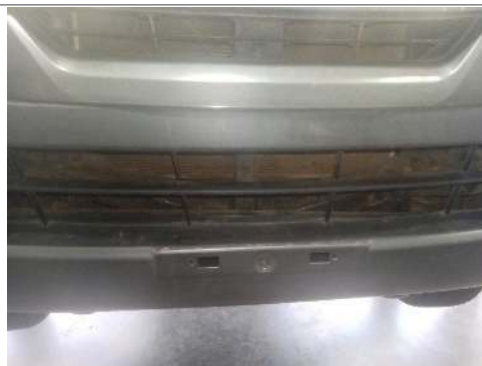
| Damage | Repair Way |
|---|---|
| Number Plate Front Missing | Replace |

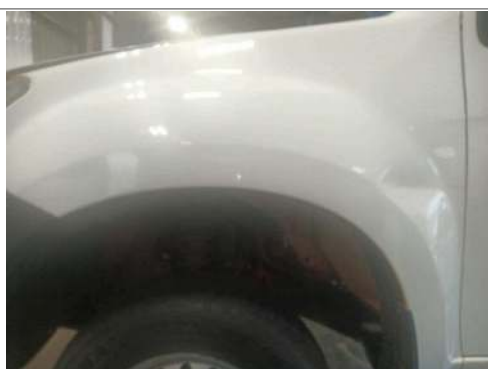
| Damage | Repair Way |
|---|---|
| Front Fender Left Dented | Repair |

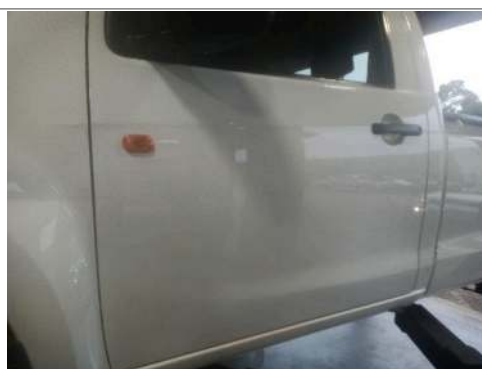
| Damage | Repair Way |
|---|---|
| Door Front Left Dented | Repair |

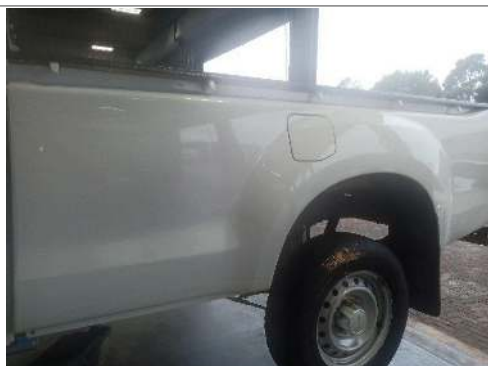
| Damage | Repair Way |
|---|---|
| Rear Fender Left Paintwork • Scratched | Repair |

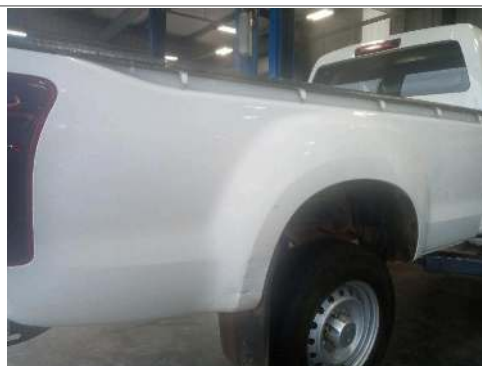
| Damage | Repair Way |
|---|---|
| Rear Fender Right Paintwork • Scratched | Repair |

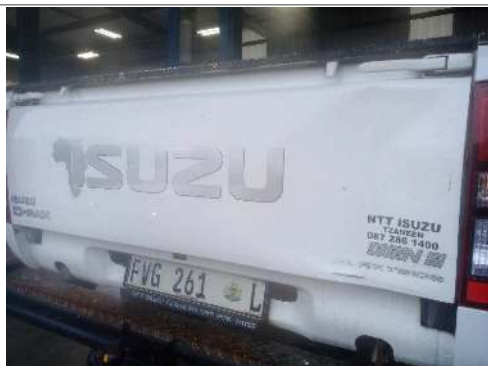
| Damage | Repair Way |
|---|---|
| Tailgate Dented | Repair |

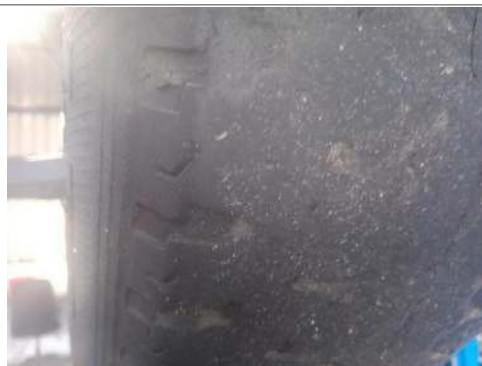
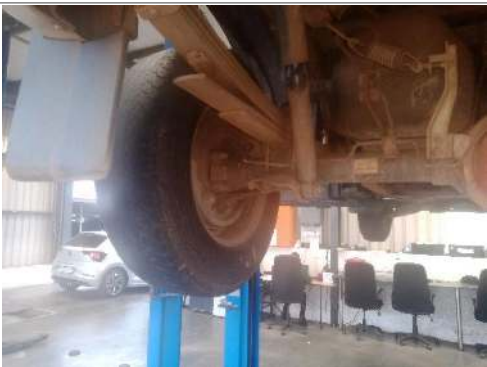
| Damage | Repair Way |
|---|---|
| Tyre Rear Left Smooth | Replace |

| | Size | Load/Speed Index | Manufacture | Model | Type* | Production Date | Tread Depth (mm) |
|---|---|---|---|---|---|---|---|
| Rear Left | 205R16 | 110/108S | Goodyear | Wrangler | V | 0922 | 0 mm |

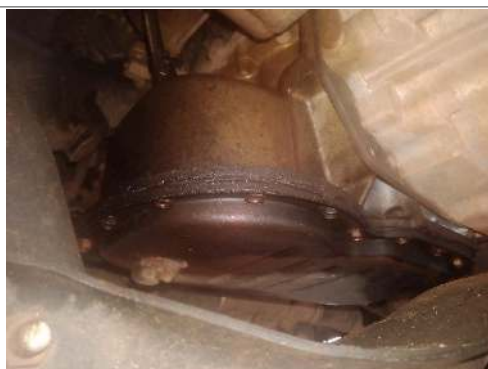
| Damage | Repair Way |
|---|---|
| Engine Oil Sweat | Repair |

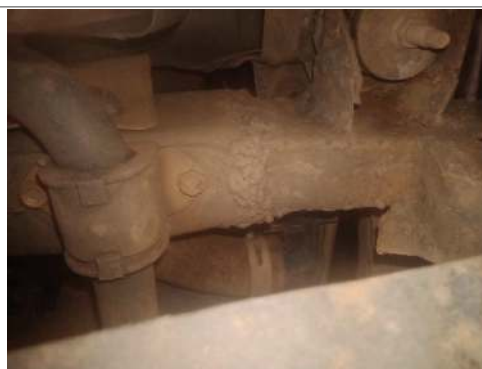
| Damage | Repair Way |
|---|---|
| Main Beam Right Welded | Repair |

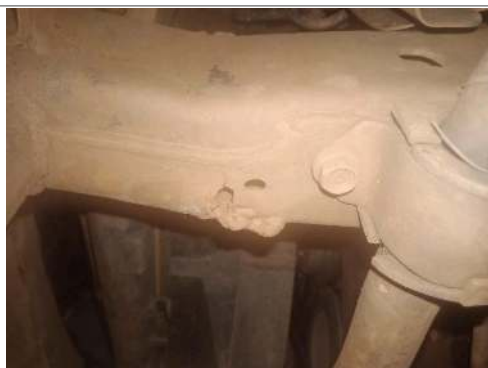
| Damage | Repair Way |
|---|---|
| Main Beam Left Welded | Repair |
