MFC Auction House  
M57 Pretoria Rd, Glenmarais, KEMPTON PARK  
Gauteng

## CONDITION REPORT

Report No: 2016209209

DATE  
21/12/2023

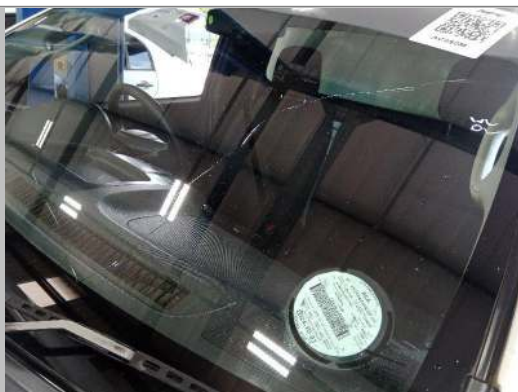
| Damage | Repair Way |
|---|---|
| Windscreen Cracked | Replace |

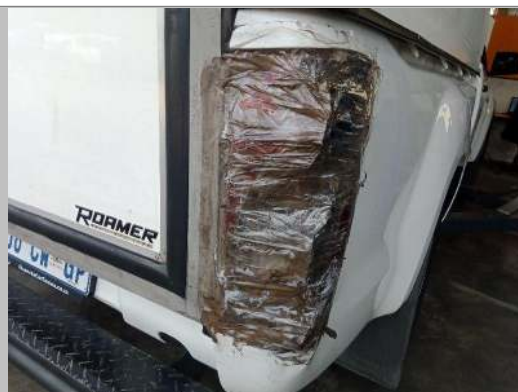
| Damage | Repair Way |
|---|---|
| Tail Light Right Broken | Replace |

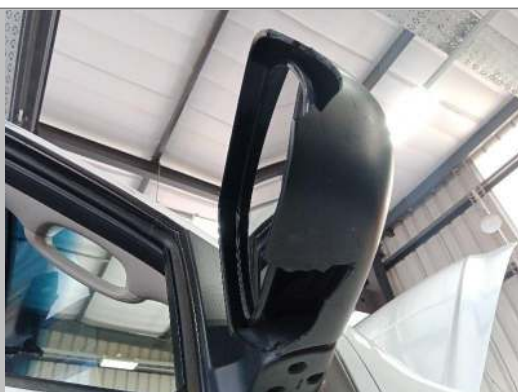
| Damage | Repair Way |
|---|---|
| Side Mirror Right Damaged | Replace |

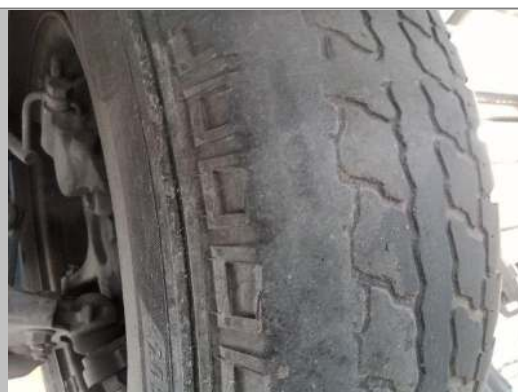
| Damage | Repair Way |
|---|---|
| Tyre Front Right Smooth | Replace |

| | Size | Load/Speed Index | Manufacture | Model | Type* | Production Date | Tread Depth (mm) |
|---|---|---|---|---|---|---|---|
| Front Right | 205R16 | 110/108S | Continental | Contact | V | 1821 | 0 mm |

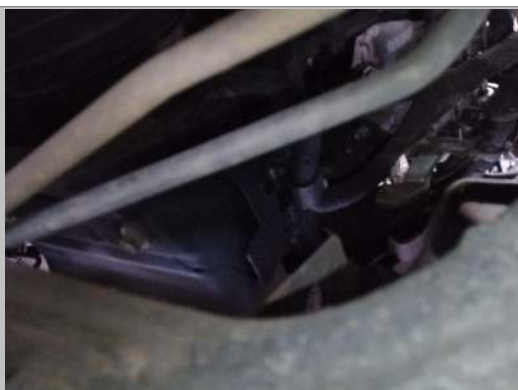
| Damage | Repair Way |
|---|---|
| Engine Oil Sweat | Repair |

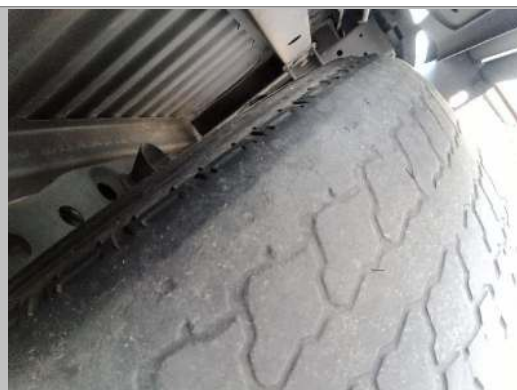
| Damage | Repair Way |
|---|---|
| Spare Tyre Smooth | Replace |

| | Size | Load/Speed Index | Manufacture | Model | Type* | Production Date | Tread Depth (mm) |
|---|---|---|---|---|---|---|---|
| Spare | 205R16 | 110/108T | Continental | Contact | V | 0000 | 0 mm |

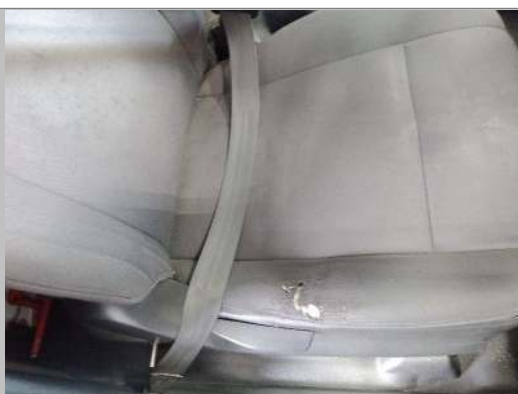
| Damage | Repair Way |
|---|---|
| Seat Front Right Torn / Cut | Repair |
