## CONDITION REPORT

Report No: 2016868717

| Manufacturer | CHEVROLET | Registration Number | JYM007MP |
| Model | UTILITY 1.8 SPORT PU [2011-2017] | Register Number | |

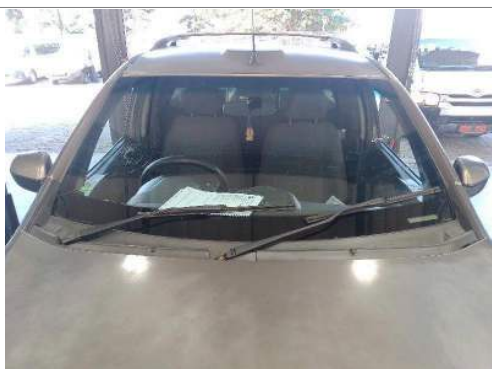
LICENSE DISC

| Damage | Repair Way |
|---|---|
| No license disc | Replace |

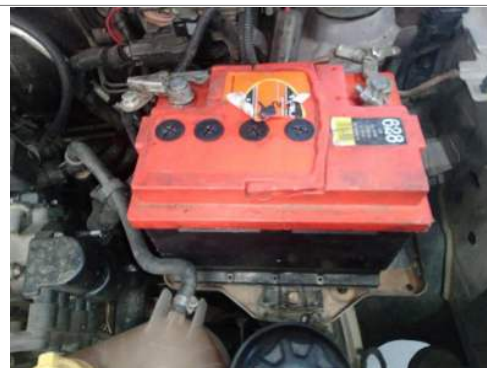
| Damage | Repair Way |
|---|---|
| Battery loose | Repair |

Battery loose

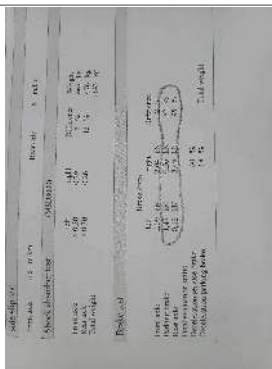
| Damage | Repair Way |
|---|---|
| Parking Brake Performance Left / Right Difference out of legal range | Repair |

| | Left | Right | | |
|---|---|---|---|---|
| Emergency / Parking | 1.4 | 0.5 | - | |

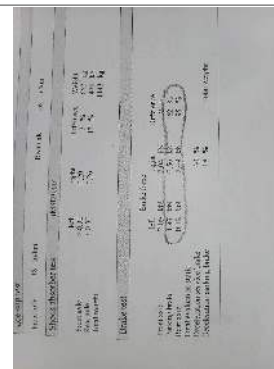
| Damage | Repair Way |
|---|---|
| Service Brake Performance Rear Axle Left / Right | Repair |
| Difference out of legal range | |

| | Left | Right | | |
|---|---|---|---|---|
| Rear | 0.1 | 2.4 | - | |

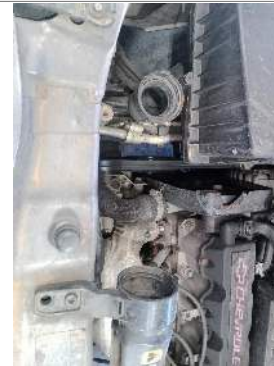
| Damage | Repair Way |
|---|---|
| Air cleaner Damaged | Replace |

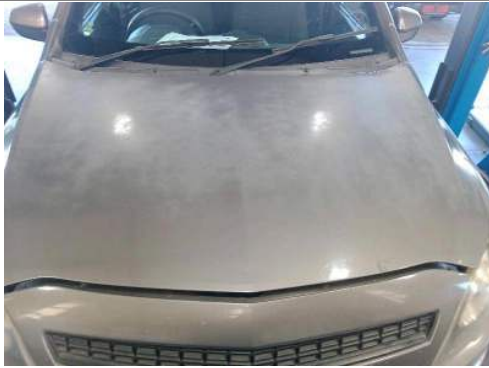
| Damage | Repair Way |
|---|---|
| Bonnet Residual Traces of Repair | Repair |

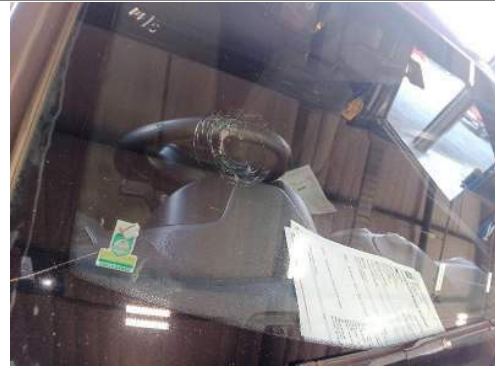
| Damage | Repair Way |
|---|---|
| Windscreen Cracked | Replace |

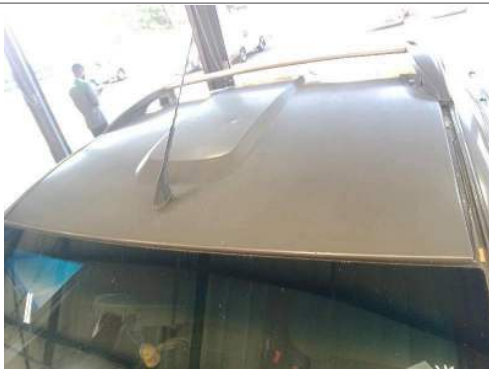
| Damage | Repair Way |
|---|---|
| Roof Paintwork • Discoloured | Repair |

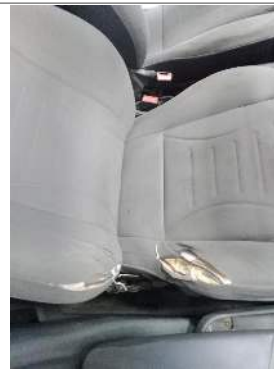
| Damage | Repair Way |
|---|---|
| Seat Front Right Torn / Cut | Repair |

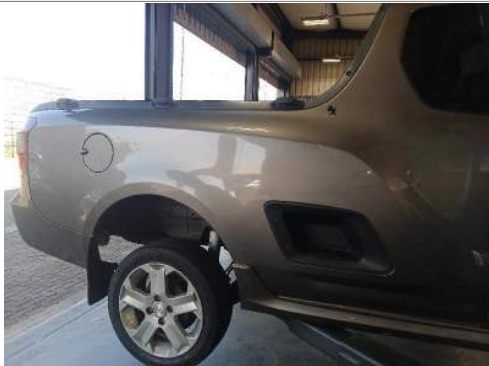
| Damage | Repair Way |
|---|---|
| Rear Fender Right Dented | Repair |

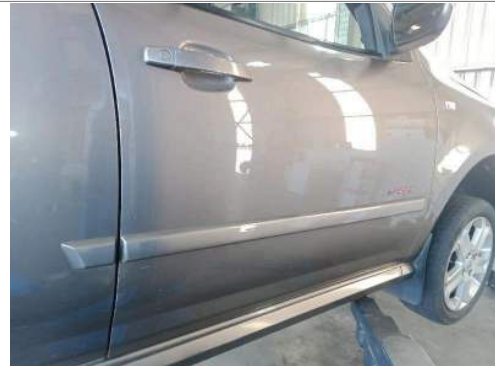
| Damage | Repair Way |
|---|---|
| Door Front Right Paintwork • Scratched | Repair |

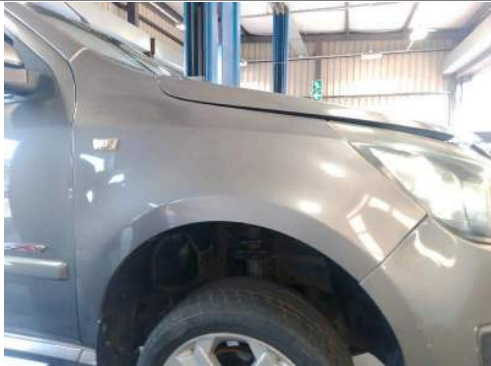
| Damage | Repair Way |
|---|---|
| Front Fender Right Residual Traces of Repair | Repair |

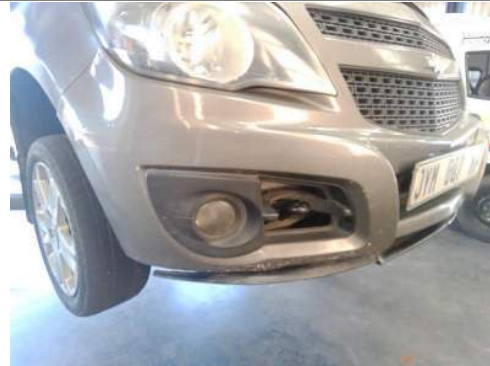
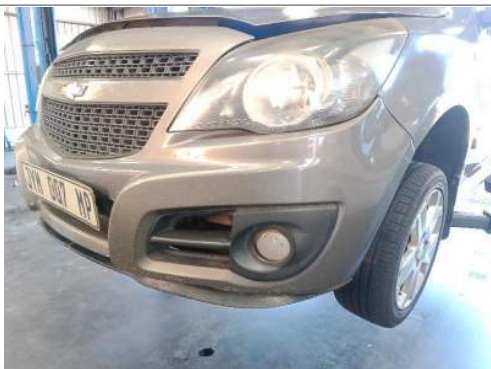
| Damage | Repair Way |
|---|---|
| Front Bumper Paintwork • Scratched | Repair |

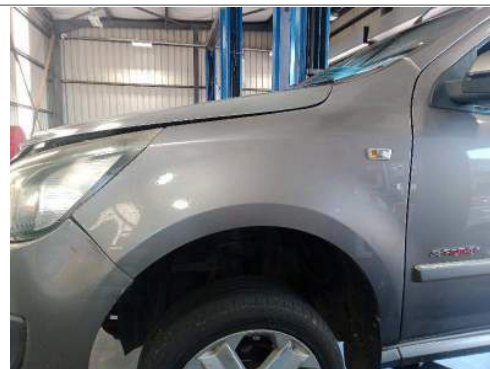
| Damage | Repair Way |
|---|---|
| Front Fender Left Residual Traces of Repair | Repair |

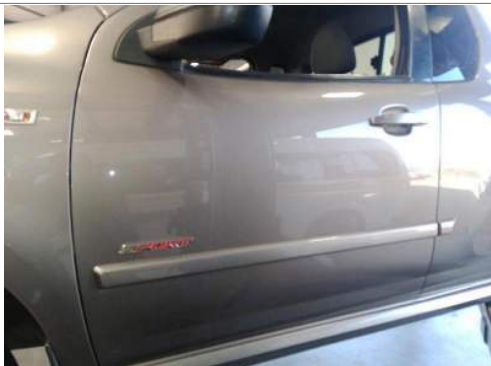
| Damage | Repair Way |
|---|---|
| Door Front Left Paintwork • Scratched | Repair |

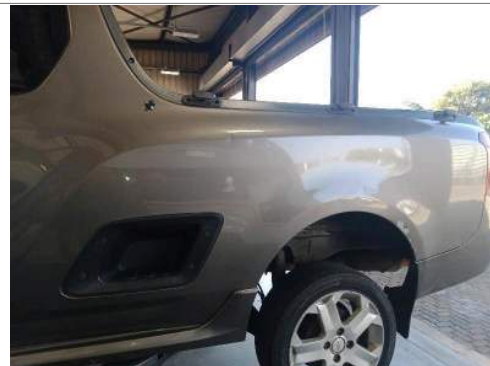
| Damage | Repair Way |
|---|---|
| Rear Fender Left Dented | Repair |

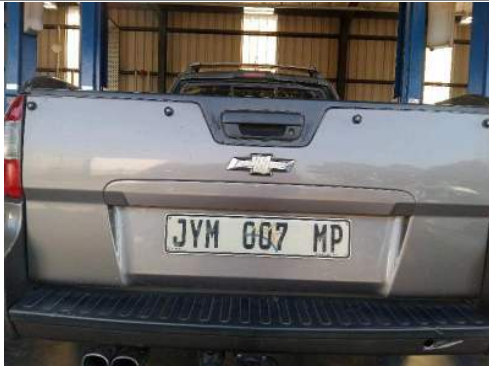
| Damage | Repair Way |
|---|---|
| Tailgate Paintwork • Scratched | Repair |

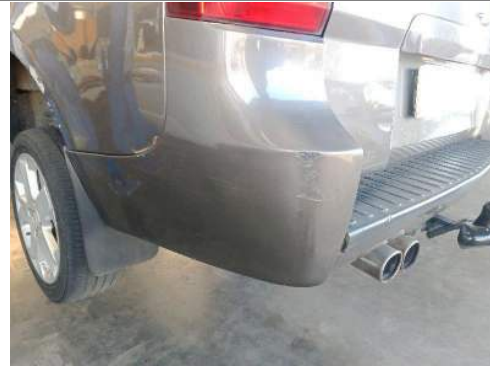
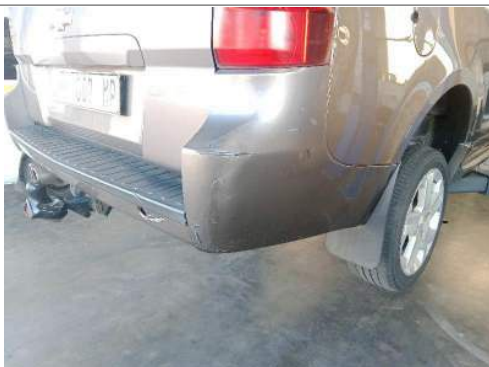
| Damage | Repair Way |
|---|---|
| Rear bumper Paintwork • Scratched | Repair |

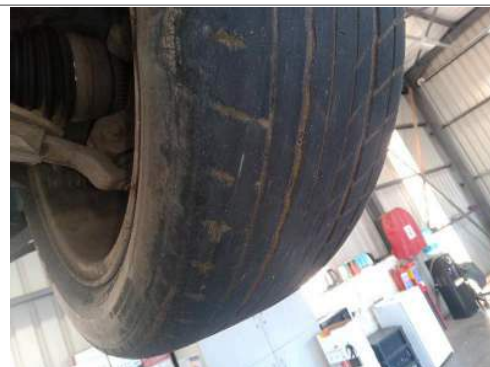
| Damage | Repair Way |
|---|---|
| Tyre Front Right Damaged | Replace |

| | Size | Load/Speed Index | Manufacture | Model | Type* | Production Date | Tread Depth (mm) |
|---|---|---|---|---|---|---|---|
| Front Right | 195/50R15 | 82W | Sumitomo | Htr | V | 1717 | 0 mm |

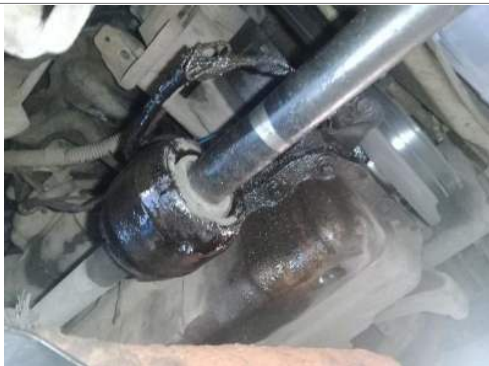
| Damage | Repair Way |
|---|---|
| Engine Oil Leak | Repair |

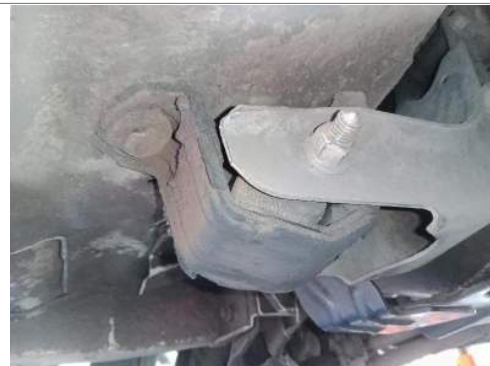
| Damage | Repair Way |
|---|---|
| Gearbox Mountings Cracked | Replace |

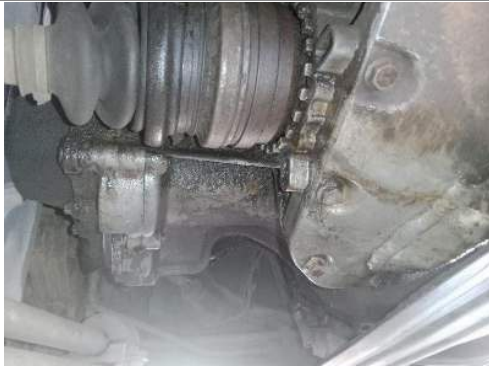
| Damage | Repair Way |
|---|---|
| Gearbox Oil Leak | Repair |

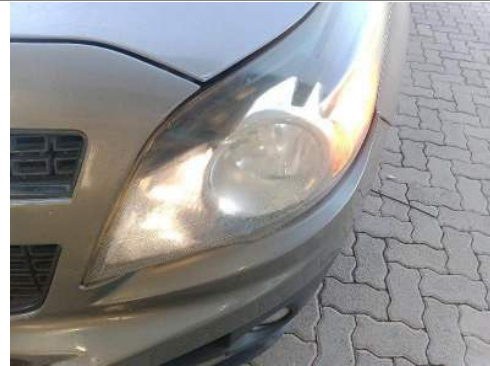
| Damage | Repair Way |
|---|---|
| Dim Light Left Malfunction | Repair |

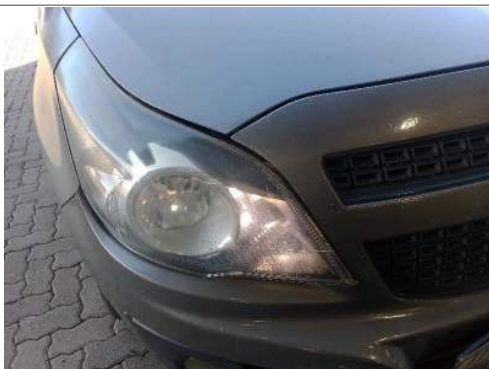
| Damage | Repair Way |
|---|---|
| Dim Light Right Malfunction | Repair |

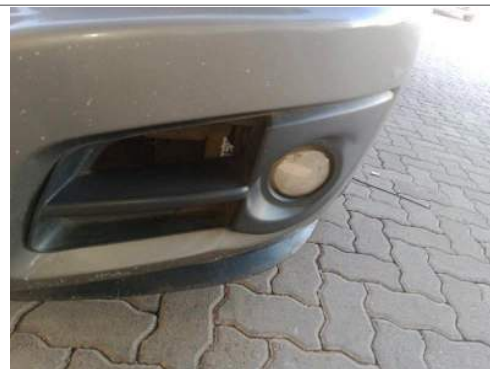
| Damage | Repair Way |
|---|---|
| Fog Light Front Left Malfunction | Repair |

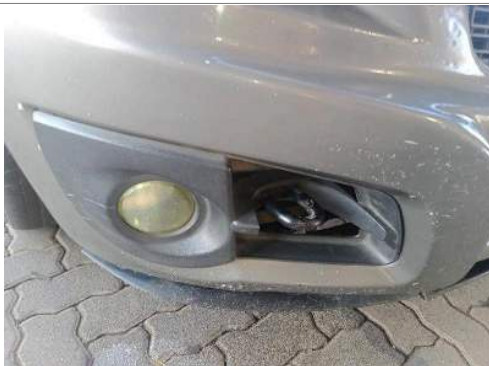
| Damage | Repair Way |
|---|---|
| Fog Light Front Right Malfunction | Repair |
