## CONDITION REPORT

Report No: 2016481849

| Manufacturer | CHEVROLET | Registration Number | JDR491MP |
| VIN | ADMJF4MR5G4782160 | Date Of First Licensing | |

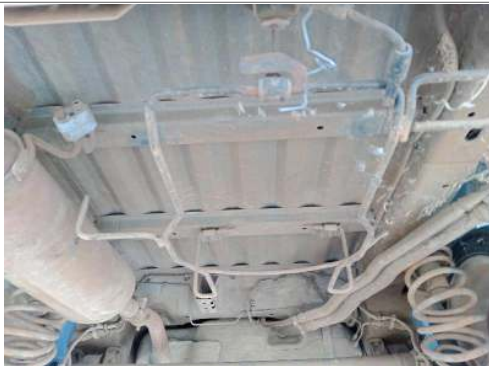
No sparewheel

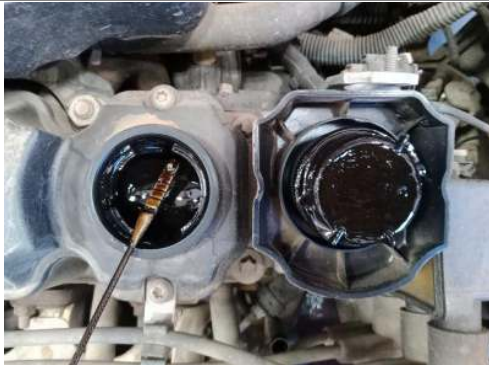
Oil cap and dipstick

| Damage | Repair Way |
|---|---|
| oil sludge on oil cap. | Repair. |

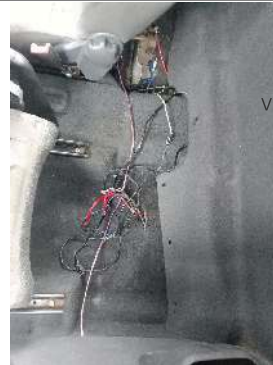
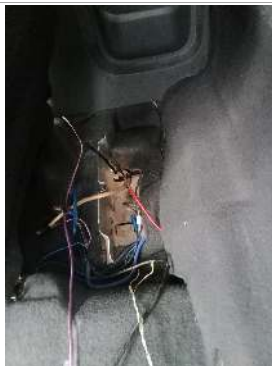
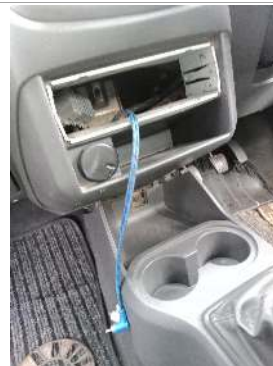
| Damage | Repair Way |
|---|---|
| Wiring connections Defective | Repair |

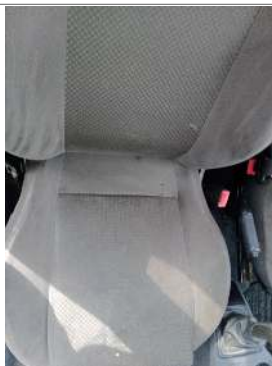
| Damage | Repair Way |
|---|---|
| Seat Front Right Torn / Cut | Repair |

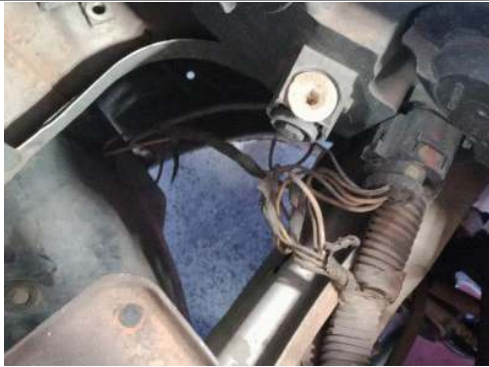
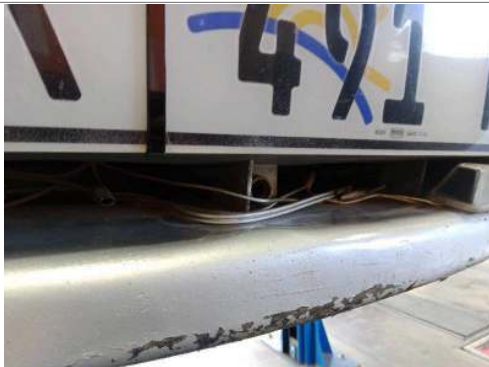
| Damage | Repair Way |
|---|---|
| Engine Wiring Defective | Repair |

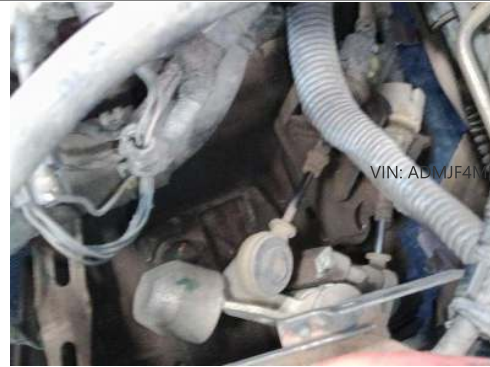
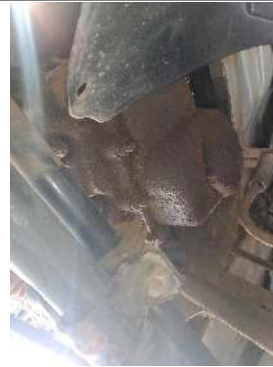
| Damage | Repair Way |
|---|---|
| Gearbox Oil Leak | Repair |

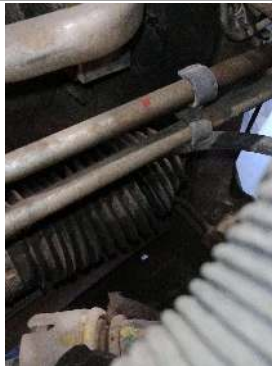
| Damage | Repair Way |
|---|---|
| Steering Rack Boot Left Torn / Cut | Replace |

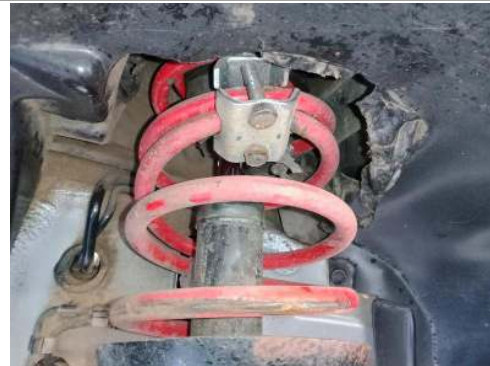
| Damage | Repair Way |
|---|---|
| Spring Front Right Defective | Repair |

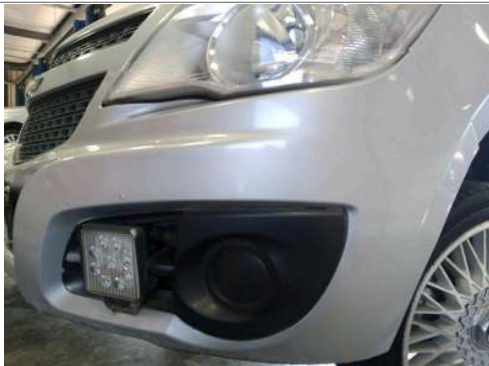
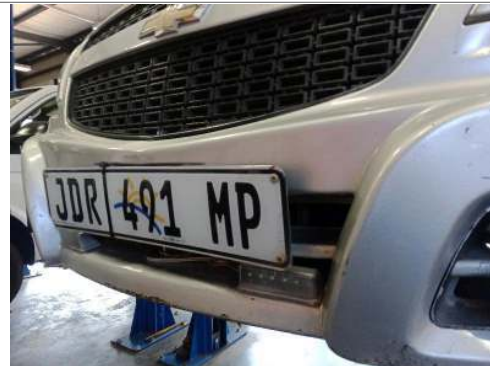
| Damage | Repair Way |
|---|---|
| Front Bumper Residual Traces of Repair | Repair |

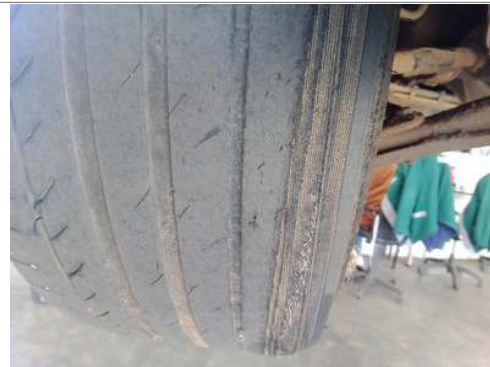
| Damage | Repair Way |
|---|---|
| Tyre Front Left Excessive Wear & Tear | Replace |

| | Size | Load/Speed Index | Manufacture | Model | Type* | Production Date | Tread Depth (mm) |
|---|---|---|---|---|---|---|---|
| Front Left | 215/40R17 | 87W | Tracmak | Privilo | V | 0000 | 0 mm |

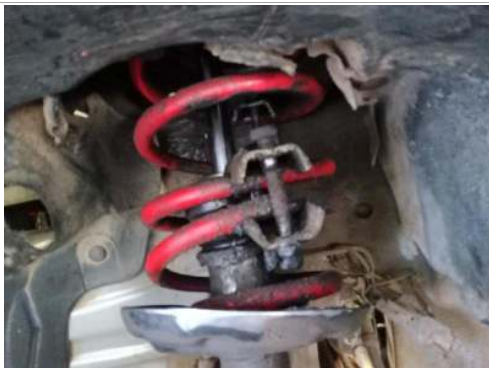
| Damage | Repair Way |
|---|---|
| Spring Front Left Defective | Replace |

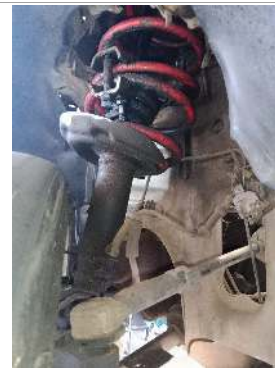
| Damage | Repair Way |
|---|---|
| Shock Absorber Front Left Leak | Replace |
| L/F shock weak | Replace. |

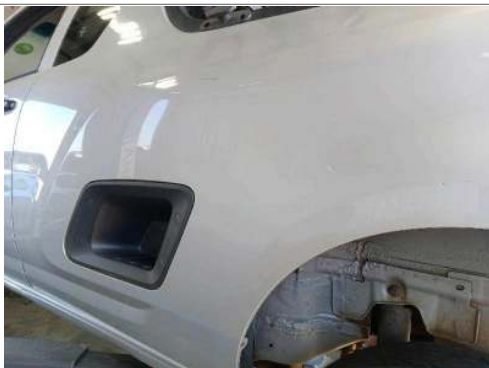
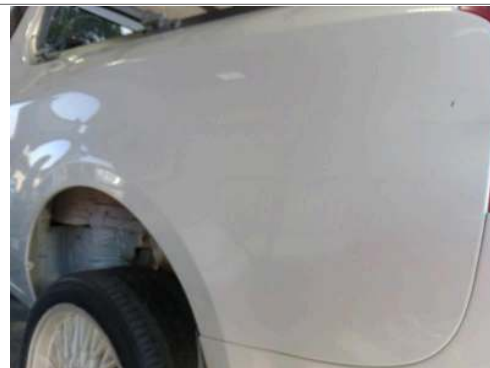
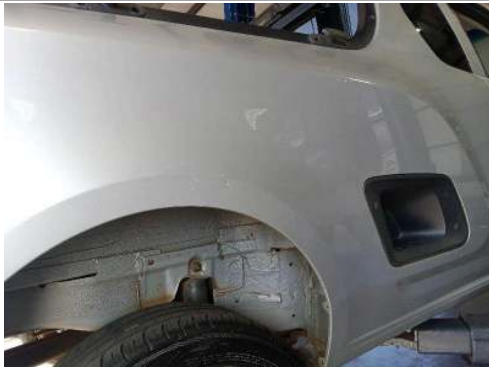
| Damage | Repair Way |
|---|---|
| Load Body Paintwork • Scratched | Repair |

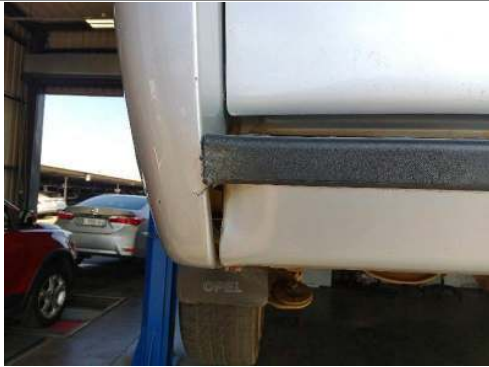
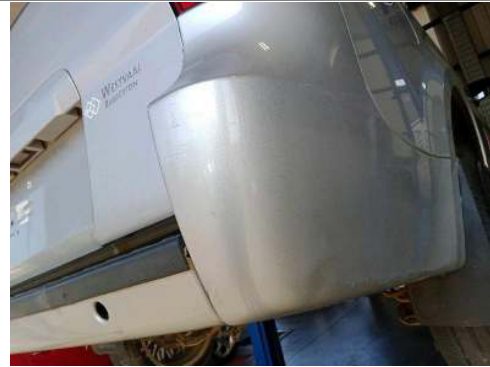
| Damage | Repair Way |
|---|---|
| Rear bumper Damaged | Repair |

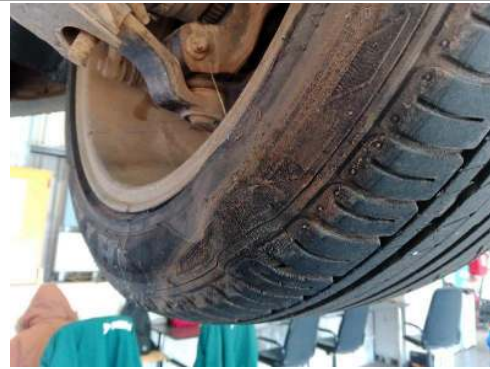
| Damage | Repair Way |
|---|---|
| Tyre Front Right Damaged | Replace |

| | Size | Load/Speed Index | Manufacture | Model | Type* | Production Date | Tread Depth (mm) |
|---|---|---|---|---|---|---|---|
| Front Right | 195/50R15 | 82V | Sumitomo | HTR | V | 4218 | 3 mm |

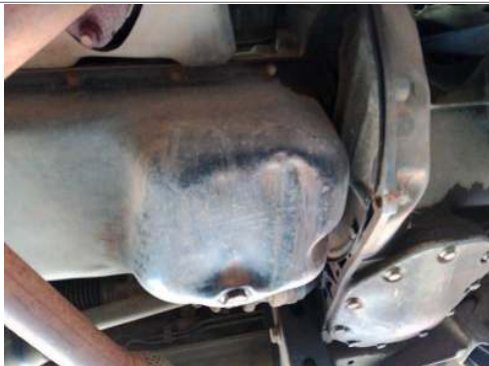
| Damage | Repair Way |
|---|---|
| Engine Damaged | Repair |

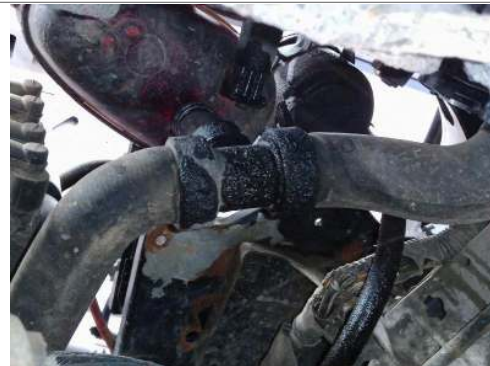
| Damage | Repair Way |
|---|---|
| Hoses Oil Sweat | Replace |

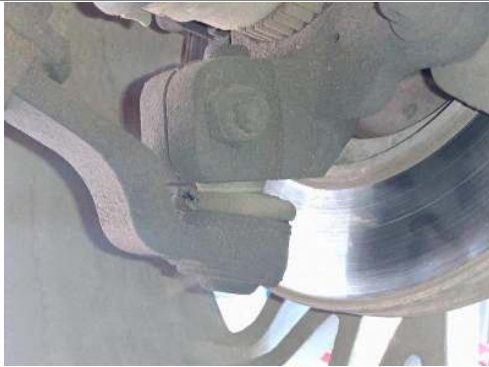
| Damage | Repair Way |
|---|---|
| Ball Joint(s) Front Axle Left Damaged | Replace |

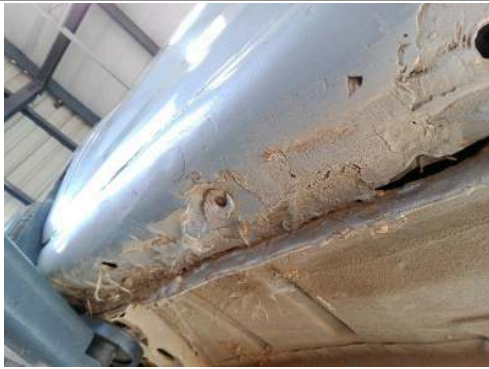
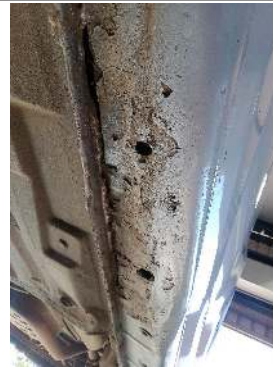
| Damage | Repair Way |
|---|---|
| Sill Panel Left Residual Traces of Repair | Repair |

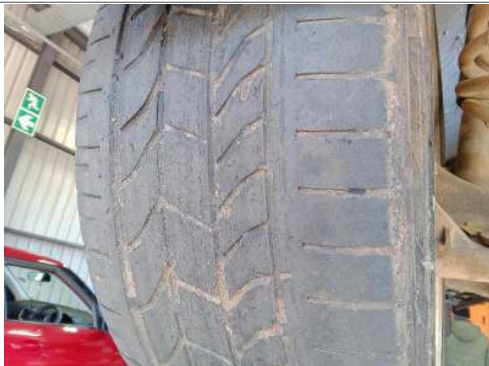
| Damage | Repair Way |
|---|---|
| Tyre Rear Left Excessive Wear & Tear | Replace |

| | Size | Load/Speed Index | Manufacture | Model | Type* | Production Date | Tread Depth (mm) |
|---|---|---|---|---|---|---|---|
| Rear Left | 215/45R17 | 91W | Continental | Contact | V | 2420 | 1 mm |

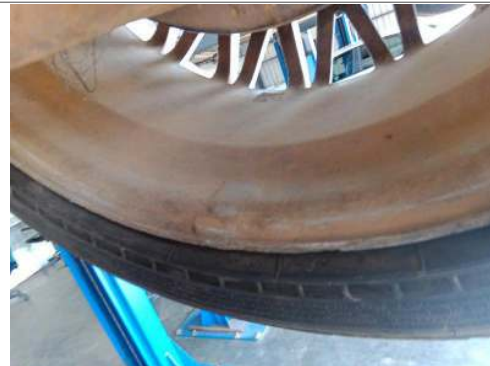
| Damage | Repair Way |
|---|---|
| Rim Rear Right Damaged | Repair |

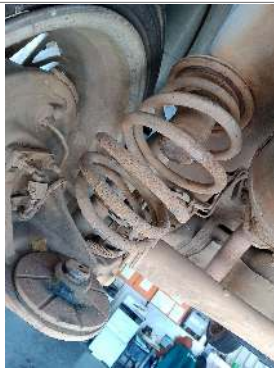
| Damage | Repair Way |
|---|---|
| Spring Rear Left Incorrect | Replace |

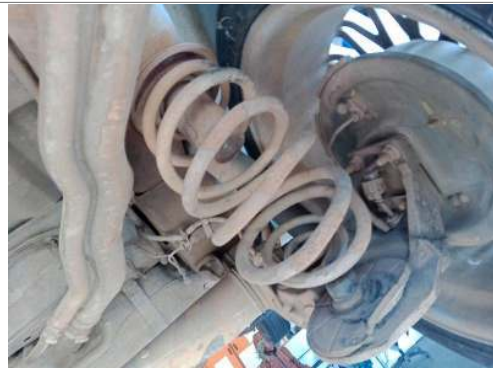
| Damage | Repair Way |
|---|---|
| Spring Rear Right Incorrect | Replace |

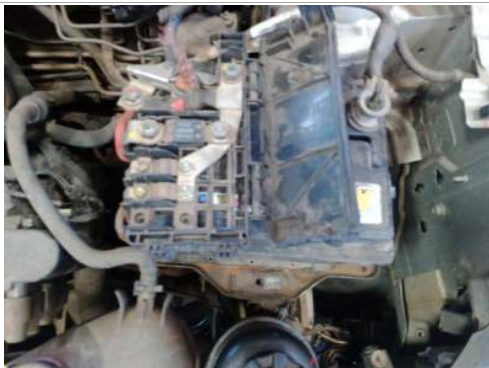
| Damage | Repair Way |
|---|---|
| Battery clamps Defective | Repair |

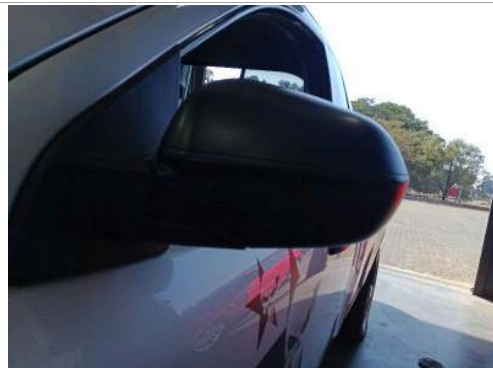
| Damage | Repair Way |
|---|---|
| Side Mirror Left Damaged | Repair |
