MFC Auction House  
M57 Pretoria Rd, Glenmarais, KEMPTON PARK  
Gauteng

## Assignment

## Vehicle Data

## VEHICLE INSPECTION

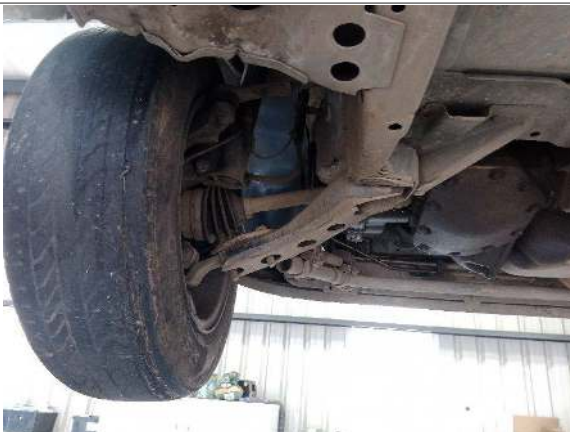
LF TYRE TREAD

| Damage | Repair Way |
|---|---|
| Tyre Front Left Damaged | Replace |

| | Size | Load/Speed Index | Manufacture | Model | Type* | Production Date | Tread Depth (mm) |
|---|---|---|---|---|---|---|---|
| Front Left | 185/65 R14 | 86H | Dunlop | Sp-Sport | V | 0816 | 0 mm |

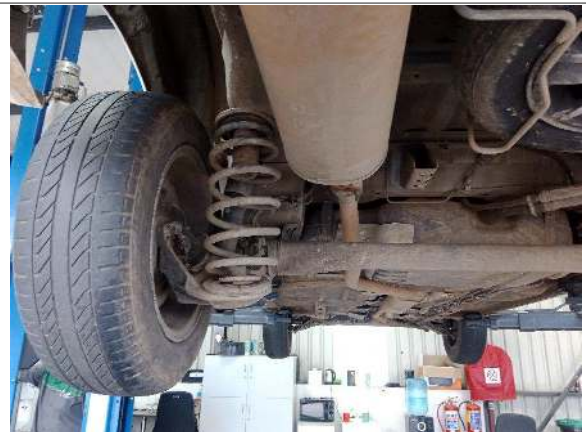
LR TYRE TREAD

| | Size | Load/Speed Index | Manufacture | Model | Type* | Production Date | Tread Depth (mm) |
|---|---|---|---|---|---|---|---|
| Rear Left | 185/65 R14 | 86H | Dunlop | Sp-Sport | V | 0816 | 1 mm |

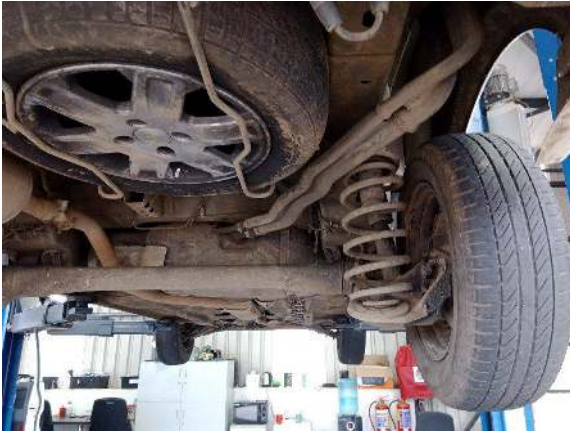
RR TYRE TREAD

| | Size | Load/Speed Index | Manufacture | Model | Type* | Production Date | Tread Depth (mm) |
|---|---|---|---|---|---|---|---|
| Rear Right | 185/65 R14 | 86H | Dunlop | Sp-Sport | V | 0916 | 2 mm |

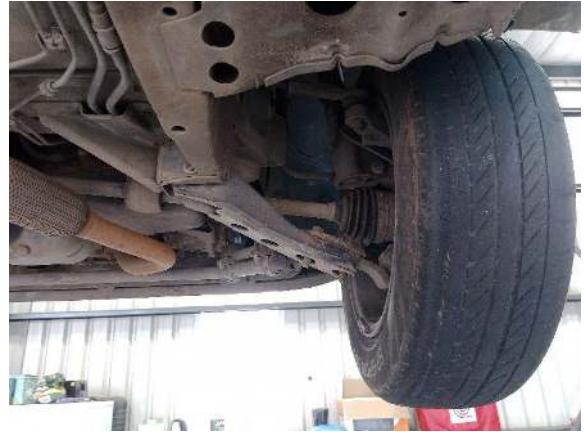
RF TYRE TREAD

| | Size | Load/Speed Index | Manufacture | Model | Type* | Production Date | Tread Depth (mm) |
|---|---|---|---|---|---|---|---|
| Front Right | 185/65 R14 | 86H | Dunlop | Sp-Sport | V | 3018 | 0 mm |

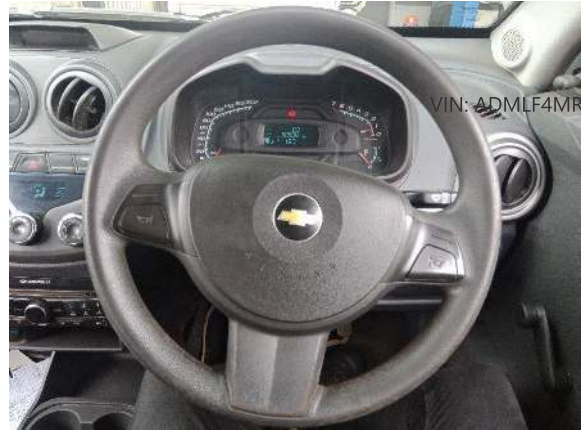
| Damage | Repair Way |
|---|---|
| Steering Wheel Trim Defective | Repair |

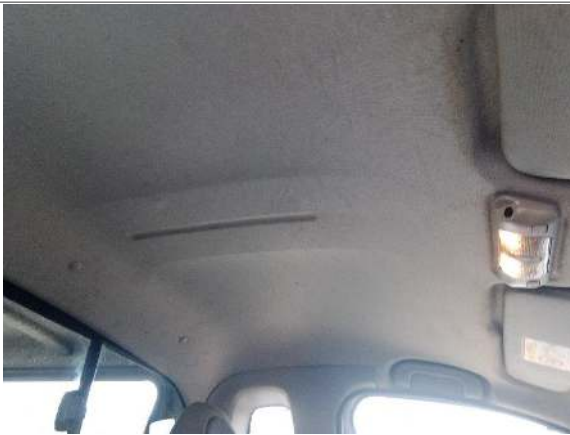
| Damage | Repair Way |
|---|---|
| Hood Lining Dirty | Repair |

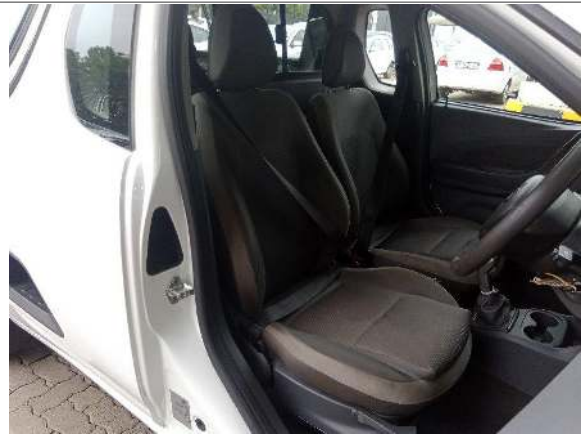
| Damage | Repair Way |
|---|---|
| Seat Front Right Defective | Repair |

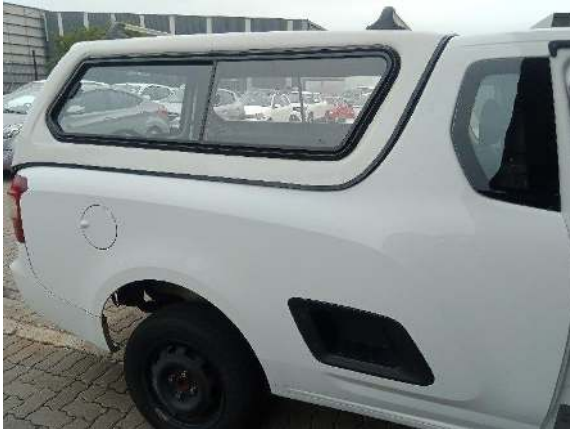
| Damage | Repair Way |
|---|---|
| Rear Fender Right Dented | Repair |

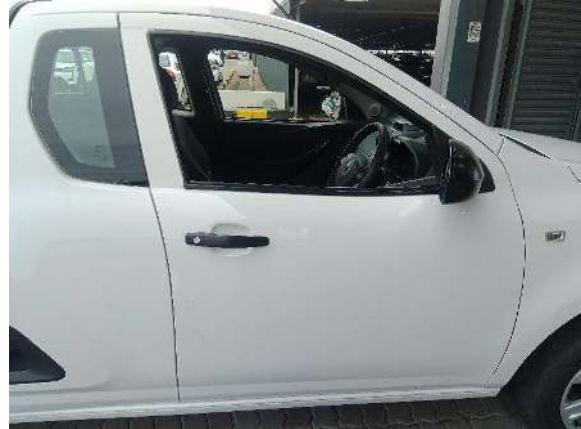
| Damage | Repair Way |
|---|---|
| Door Front Right Dented | Repair |

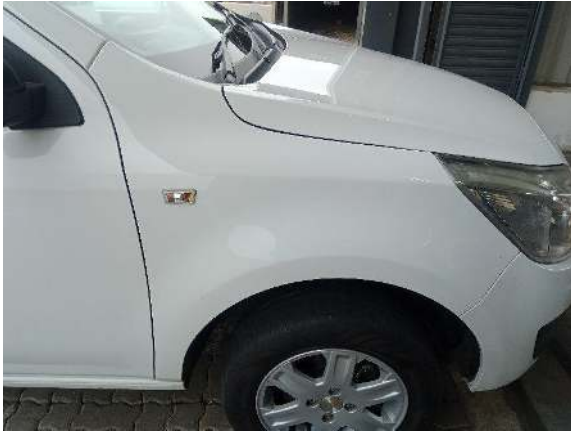
| Damage | Repair Way |
|---|---|
| Front Fender Right Paintwork • Scratched | Repair |

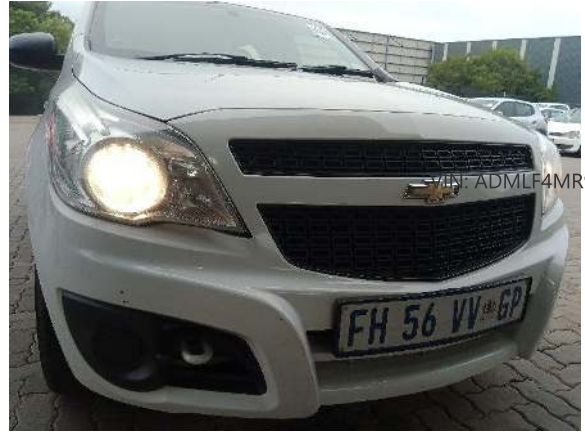
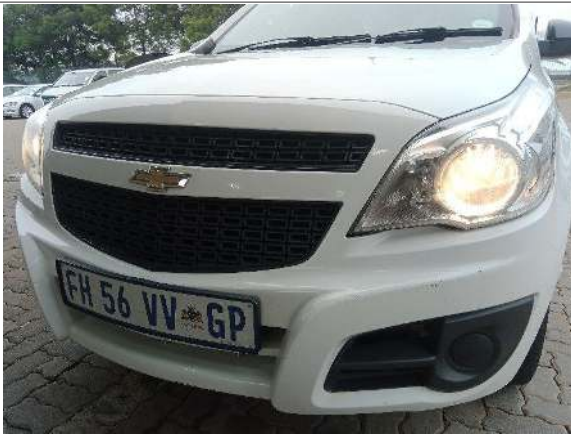
| Damage | Repair Way |
|---|---|
| Front Bumper Paintwork • Scratched | Repair |

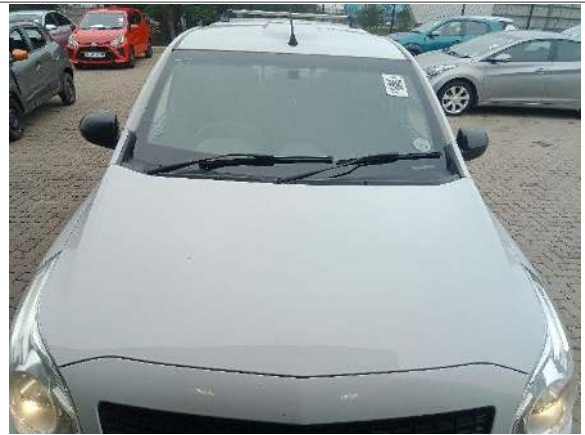
| Damage | Repair Way |
|---|---|
| Bonnet Paintwork • Chipmarks | Repair |

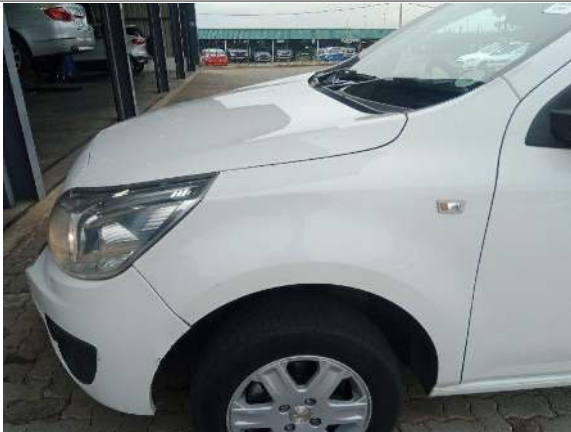
| Damage | Repair Way |
|---|---|
| Front Fender Left Paintwork • Scratched | Repair |

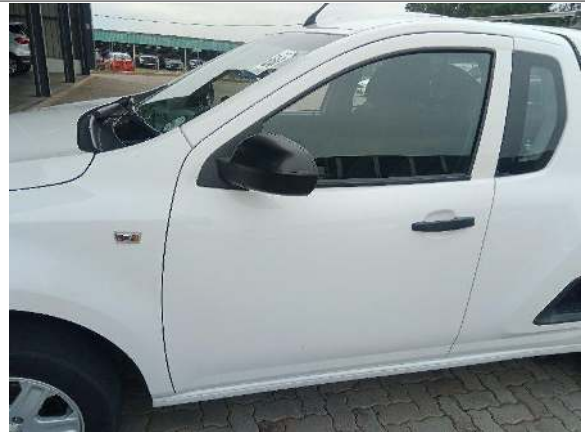
| Damage | Repair Way |
|---|---|
| Door Front Left Paintwork • Scratched | Repair |

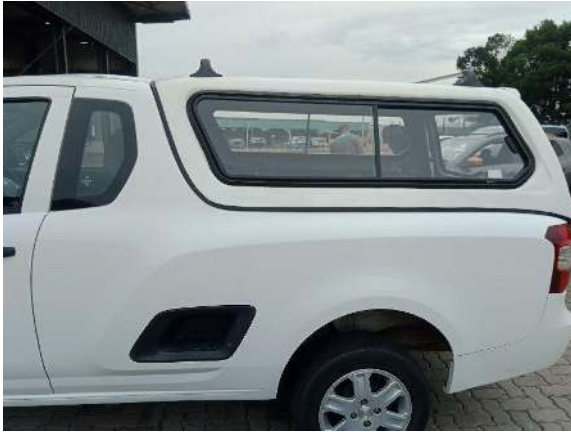
| Damage | Repair Way |
|---|---|
| Rear Fender Left Paintwork • Scratched | Repair |

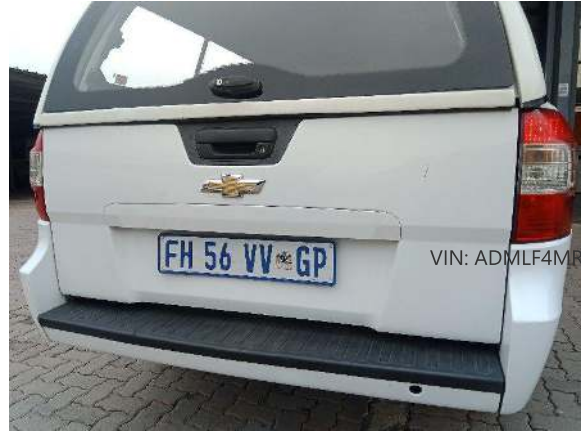
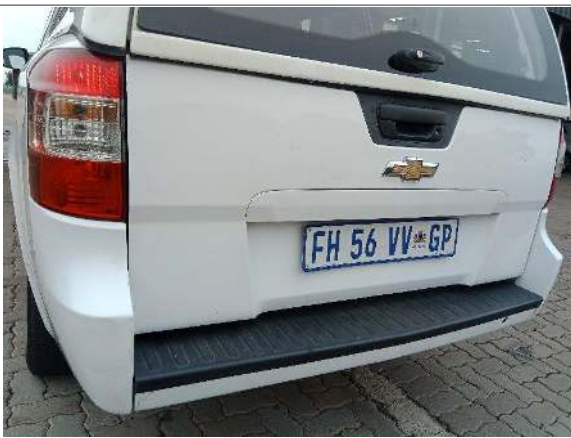
| Damage | Repair Way |
|---|---|
| Rear bumper Paintwork • Scratched | Repair |

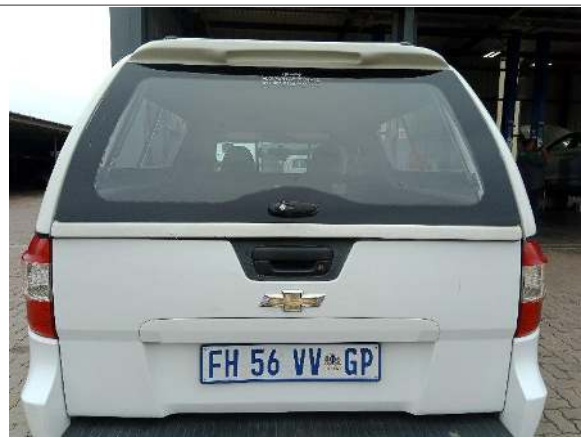
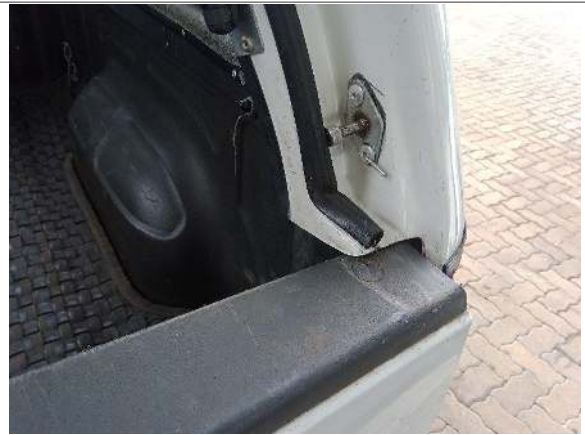
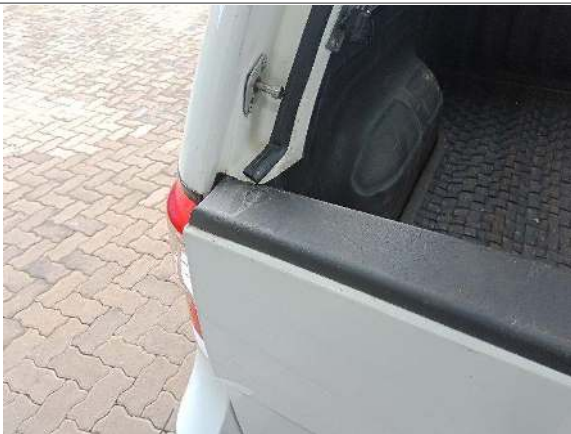
| Damage | Repair Way |
|---|---|
| Tailgate Paintwork • Scratched | Repair |

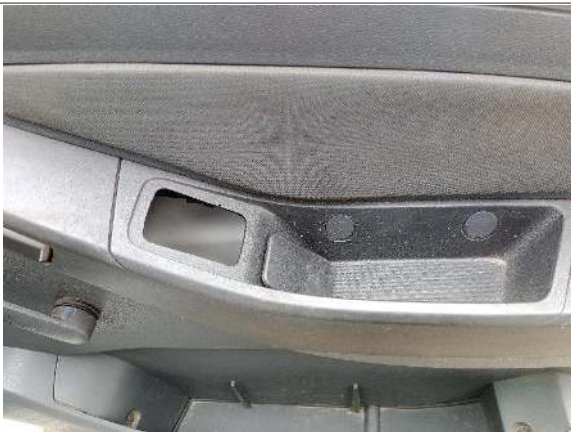
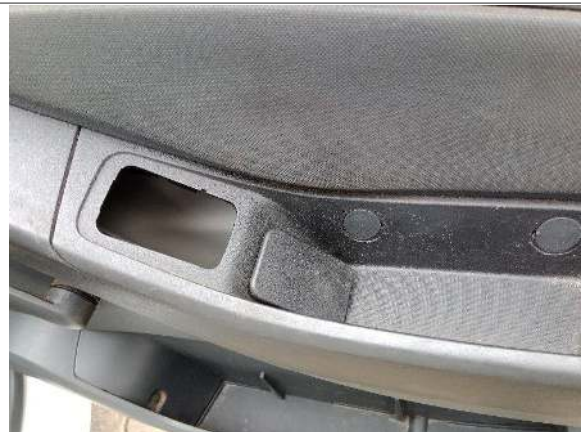
| Damage | Repair Way |
|---|---|
| Door Panel Front Right Defective | Repair |

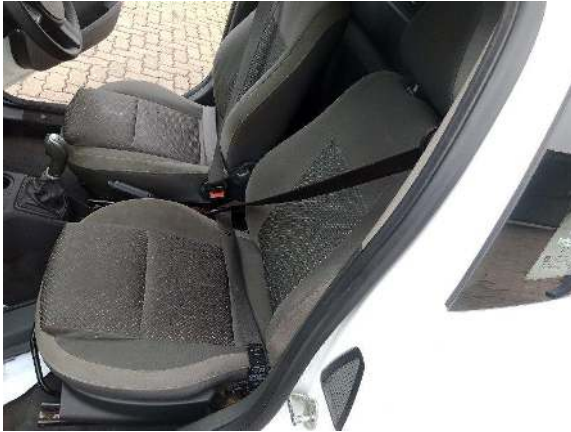
| Damage | Repair Way |
|---|---|
| Seat Front Left Dirty | Repair |

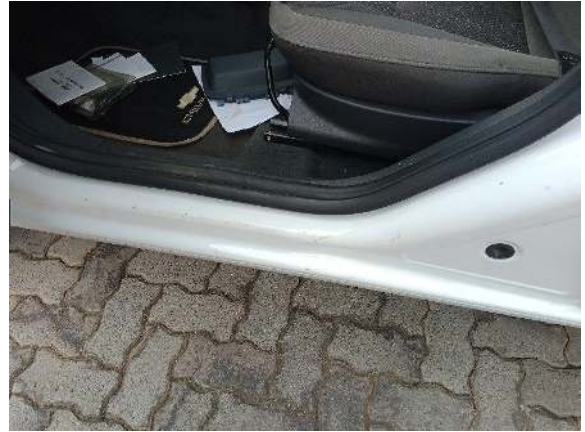
| Damage | Repair Way |
|---|---|
| Sill Panel Left Paintwork • Scratched | Repair |

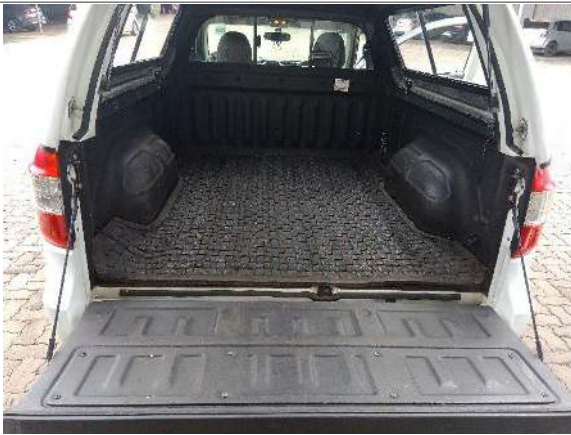
| Damage | Repair Way |
|---|---|
| Load Body Paintwork • Scratched | Repair |

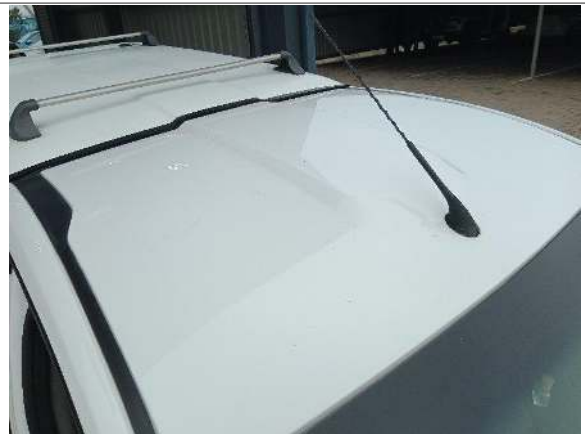
| Damage | Repair Way |
|---|---|
| Roof Paintwork • Scratched | Repair |

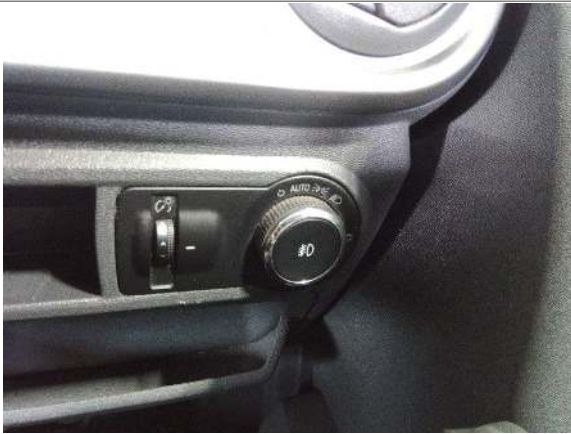
| Damage | Repair Way |
|---|---|
| Head Light Switch Damaged | Replace |

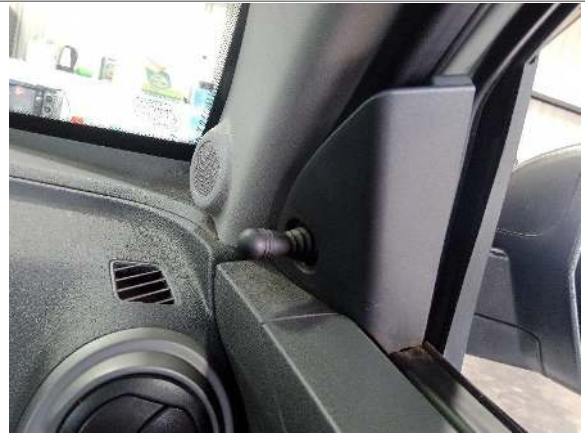
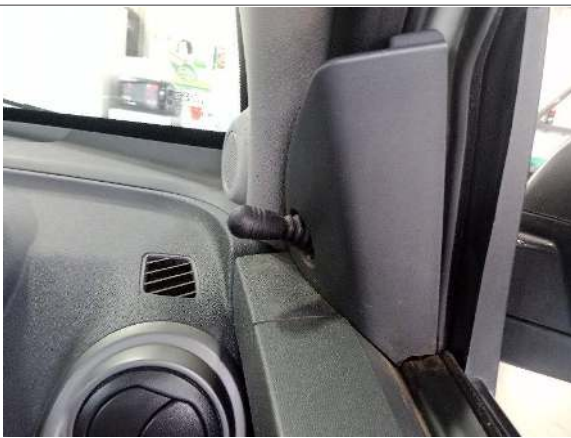
| Damage | Repair Way |
|---|---|
| Mirror Adjusters Defective | Repair |

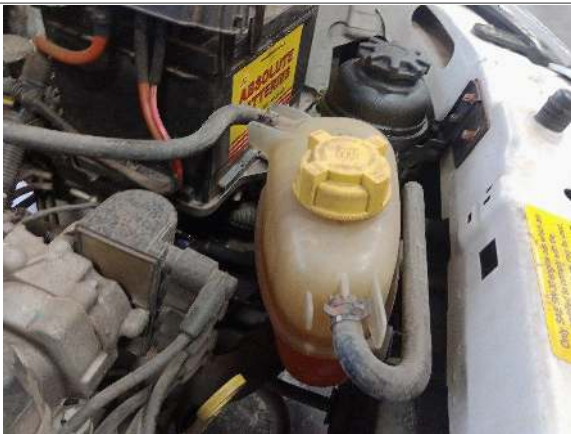
| Damage | Repair Way |
|---|---|
| Expansion Bottle Damaged | Replace |

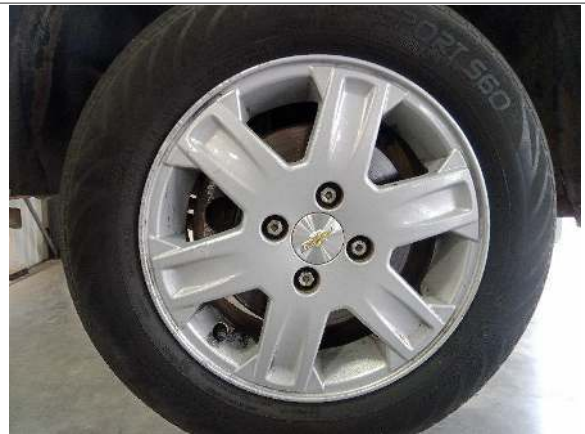
| Damage | Repair Way |
|---|---|
| Rim Front Left Scratched | Repair |

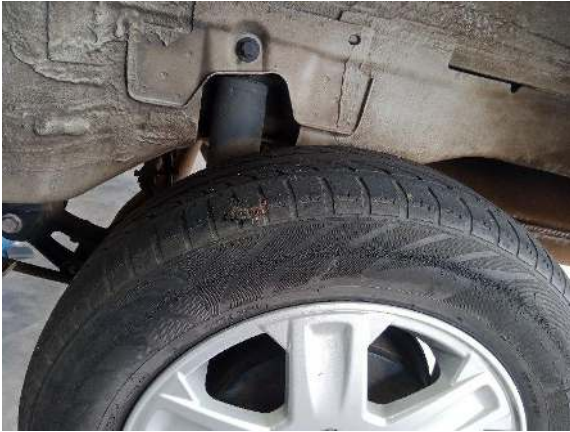
| Damage | Repair Way |
|---|---|
| Tyre Rear Left Defective | Replace |

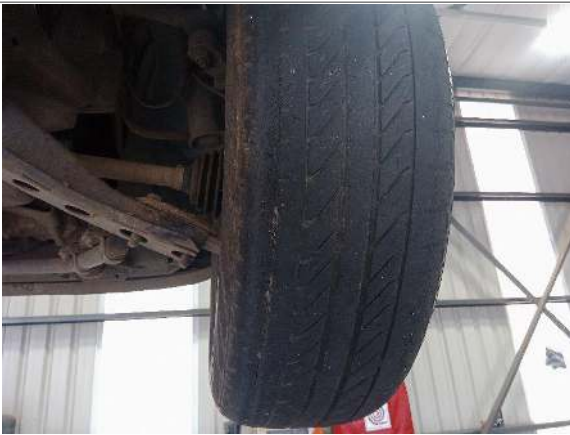
| Damage | Repair Way |
|---|---|
| Tyre Front Right Damaged | Replace |

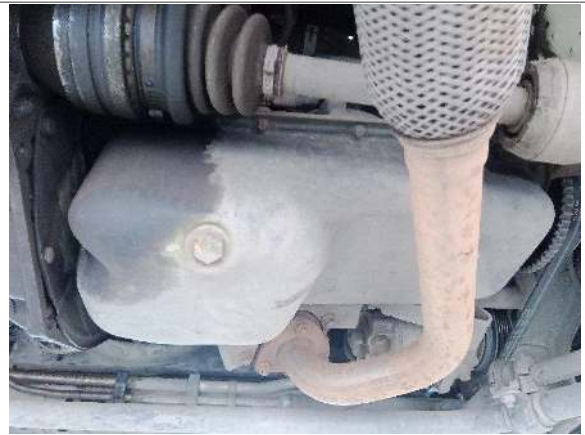
| Damage | Repair Way |
|---|---|
| Engine Oil Sweat | Repair |

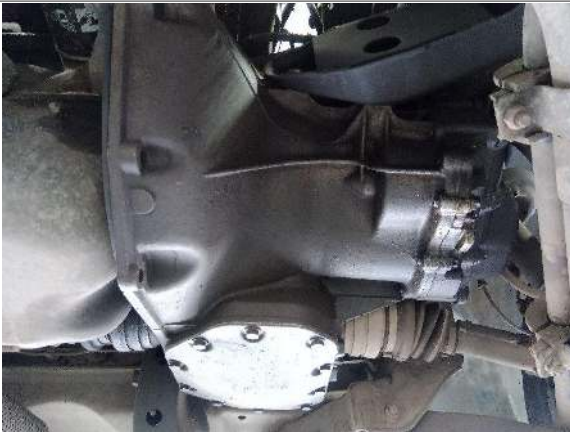
Engine to silencer pipe Defective  
Silencer Corrosion  
Gearbox Oil Leak  
Oil sweat on power steering reservoir

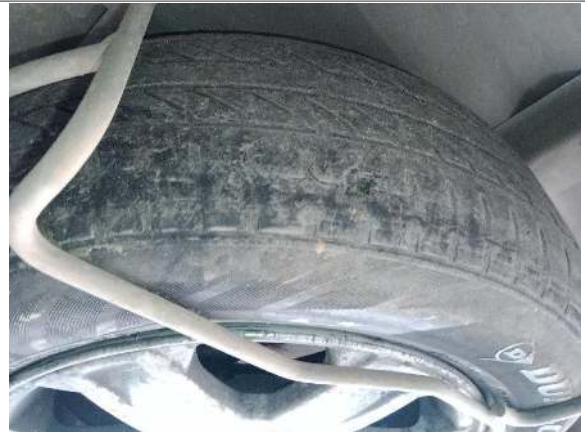
| Damage | Repair Way |
|---|---|
| Spare Tyre Damaged | Replace |

| | Size | Load/Speed Index | Manufacture | Model | Type* | Production Date | Tread Depth (mm) |
|---|---|---|---|---|---|---|---|
| Spare | 185/65 R14 | 86H | Dunlop | Sp-Sport | V | 0916 | 0 mm |

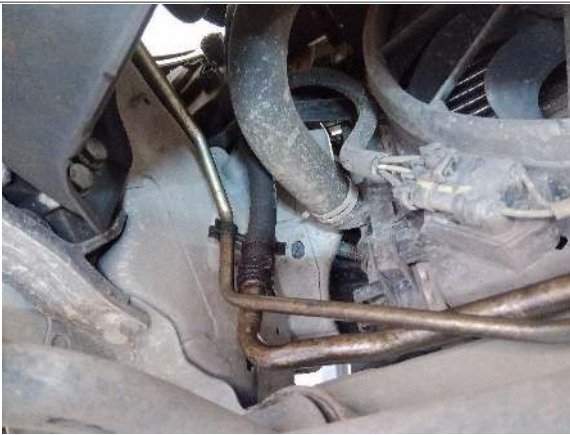
| Damage | Repair Way |
|---|---|
| Hoses Oil Leak | Repair |

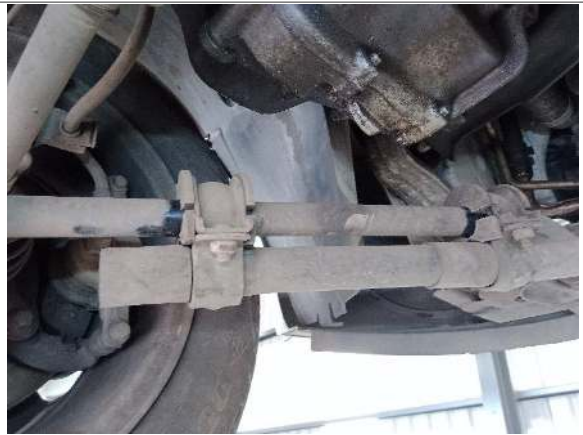
| Damage | Repair Way |
|---|---|
| Stabilizer Mounting Front Left Defective | Repair |
