MFC Auction House  
M57 Pretoria Rd, Glenmarais, KEMPTON PARK  
Gauteng

| Manufacturer | ISUZU | Registration Number | KMK001NW |

## CONDITION REPORT

Report No: 2016309496

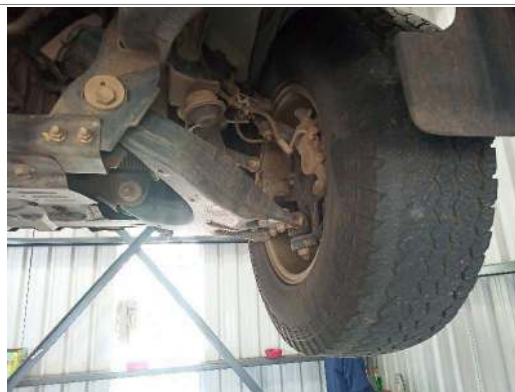
RF TYRE TREAD

| | Size | Load/Speed Index | Manufacture | Model | Type* | Production Date | Tread Depth (mm) |
|---|---|---|---|---|---|---|---|
| Front Right | 245/70R16 | 111H | General | Radial | V | 4421 | 0 mm |

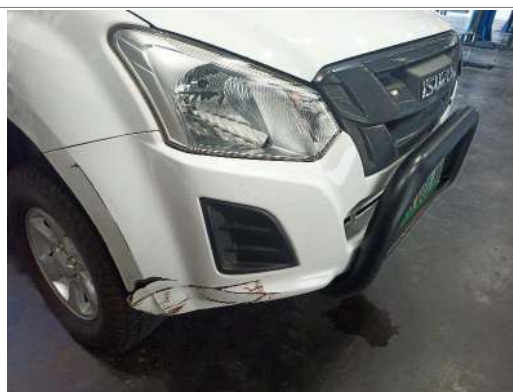
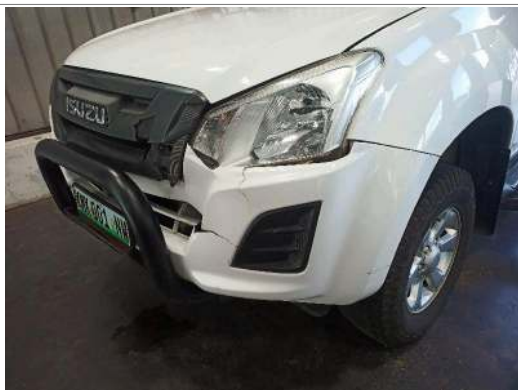
| Damage | Repair Way |
|---|---|
| Front Bumper Damaged | Repair |

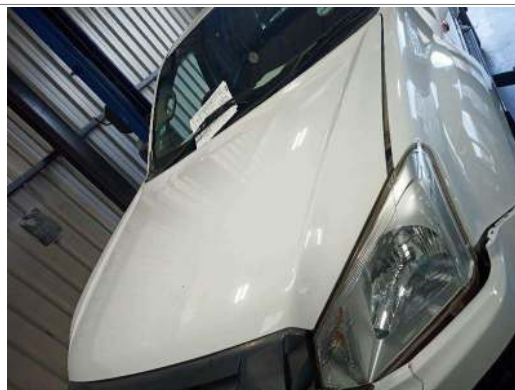
| Damage | Repair Way |
|---|---|
| Bonnet Residual Traces of Repair | Repair |

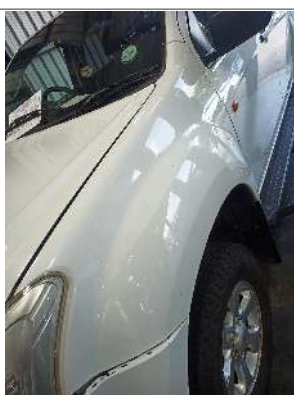
| Damage | Repair Way |
|---|---|
| Front Fender Left Damaged | Repair |

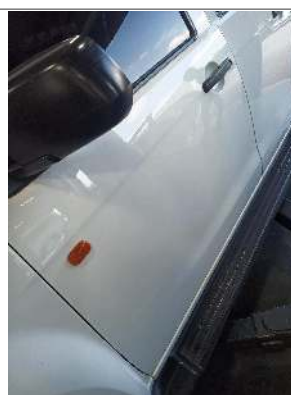
| Damage | Repair Way |
|---|---|
| Door Front Left Damaged | Repair |

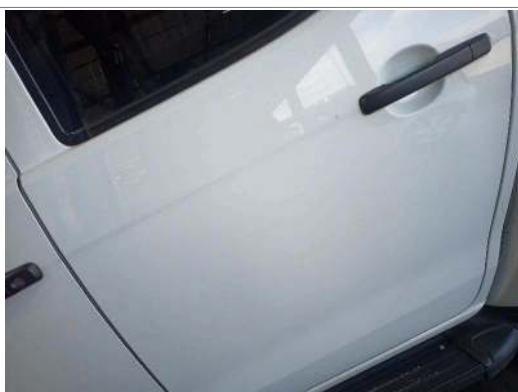
| Damage | Repair Way |
|---|---|
| Door Rear Left Damaged | Repair |

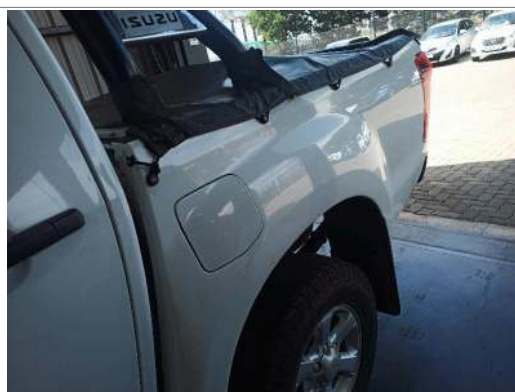
| Damage | Repair Way |
|---|---|
| Rear Fender Left Damaged | Repair |

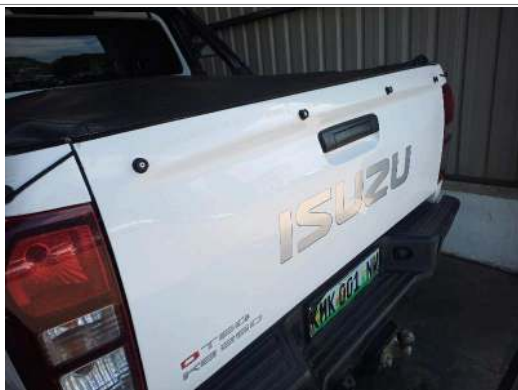
| Damage | Repair Way |
|---|---|
| Tailgate Damaged | Repair |

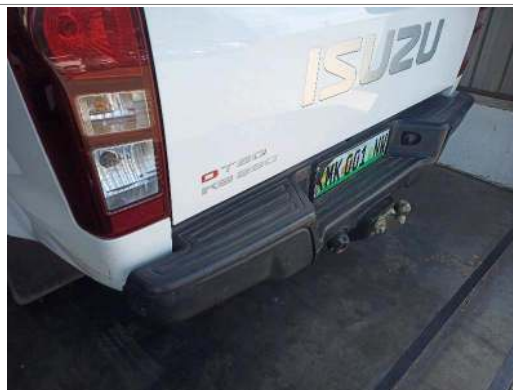
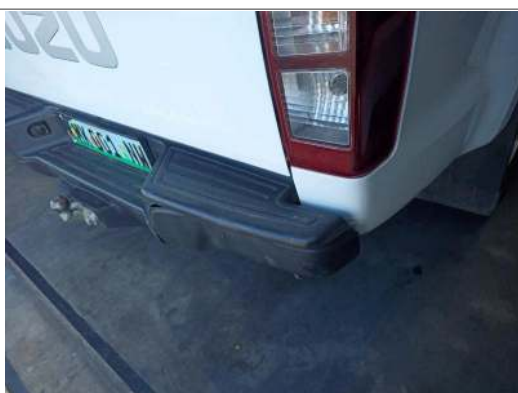
| Damage | Repair Way |
|---|---|
| Rear bumper Damaged | Repair |

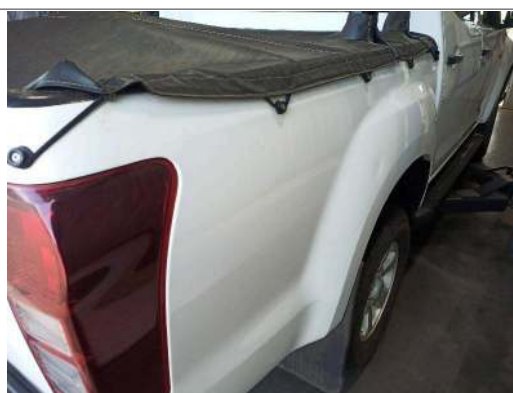
| Damage | Repair Way |
|---|---|
| Rear Fender Right Damaged | Repair |

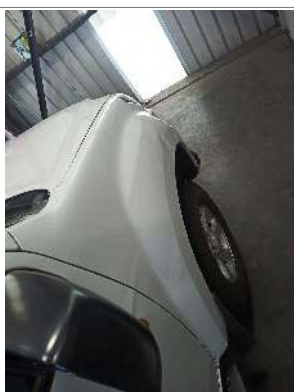
| Damage | Repair Way |
|---|---|
| Front Fender Right Damaged | Repair |

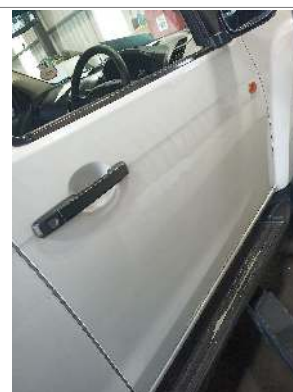
| Damage | Repair Way |
|---|---|
| Door Front Right Damaged | Repair |

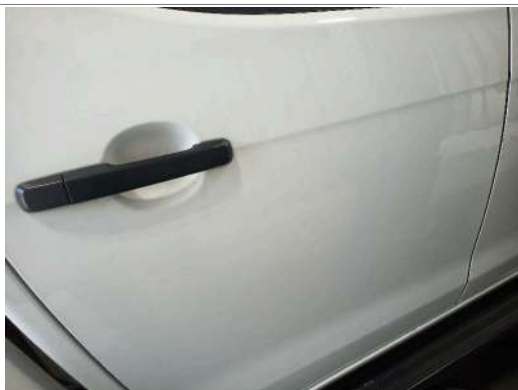
| Damage | Repair Way |
|---|---|
| Door Rear Right Damaged | Repair |

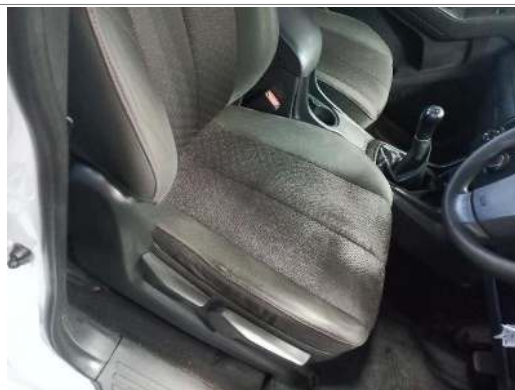
| Damage | Repair Way |
|---|---|
| Seat Front Right Worn | Repair |

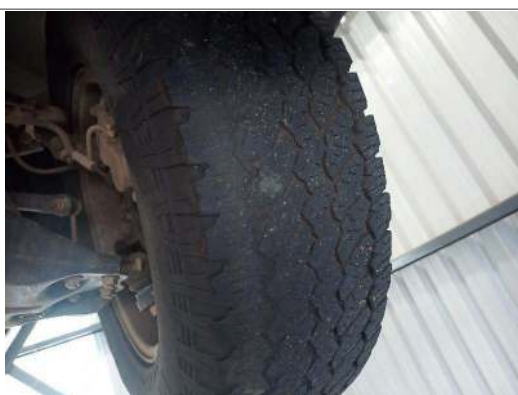
| Damage | Repair Way |
|---|---|
| Tyre Front Right Worn | Replace |

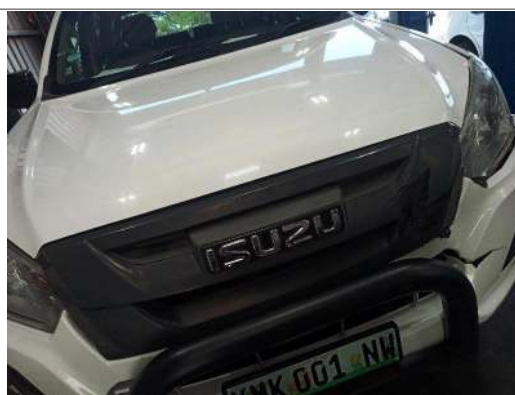
| Damage | Repair Way |
|---|---|
| Grill Damaged | Replace |

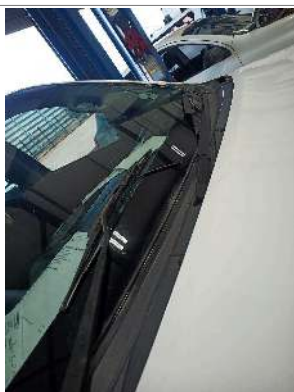
| Damage | Repair Way |
|---|---|
| Windscreen Wiper Damaged | Replace |

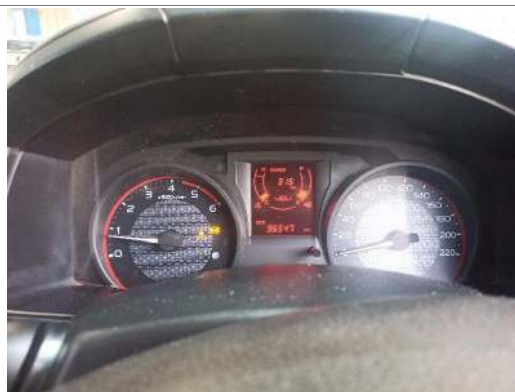
| Damage | Repair Way |
|---|---|
| Engine Management Lights Set | Repair |

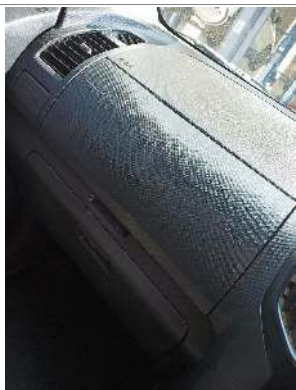
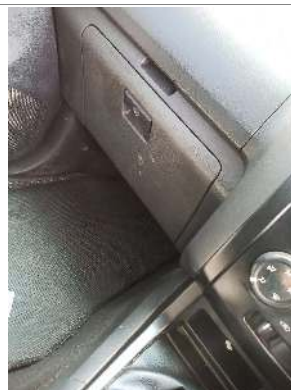
| Damage | Repair Way |
|---|---|
| Center Console / Cubbyhole + Lid Damaged | Replace |
