CONDITION REPORT

Report No: 2016232602

DATE
18/01/2024

Vehicle Type	LIGHT LOAD VEHICLE	Registered Owner	MFC AUCTION HOUSE
Manufacturer	NISSAN	Registration Number	FK48JCGP
Model	NP300 HARDBODY	Register Number	
VIN	ADNCDGD22ZR088423	Date Of First Licensing	
Engine Number		Last COR	
Doors	4	License Expiry Date	31/01/2024
Color	WHITE	Power / Displacement	
Year Model		Paint Finish	TWO COAT METALLIC
Km Reading	161,494 KM	Fuel	PETROL
Cab / Body Type	DOUBLE CAB	Transmission	MANUAL

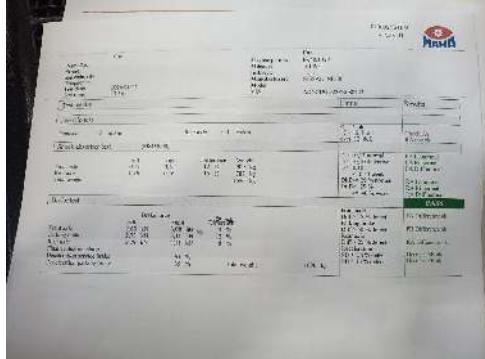
Brake and shock test

Left	Right	Axle Weight [KG]	Deceleration [m/s ²]
	Braking Force [kN]	Braking Force [kN]		
Front	2.65	3.08	-	
Rear	2.29	2.11	-	
Emergency / Parking	2.73	3.11	-

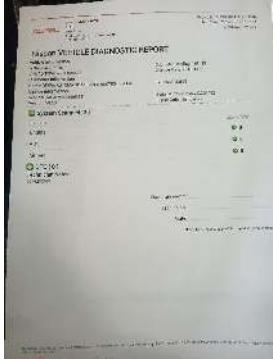
Diagnostic report

During the diagnostic no active error messages were detected. (See also attached Diagnostic Report. For more information regarding the Fault Codes (DTC) and the recommended rectifications please contact the workshops of the vehicle manufacture).

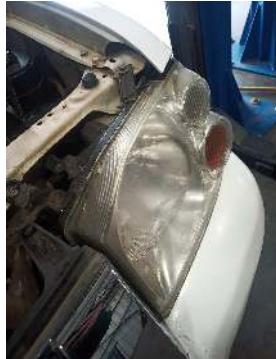
Damage	Repair Way
Engine Oil Leak	Repair
Tail Light Left Damaged	Replace
Headlight Left Damaged	Replace
Seat Front Left Damaged	Repair
Seat Front Right Damaged	Repair
Door Panel Front Right Damaged	Repair
Front Bumper Damaged	Repair
Bonnet Damaged	Repair
C • Pillar Left Damaged	Repair
Front Fender Left Damaged	Repair
Front Fender Right Damaged	Repair
Rear Fender Left Damaged	Repair
Rear Fender Right Damaged	Repair
Door Front Left Damaged	Repair
Door Front Right Damaged	Repair
Door Rear Left Damaged	Repair
Door Rear Right Damaged	Repair
Tailgate Damaged	Repair
Rear bumper Damaged	Replace
Steering Stopper Left Damaged	Replace
Steering Stopper Right Damaged	Replace
Torsion Bar Front Left Deformed	Replace
Alignment Poor Alignment	Repair
Tyre Front Right Damaged	Replace
Center Prop Shaft Rubber(s) Worn	Repair

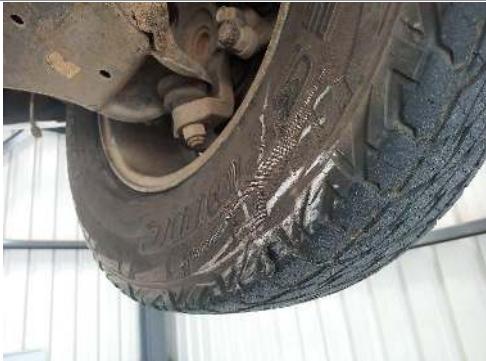
Tyre Front Right

Size	Load/Speed Index	Manufacture	Model	Type*	Production Date	Tread Depth (mm)
Front Left	245/70R16	107S	Bridgestone	Radial	V	3319	2 mm
Front Right	245/70R16	107S	Bridgestone	Radial	V	3219	2 mm
Rear Left	245/70R16	107S	Bridgestone	Radial	V	3319	2 mm
Rear Right	245/70R16	107S	Bridgestone	Radial	V	3319	2 mm
