CONDITION REPORT

Report No: 2016218774

| Manufacturer | NISSAN | Registration Number | HX72GTGP |
| Model | NP200 | Register Number | |

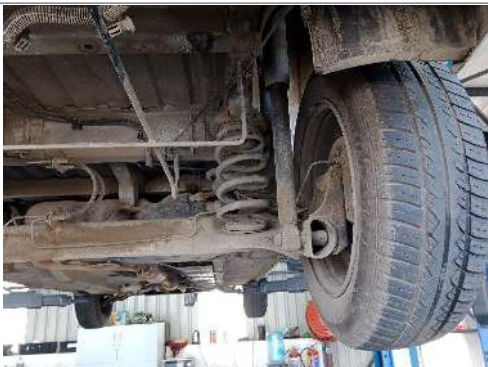
RR TYRE TREAD

| | Size | Load/Speed Index | Manufacture | Model | Type* | Production Date | Tread Depth (mm) |
|---|---|---|---|---|---|---|---|
| Rear Right | 185/65 R15 | 92T | Barum | Brillantis | V | 3118 | 3 mm |

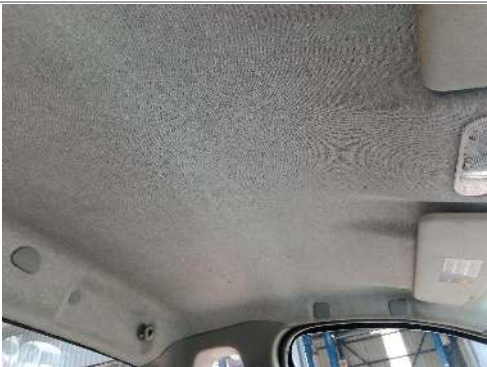
| Damage | Repair Way |
|---|---|
| Hood Lining Dirty | Repair |

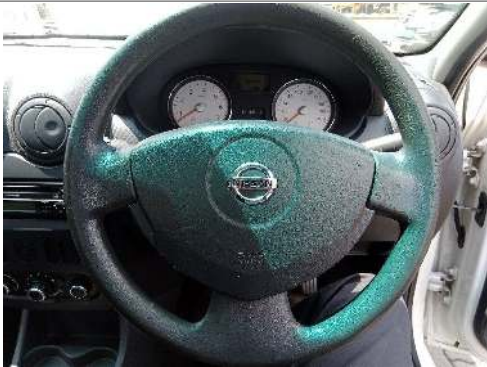
| Damage | Repair Way |
|---|---|
| Steering Wheel Trim Defective | Repair |

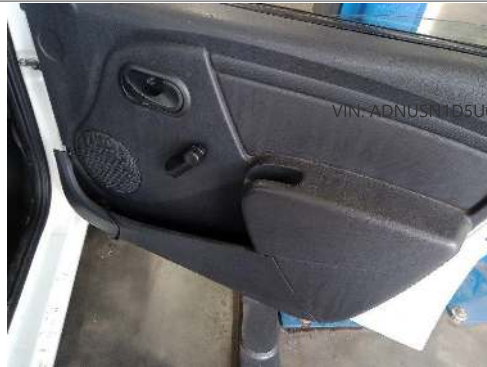
| Damage | Repair Way |
|---|---|
| Door Panel Front Right Damaged | Repair |

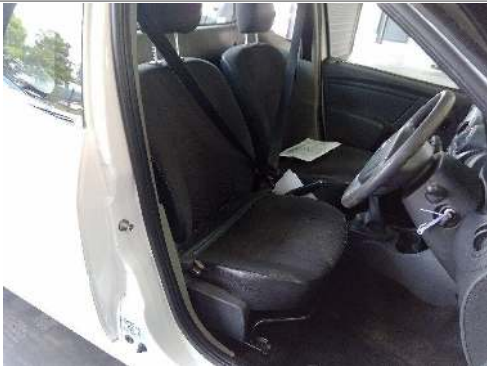
| Damage | Repair Way |
|---|---|
| Seat Front Right Damaged | Repair |

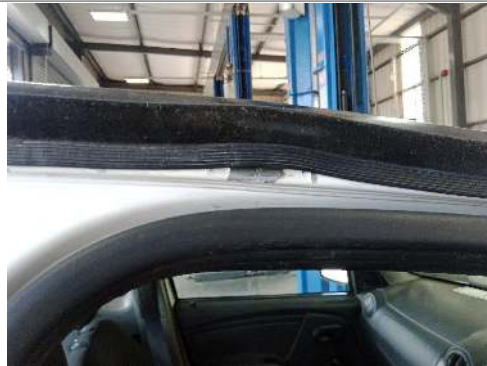
| Damage | Repair Way |
|---|---|
| B • Pillar Right Dented | Repair |

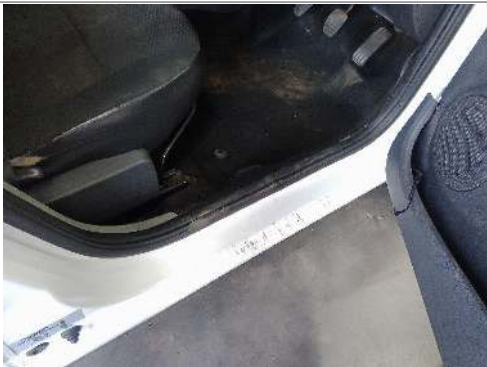
| Damage | Repair Way |
|---|---|
| Sill Panel Right Paintwork • Scratched | Repair |

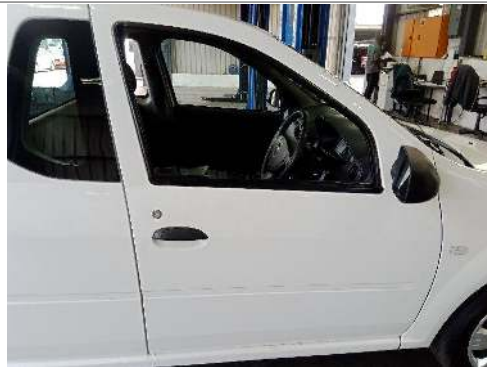
| Damage | Repair Way |
|---|---|
| Door Front Right Dented | Repair |

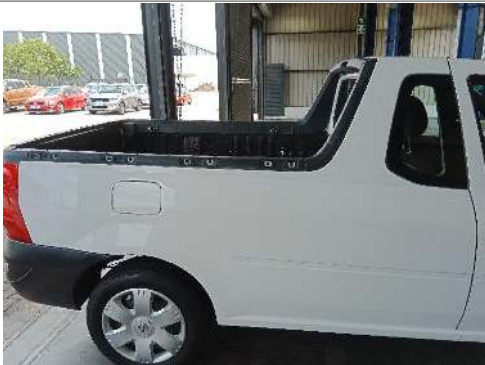
| Damage | Repair Way |
|---|---|
| Rear Fender Right Paintwork • Scratched | Repair |

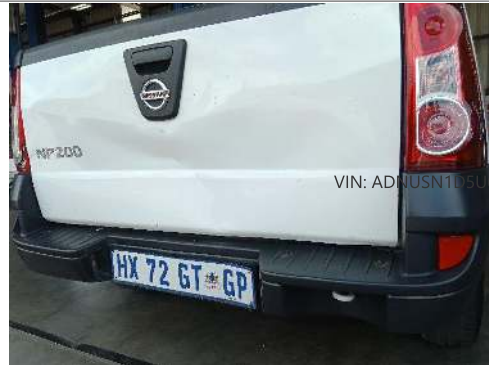
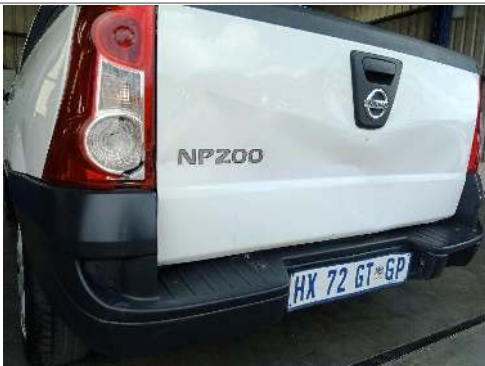
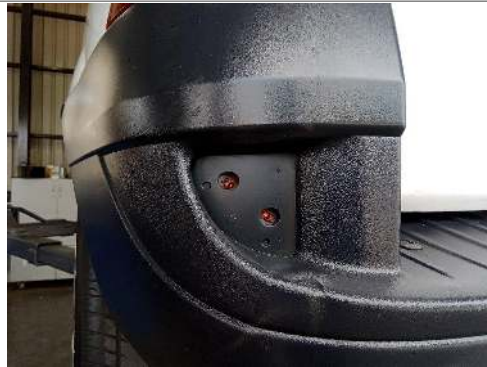
| Damage | Repair Way |
|---|---|
| Rear bumper Damaged | Repair |

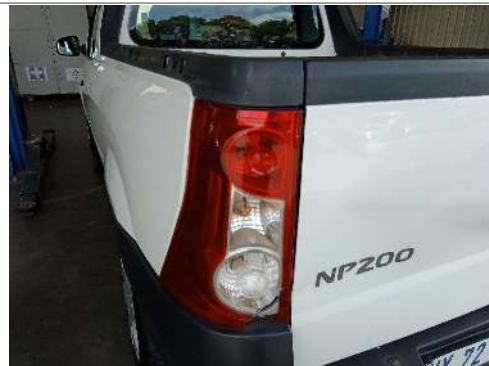
| Damage | Repair Way |
|---|---|
| Tail Light Left Damaged | Replace |

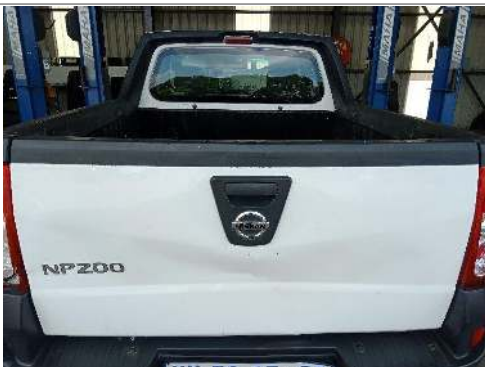
| Damage | Repair Way |
|---|---|
| Tailgate Damaged | Replace |

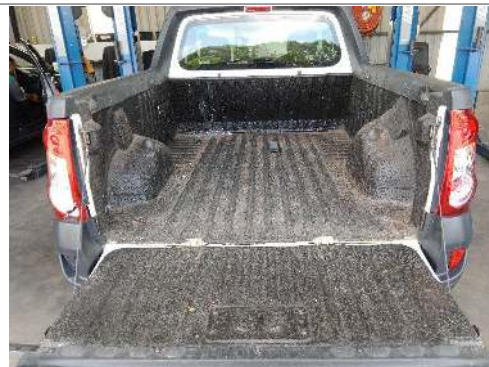
| Damage | Repair Way |
|---|---|
| Load Body Paintwork • Scratched | Repair |

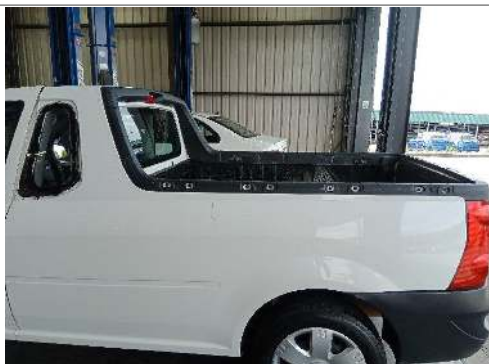
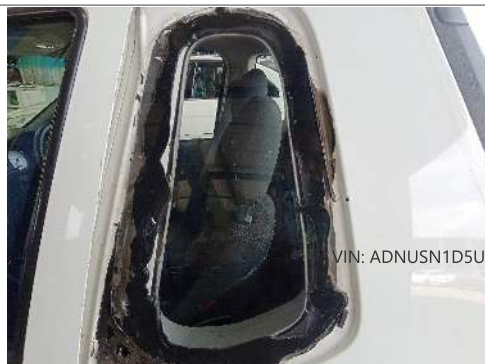
| Damage | Repair Way |
|---|---|
| Rear Fender Left Damaged | Repair |

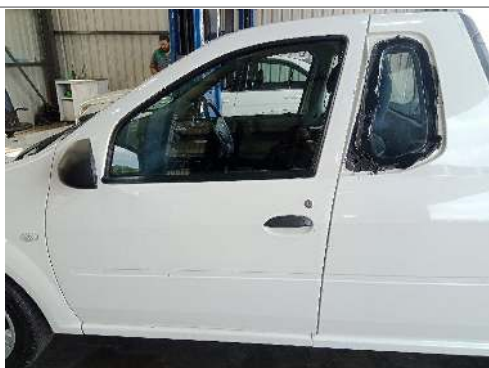
| Damage | Repair Way |
|---|---|
| Door Front Left Paintwork • Scratched | Repair |

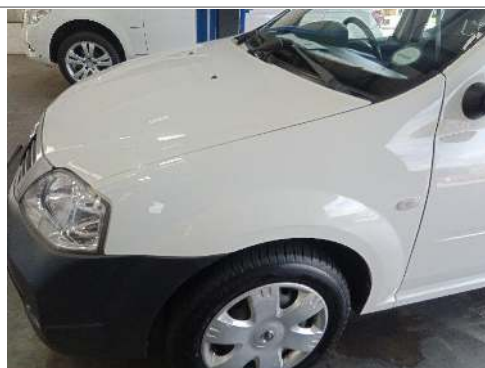
| Damage | Repair Way |
|---|---|
| Front Fender Left Paintwork • Scratched | Repair |

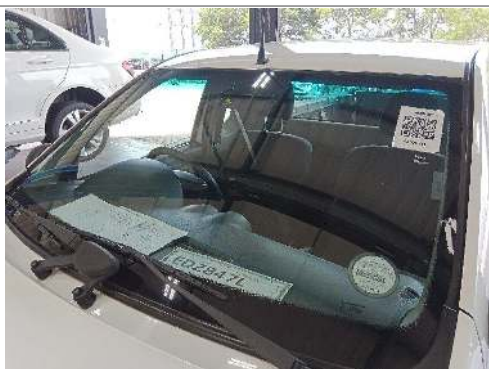
| Damage | Repair Way |
|---|---|
| Windscreen Damaged | Replace |

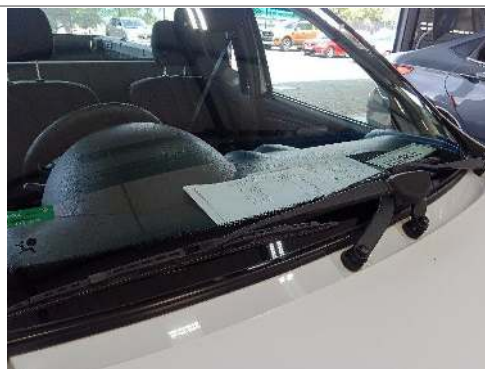
| Damage | Repair Way |
|---|---|
| Windscreen Wiper Damaged | Replace |

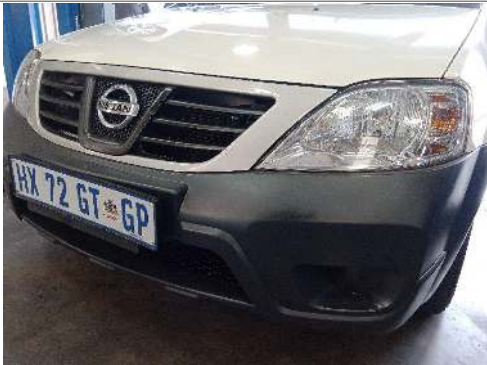
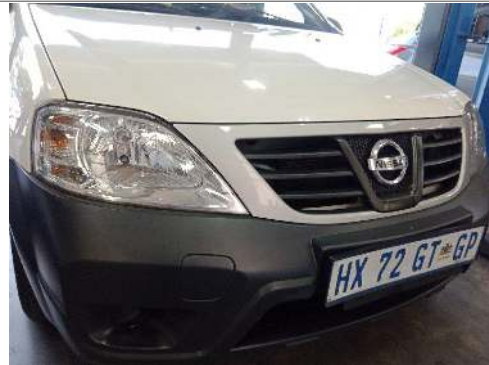
| Damage | Repair Way |
|---|---|
| Front Bumper Paintwork • Scratched | Repair |

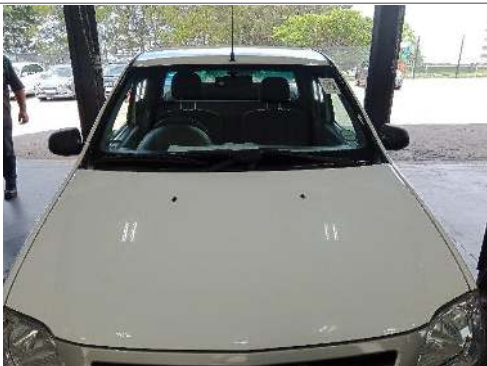
| Damage | Repair Way |
|---|---|
| Bonnet Paintwork • Chipmarks | Repair |

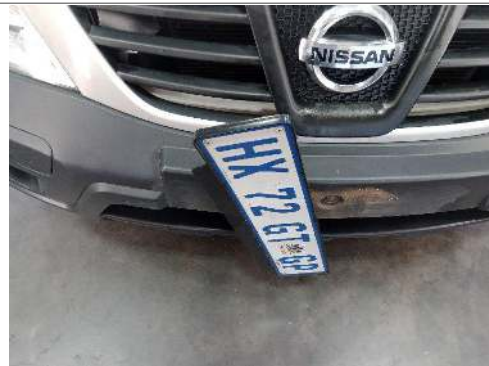
| Damage | Repair Way |
|---|---|
| Number Plate Front Defective | Repair |

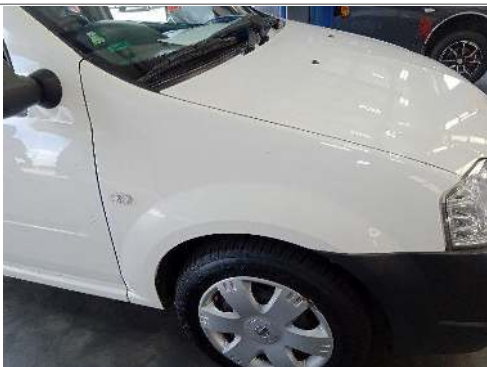
| Damage | Repair Way |
|---|---|
| Front Fender Right Dented | Repair |

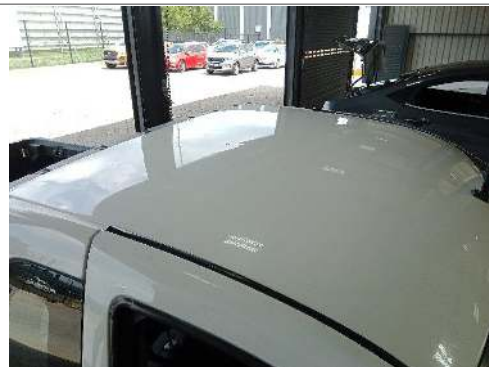
| Damage | Repair Way |
|---|---|
| Roof Dented | Repair |

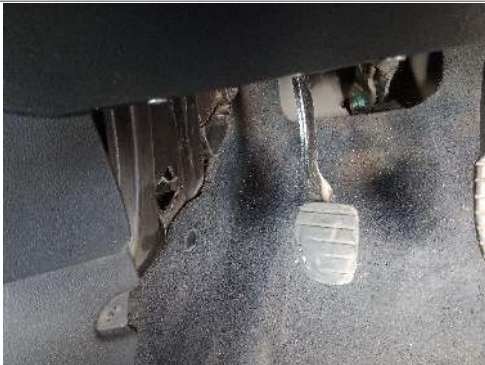
| Damage | Repair Way |
|---|---|
| Clutch Pedal Rubber Torn / Cut | Replace |

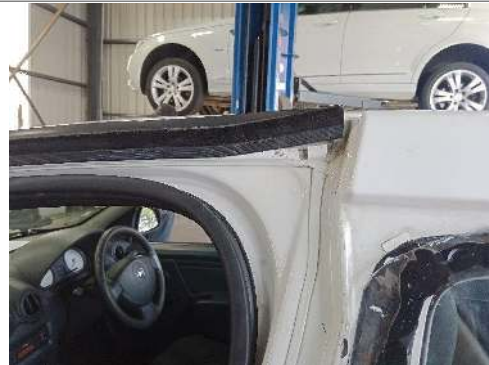
| Damage | Repair Way |
|---|---|
| B • Pillar Left Dented | Repair |

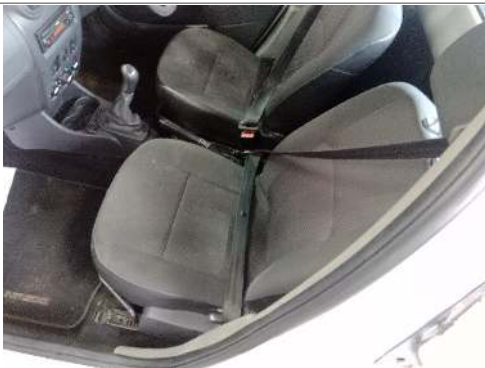
| Damage | Repair Way |
|---|---|
| Seat Front Left Torn / Cut | Repair |

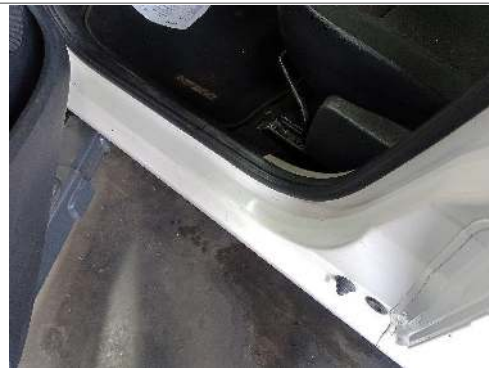
| Damage | Repair Way |
|---|---|
| Sill Panel Left Paintwork • Scratched | Repair |

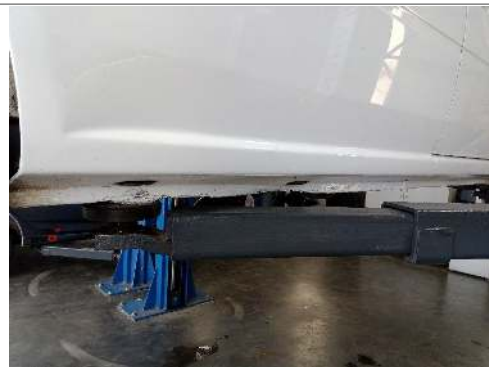
| Damage | Repair Way |
|---|---|
| Rocker Panel Right Damaged | Repair |

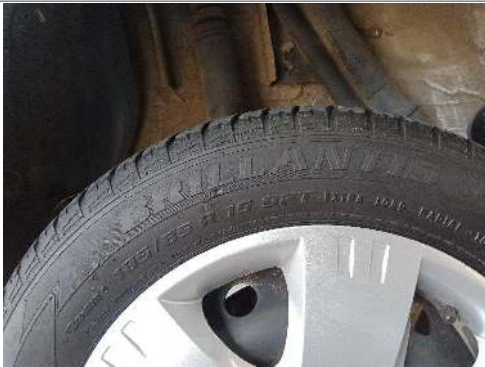
| Damage | Repair Way |
|---|---|
| Tyre Rear Right Torn / Cut | Replace |

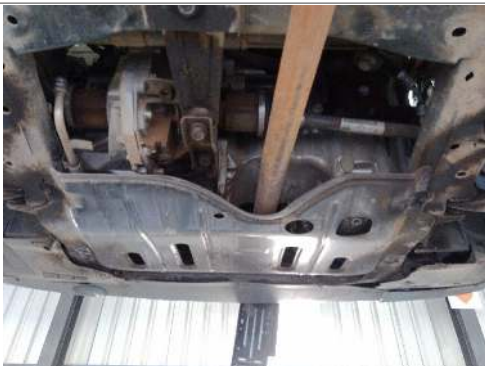
| Damage | Repair Way |
|---|---|
| Belly plates Defective | Repair |

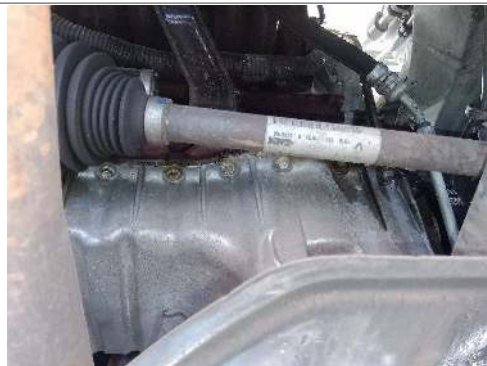
| Damage | Repair Way |
|---|---|
| Engine Oil Sweat | Repair |

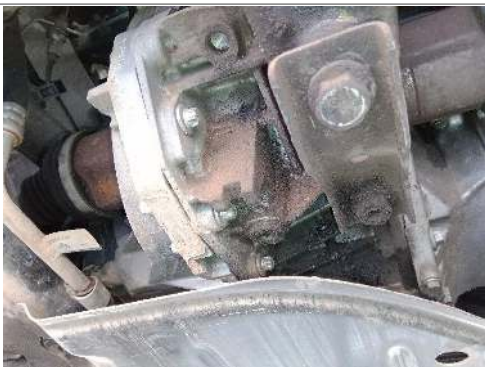
| Damage | Repair Way |
|---|---|
| Gearbox Oil Sweat | Repair |

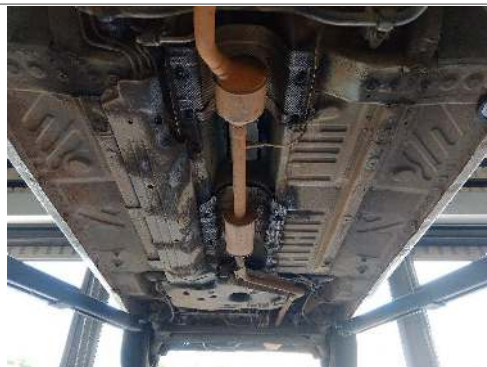
| Damage | Repair Way |
|---|---|
| Chassis Scratched | Repair |

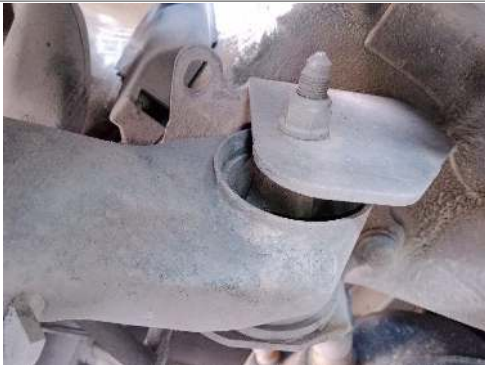
| Damage | Repair Way |
|---|---|
| Mounting Rubber(s) Rear Axle Right Cracked | Replace |

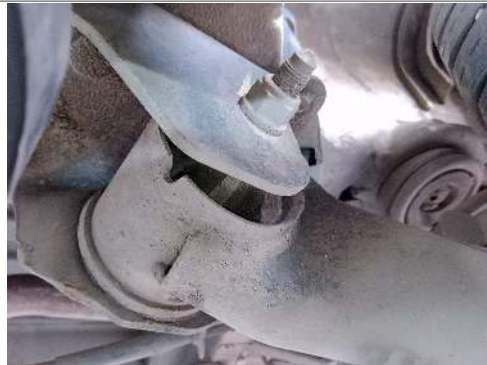
| Damage | Repair Way |
|---|---|
| Mounting Rubber(s) Rear Axle Left Cracked | Replace |

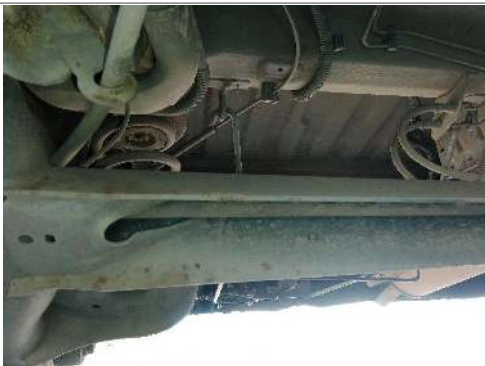
| Damage | Repair Way |
|---|---|
| Rear Axle Defective | Repair |

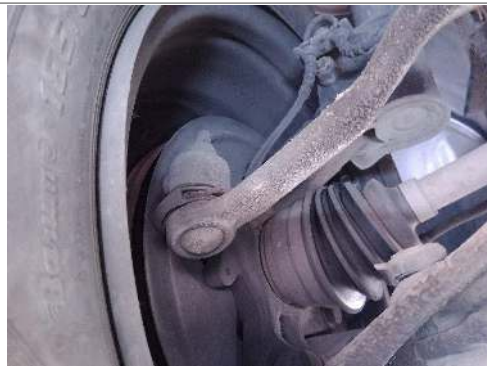
| Damage | Repair Way |
|---|---|
| Tie Rod End left Damaged | Replace |

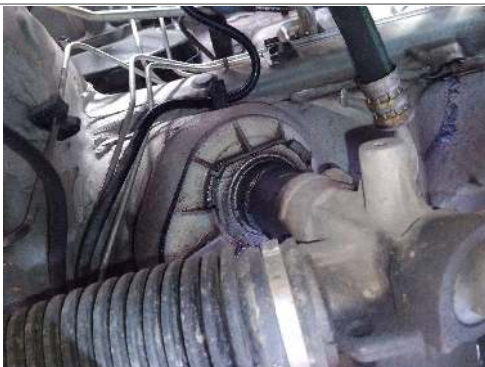
| Damage | Repair Way |
|---|---|
| Steering box Leak | Repair |

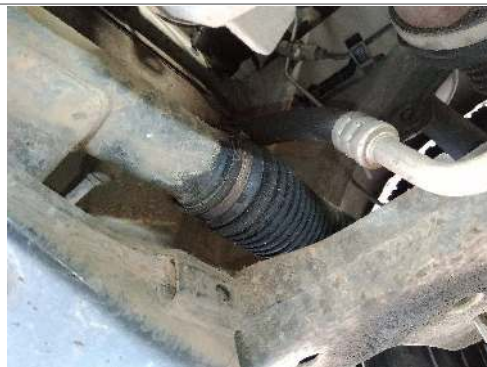
| Damage | Repair Way |
|---|---|
| Steering Rack Boot Left Sweat | Replace |

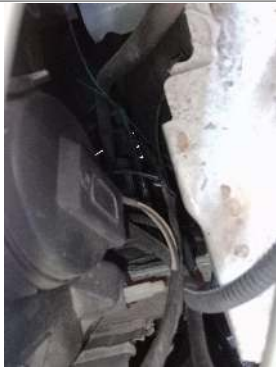
| Damage | Repair Way |
|---|---|
| Engine Wiring Damaged | Repair |
