## CONDITION REPORT

Report No: 2016272800

MFC Auction House  
M57 Pretoria Rd, Glenmarais, KEMPTON PARK  
Gauteng

| Manufacturer | NISSAN | Registration Number | JR23PWGP |

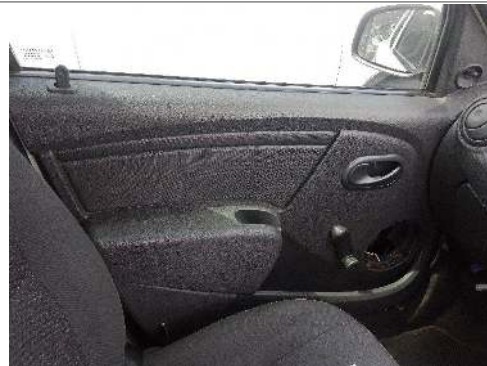
| Damage | Repair Way |
|---|---|
| Door Panel Front Left Defective | Repair |

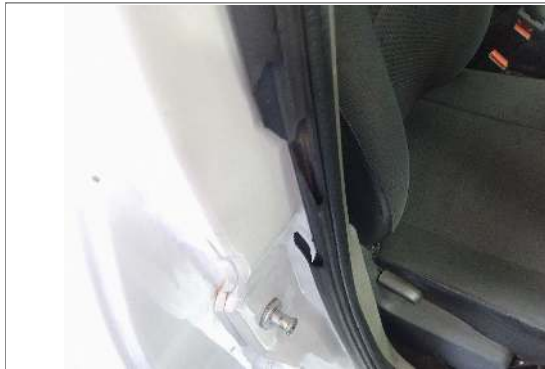
| Damage | Repair Way |
|---|---|
| Door Sealing Rubber Front Right Damaged | Replace |

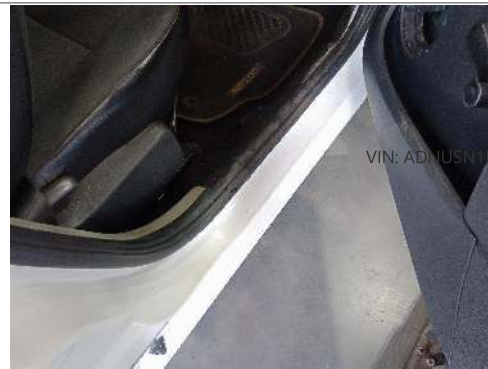
| Damage | Repair Way |
|---|---|
| Sill Panel Right Paintwork • Scratched | Repair |

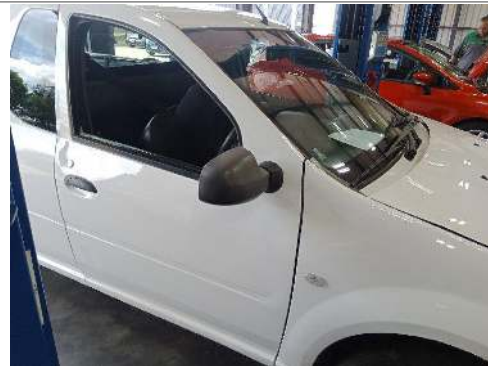
| Damage | Repair Way |
|---|---|
| Door Front Right Damaged | Repair |

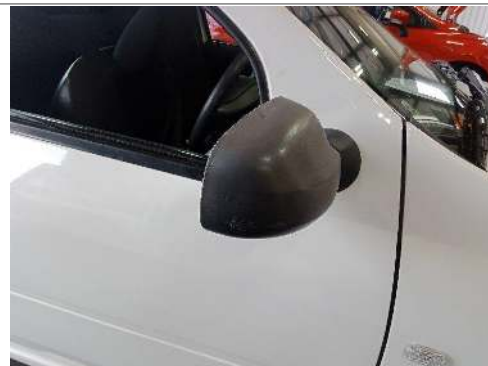
| Damage | Repair Way |
|---|---|
| Side Mirror Right Paintwork • Scratched | Repair |

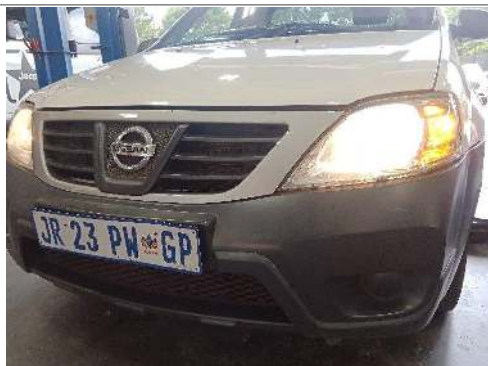
| Damage | Repair Way |
|---|---|
| Front Bumper Paintwork • Scratched | Repair |

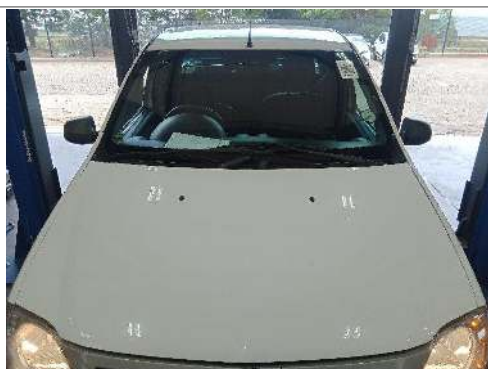
| Damage | Repair Way |
|---|---|
| Bonnet Dented | Repair |

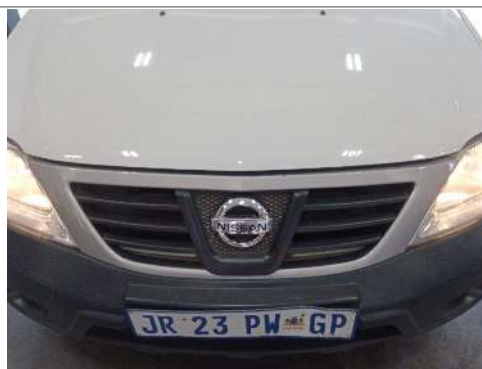
| Damage | Repair Way |
|---|---|
| Grill Paintwork • Scratched | Repair |

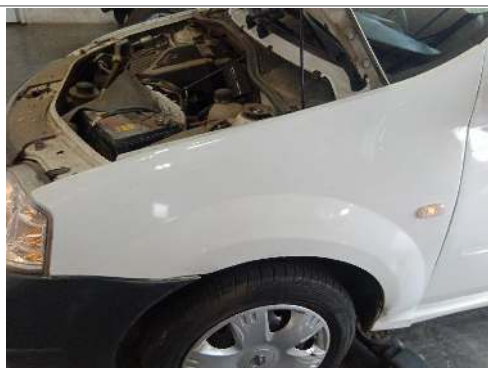
| Damage | Repair Way |
|---|---|
| Front Fender Left Residual Traces of Repair | Repair |

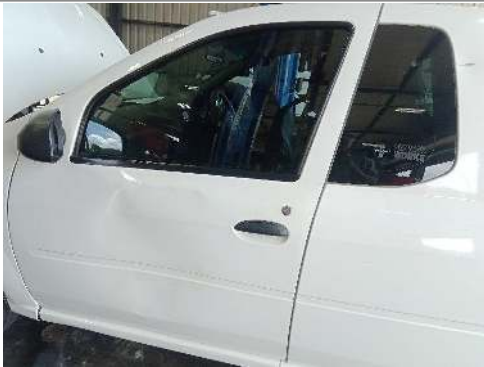
| Damage | Repair Way |
|---|---|
| Door Front Left Damaged | Repair |

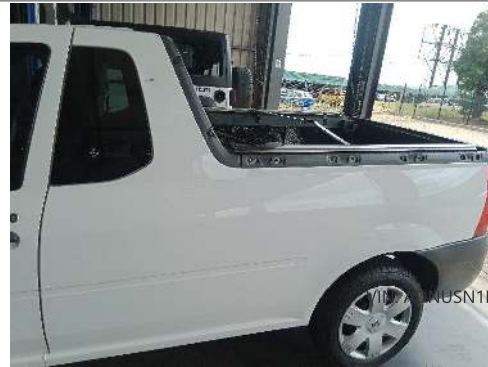
| Damage | Repair Way |
|---|---|
| Rear Fender Left Dented | Repair |

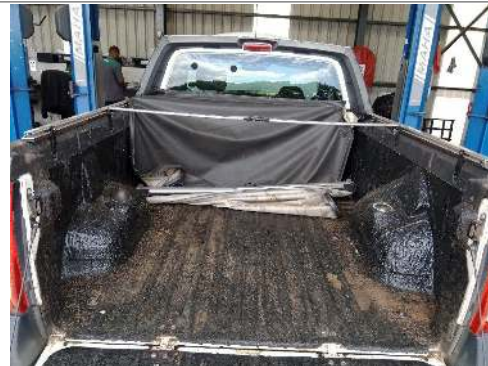
| Damage | Repair Way |
|---|---|
| Load Body Defective | Repair |

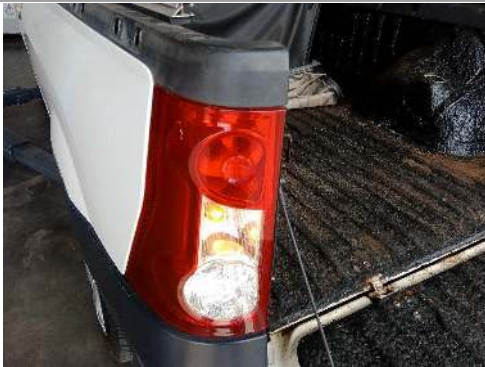
| Damage | Repair Way |
|---|---|
| Tail Light Left Cracked | Replace |

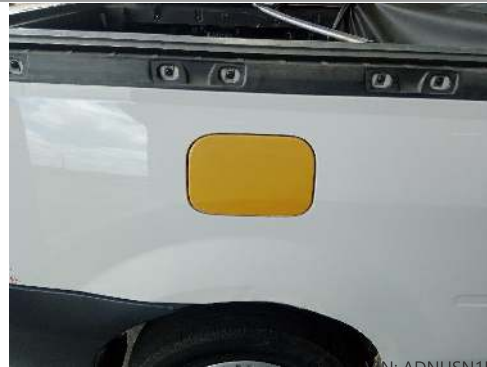
| Damage | Repair Way |
|---|---|
| Fuel Flap Defective | Repair |

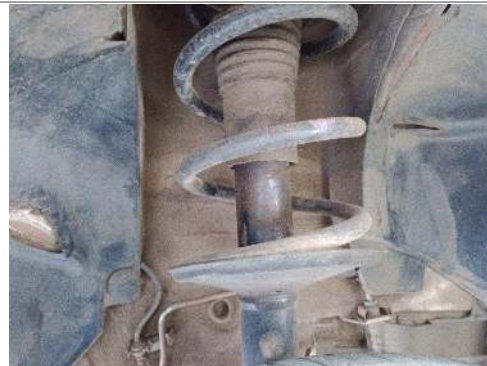
| Damage | Repair Way |
|---|---|
| Shock Absorber Front Right Sweat | Replace |

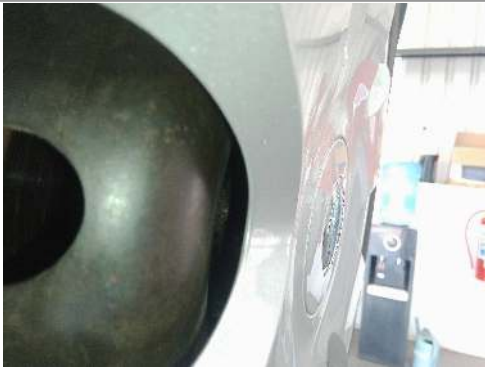
| Damage | Repair Way |
|---|---|
| Bolt(s) / Nut(s) Front Wheel Right Missing | Replace |

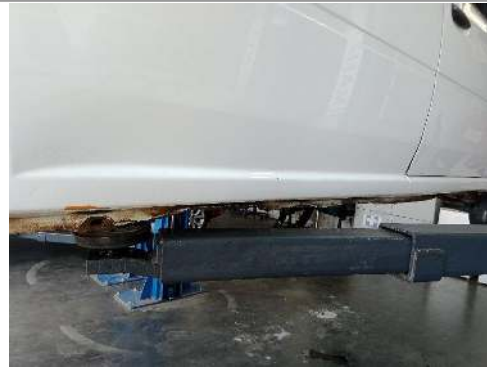
| Damage | Repair Way |
|---|---|
| Rocker Panel Right Damaged | Repair |

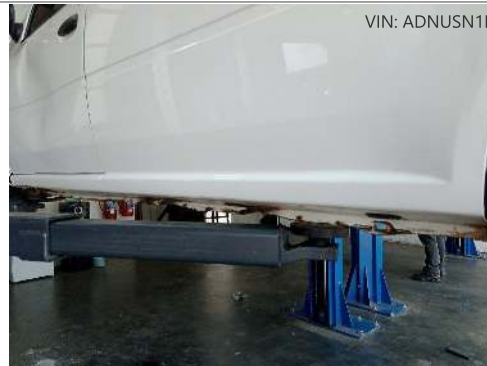
| Damage | Repair Way |
|---|---|
| Rocker Panel Left Damaged | Repair |

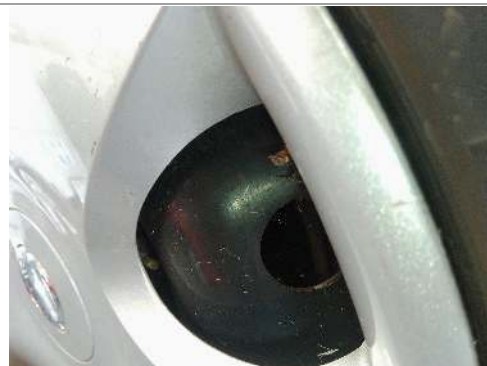
| Damage | Repair Way |
|---|---|
| Bolt(s) / Nut(s) Front Wheel Left Missing | Replace |

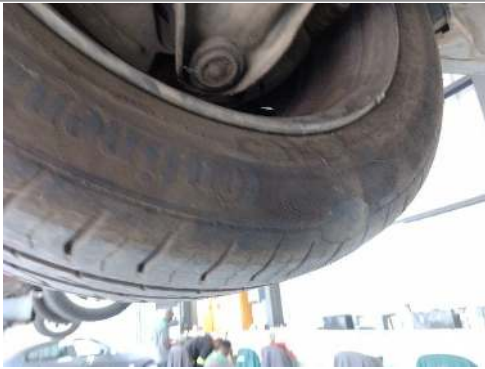
| Damage | Repair Way |
|---|---|
| Tyre Front Left Defective | Replace |

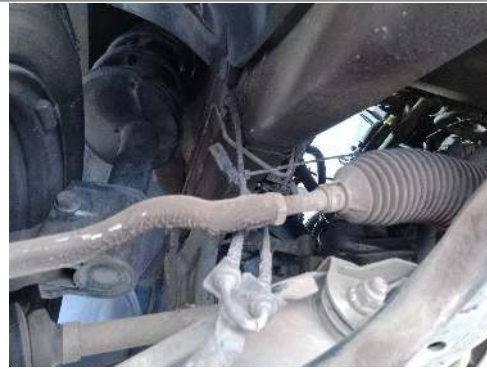
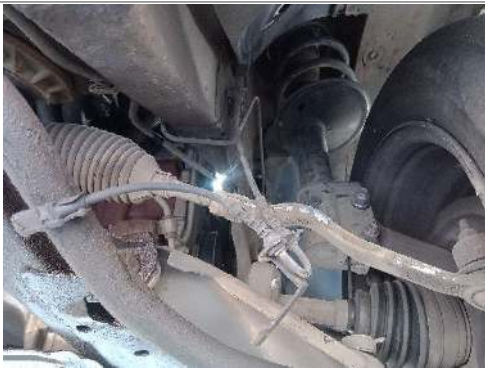
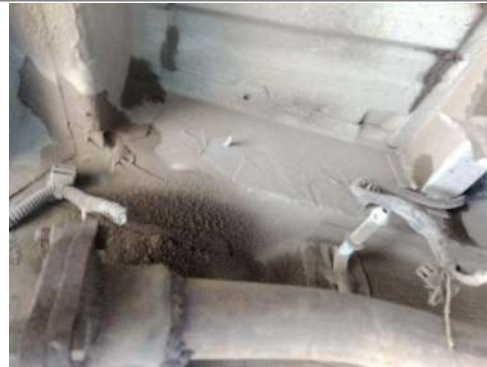
| Damage | Repair Way |
|---|---|
| Engine Wiring Defective | Repair |

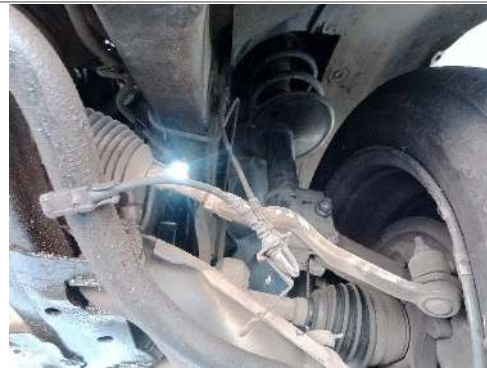
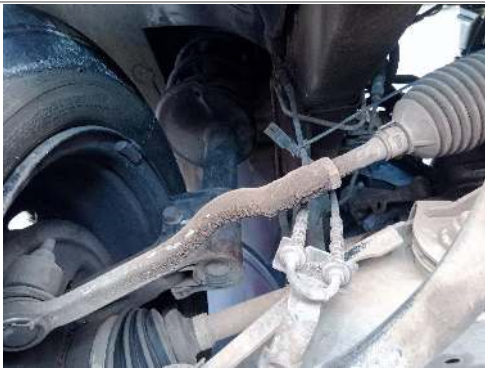
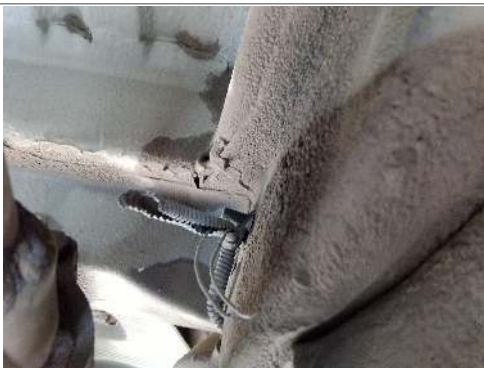
| Damage | Repair Way |
|---|---|
| Speed Sensor Damaged | Replace |
| Brakes | Rear left speed sensor damaged |

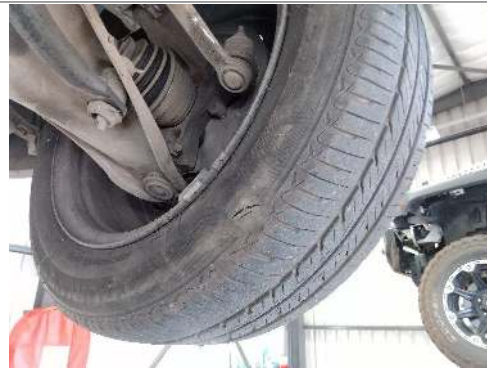
| Damage | Repair Way |
|---|---|
| Tyre Front Right Torn / Cut | Replace |

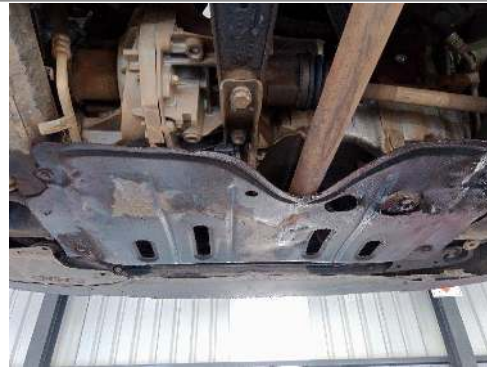
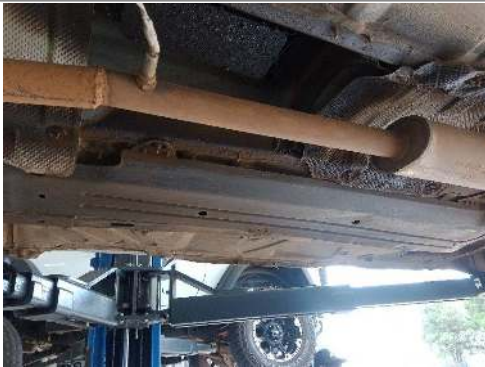
| Damage | Repair Way |
|---|---|
| Belly plates Damaged | Repair |

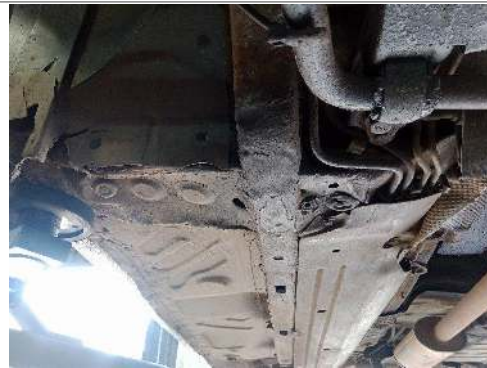
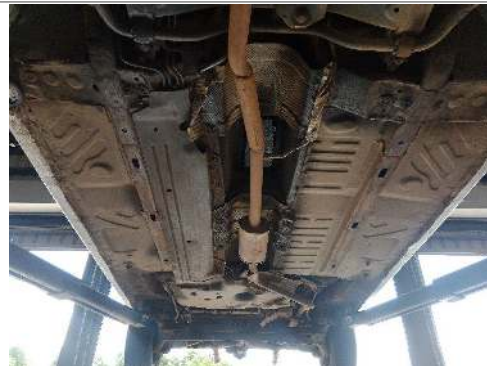
| Damage | Repair Way |
|---|---|
| Chassis Damaged | Repair |

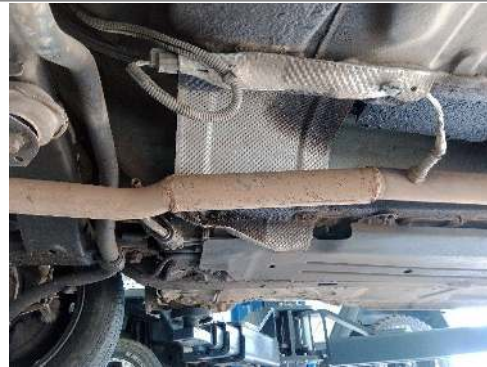
| Damage | Repair Way |
|---|---|
| Catalytic converter Missing | Replace |

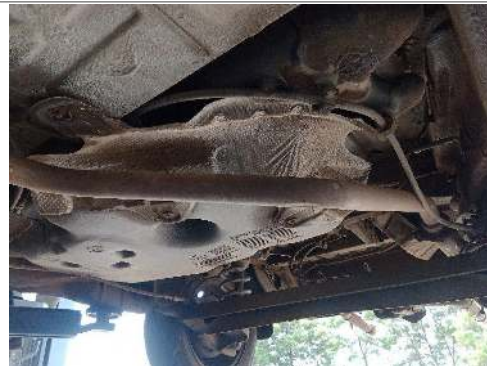
| Damage | Repair Way |
|---|---|
| Engine to silencer pipe Defective | Repair |
| Undercarriage | Exhaust loose. |
| Undercarriage | Non standard exhaust fitted to vehicle |

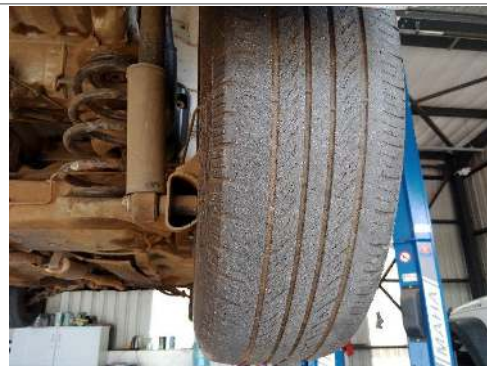
| Damage | Repair Way |
|---|---|
| Tyre Rear Right Worn | Replace |

| | Size | Load/Speed Index | Manufacture | Model | Type* | Production Date | Tread Depth (mm) |
|---|---|---|---|---|---|---|---|
| Rear Right | 185/65 R15 | 88H | Cachland | CH-268 | V | 3918 | 0 mm |

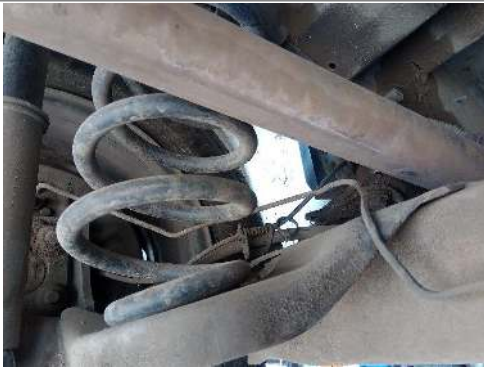
| Damage | Repair Way |
|---|---|
| Brake Piping Defective | Repair |
| Brakes | Rear left brake piping bend |

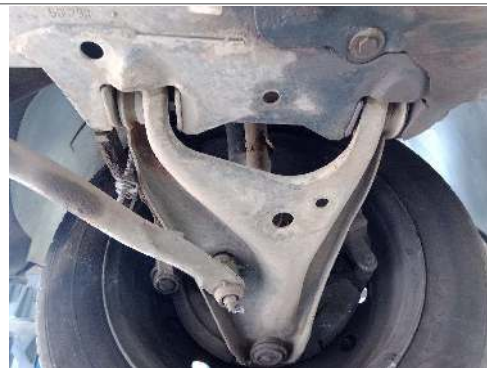
| Damage | Repair Way |
|---|---|
| Control Arm(s) Front Axle Left Defective | Replace |

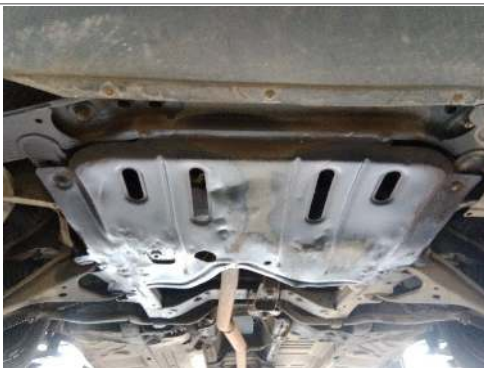
| Damage | Repair Way |
|---|---|
| Sub Frame Dented | Repair |

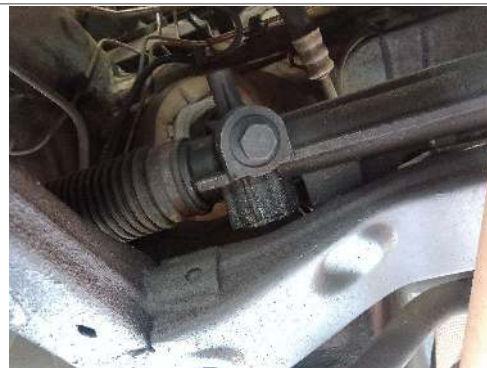
| Damage | Repair Way |
|---|---|
| Steering box Sweat | Repair |

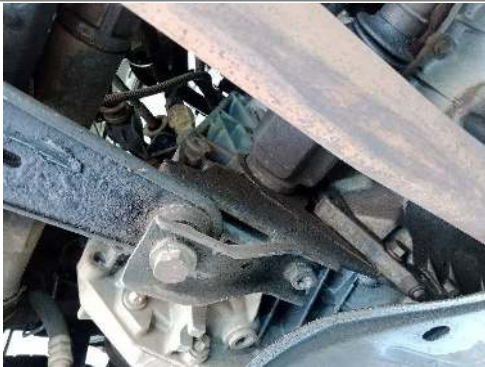
| Damage | Repair Way |
|---|---|
| Gearbox Oil Sweat | Repair |

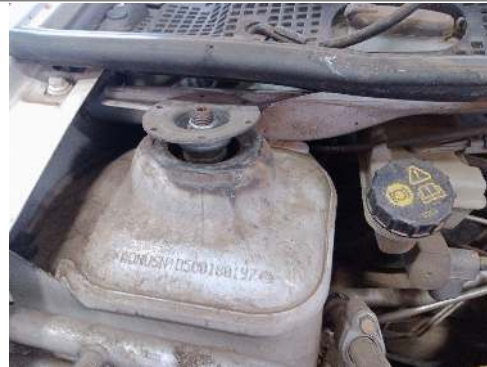
| Damage | Repair Way |
|---|---|
| Bonnet slam plate (Shock tower/ Inner tray) Welded | Repair |

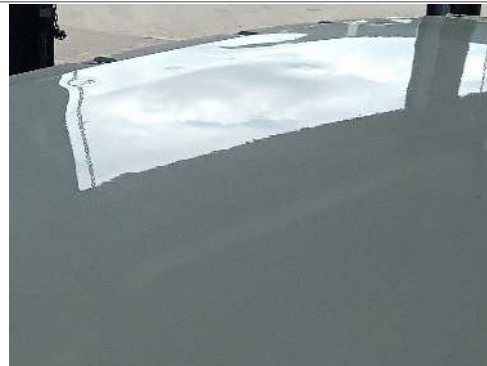
| Damage | Repair Way |
|---|---|
| Roof Dented | Repair |

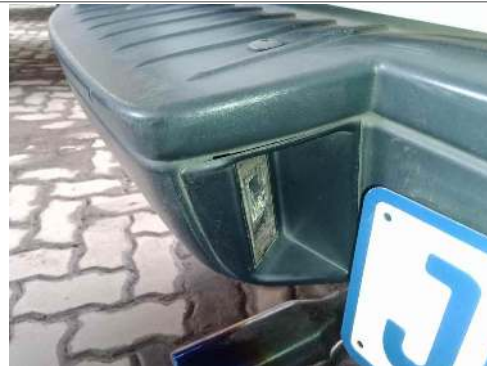
| Damage | Repair Way |
|---|---|
| Number Plate Light Left Damaged | Repair |

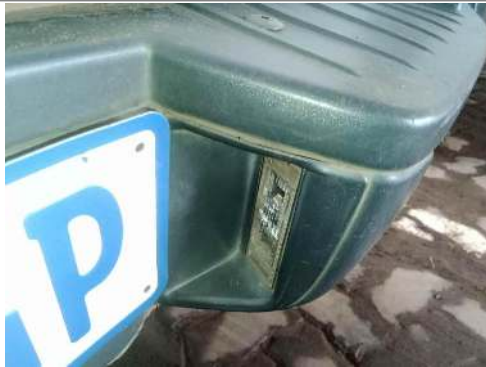
| Damage | Repair Way |
|---|---|
| Number Plate Light Right Damaged | Repair |

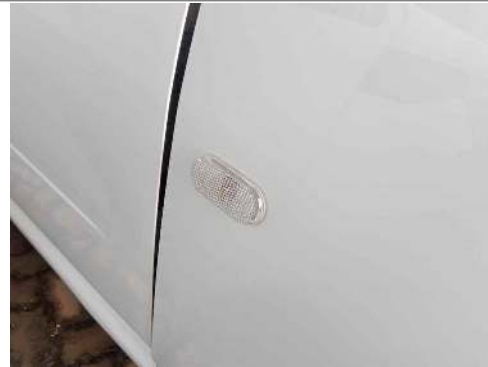
| Damage | Repair Way |
|---|---|
| Indicator Light Front Right Damaged | Repair |

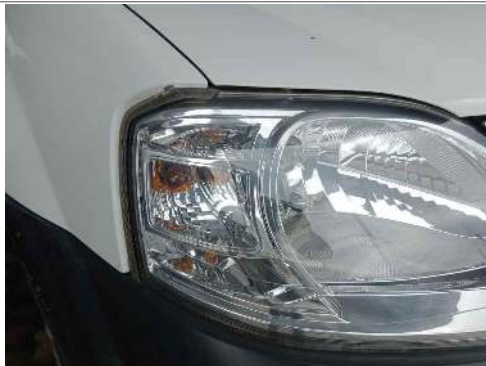
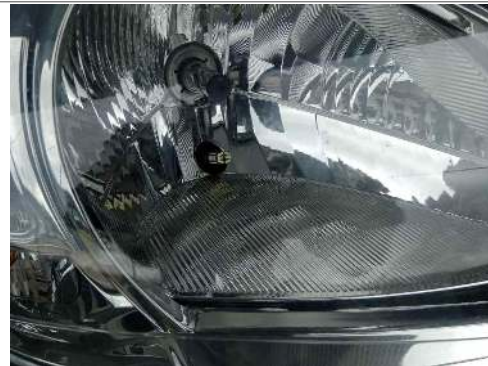
| Damage | Repair Way |
|---|---|
| Park Light Front Left Damaged | Repair |

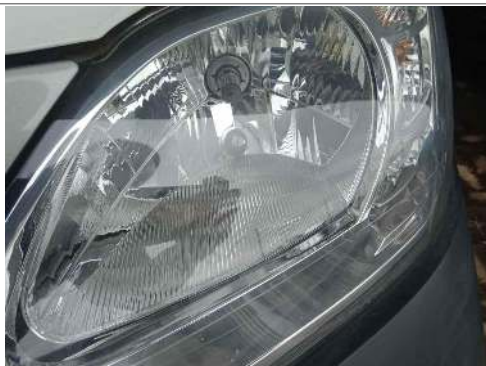
| Damage | Repair Way |
|---|---|
| Park Light Front Right Damaged | Repair |

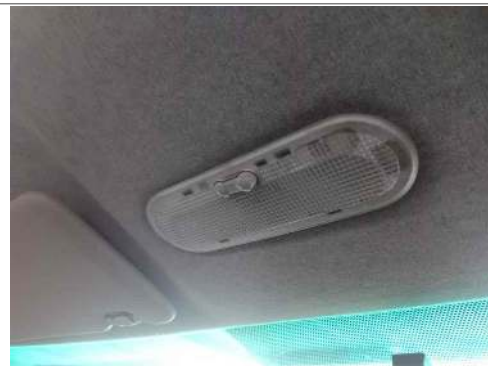
| Damage | Repair Way |
|---|---|
| Interior Lights Damaged | Replace |
