CONDITION REPORT

Report No: 2016879026

Vehicle Type	LIGHT LOAD VEHICLE	Registered Owner	
Manufacturer	NISSAN	Registration Number	HX25YJGP
Model	NP200 1.5DCI BASE +AC SAFETY DSL PU [2014-2022]	Register Number	
VIN	ADNUSN365U0160767	Date Of First Licensing	
Engine Number		Last COR	
Doors	2	License Expiry Date	
Color	WHITE	Power / Displacement	
Year Model	2019	Paint Finish	C - COMMON
Km Reading	237,246 KM	Fuel	DIESEL
Cab / Body Type	SINGLE CAB	Transmission	MANUAL

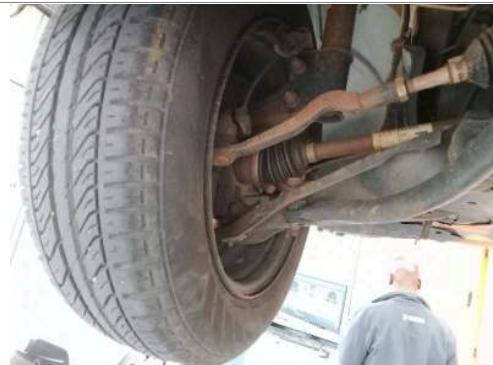
LF TYRE TREAD

Size	Load/Speed Index	Manufacture	Model	Type*	Production Date	Tread Depth (mm)
Front Left	185/65R15	92T	Dunlop	Sport	V	0000	1 mm
Front Right	185/65R15	92T	Barum	Brillantis	V	9589	3 mm
Rear Left	195/65R15	91H	Continental	Control	V	0000	1 mm
Rear Right	185/65R15	92H	Sumitomo	HTR	V	0000	0 mm

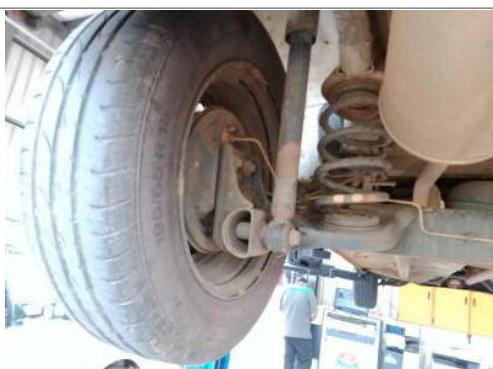
LR TYRE TREAD

Damage	Repair Way
Warning lights illuminated	Repair
Rear tyres size differs	Replace

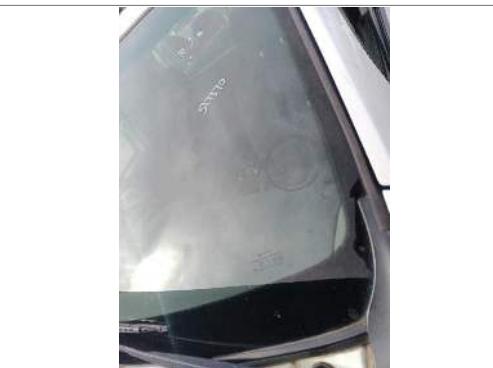
No license disc

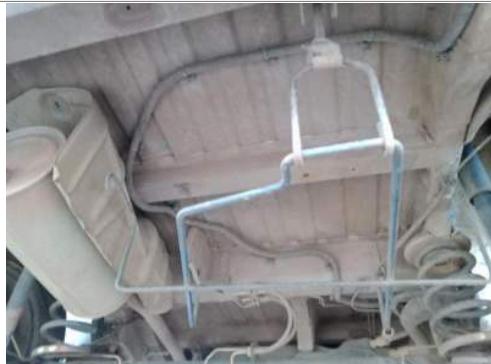
No sparewheel

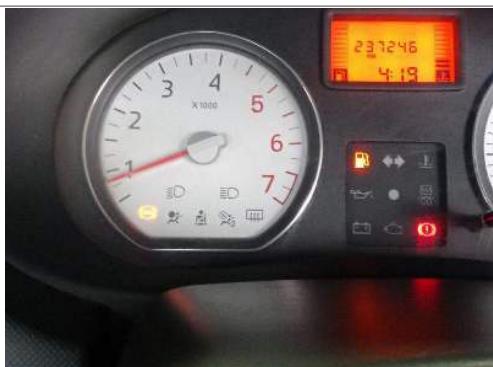
ABS warning lights illuminated

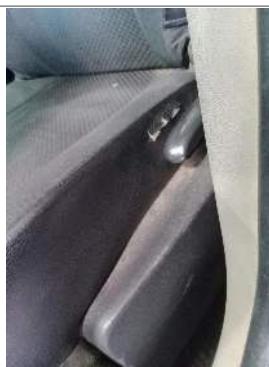
Damage	Repair Way
Engine Oil Sweat	Repair
Seat Front Left Torn / Cut	Repair
Seat Front Right Torn / Cut	Repair
Front Bumper Damaged	Repair
Grill Damaged	Repair
Bonnet Paintwork • Chipmarks	Repair
Door Front Right Dented	Repair
Tailgate Damaged	Replace
Rear bumper Damaged	Repair
Load Body Paintwork • Scratched	Repair
Windscreen Cracked	Replace
Brake Piping Torn / Cut	Replace
Service Brake Performance Rear Axle Left / Right Difference out of legal range	Repair
Parking Brake Performance Left / Right Difference out of legal range	Repair
Tyre Rear Right Smooth	Replace
Rim Front Left Dented	Repair
Rim Rear Right Dented	Repair
