MFC Auction House  
M57 Pretoria Rd, Glenmarais, KEMPTON PARK  
Gauteng

DEKRA MFC  
M57 Pretoria Rd - 1619  
KEMPTON PARK - GT  
08610 33572

| Manufacturer | NISSAN | Registration Number | KSN522MP |

Report No: 2016221031

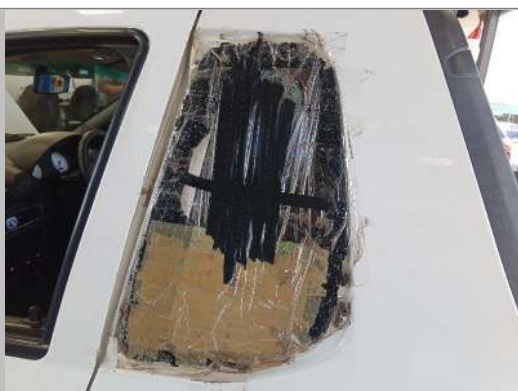
L/R quarter window broken.

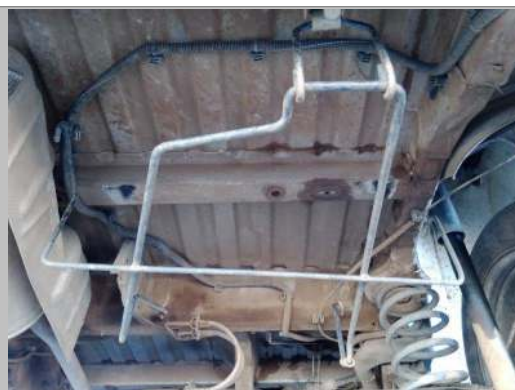
No sparewheel

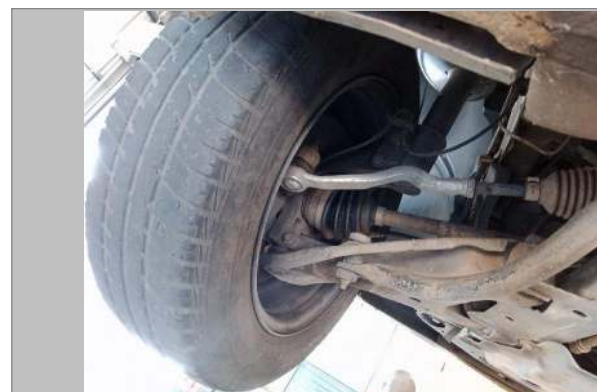
LF TYRE TREAD

| | Size | Load/Speed Index | Manufacture | Model | Type* | Production Date | Tread Depth (mm) |
|---|---|---|---|---|---|---|---|
| Front Left | 185/65R15 | 92T | Barum | Brilliantis | V | 4820 | 2 mm |

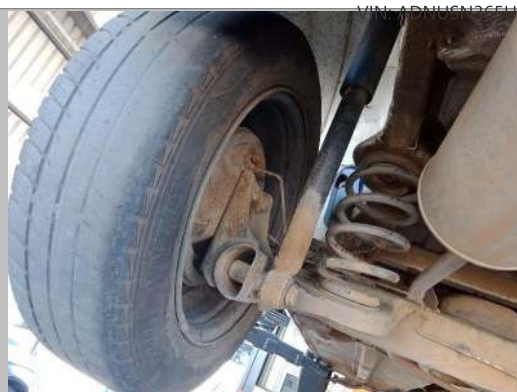
LR TYRE TREAD

| | Size | Load/Speed Index | Manufacture | Model | Type* | Production Date | Tread Depth (mm) |
|---|---|---|---|---|---|---|---|
| Rear Left | 185/65R15 | 92T | Barum | Brilliantis | V | 4620 | 0 mm |

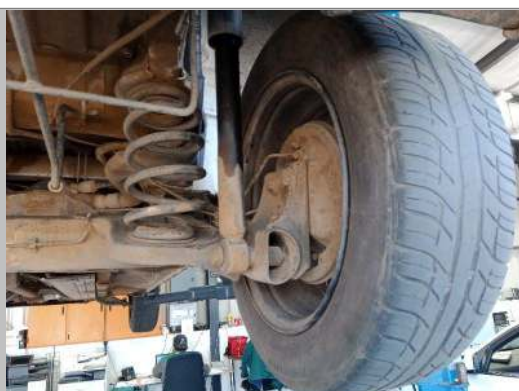
RR TYRE TREAD

| | Size | Load/Speed Index | Manufacture | Model | Type* | Production Date | Tread Depth (mm) |
|---|---|---|---|---|---|---|---|
| Rear Right | 185/60R15 | 84H | BF Goodrich | Advantage | V | 0220 | 1 mm |

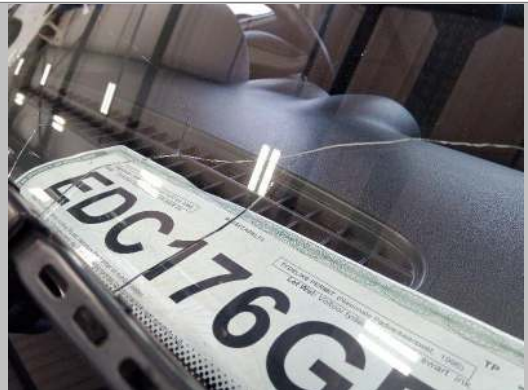
| Damage | Repair Way |
|---|---|
| Windscreen Cracked | Replace |

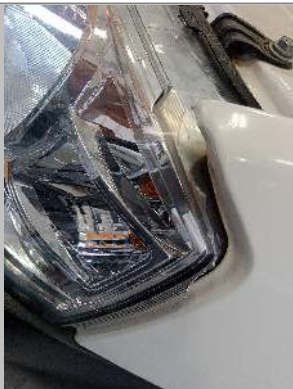
| Damage | Repair Way |
|---|---|
| Headlight Left Cracked | Replace |

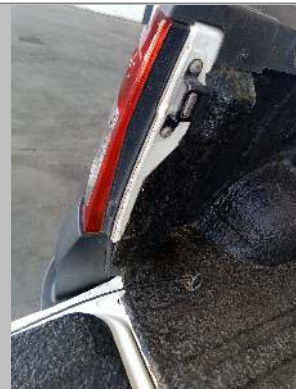
| Damage | Repair Way |
|---|---|
| Tailgate Hinge Left Damaged | Replace |

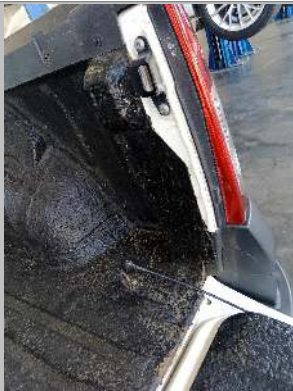
| Damage | Repair Way |
|---|---|
| Tailgate Hinge Right Damaged | Replace |

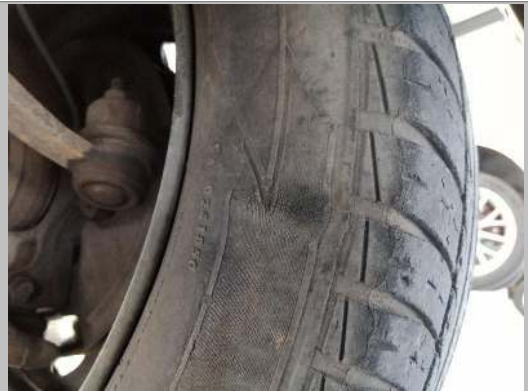
| Damage | Repair Way |
|---|---|
| Tyre Front Right Damaged | Replace |

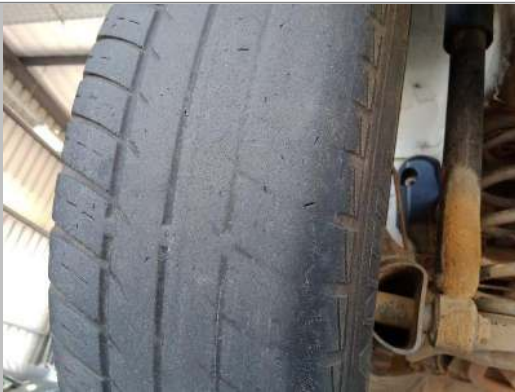
| Damage | Repair Way |
|---|---|
| Tyre Rear Left Smooth | Replace |

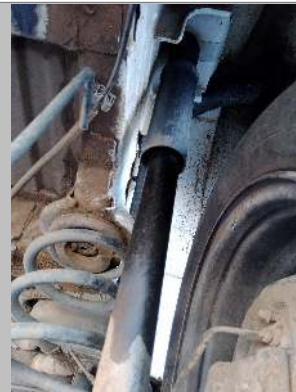
| Damage | Repair Way |
|---|---|
| Shock Absorber Rear Right Sweat | Replace |

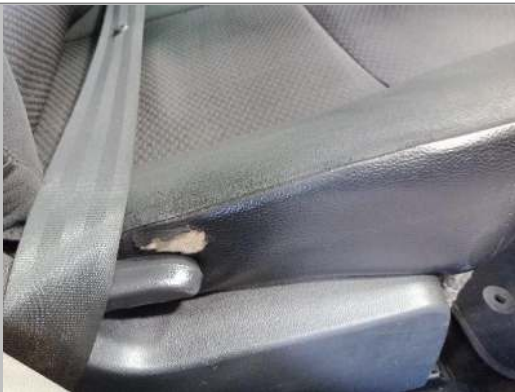
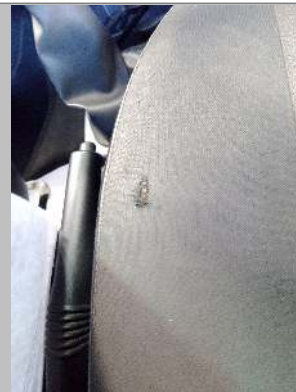
| Damage | Repair Way |
|---|---|
| Seat Front Right Torn / Cut | Repair |

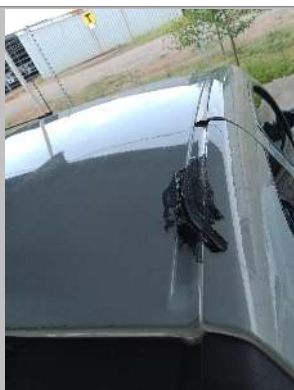
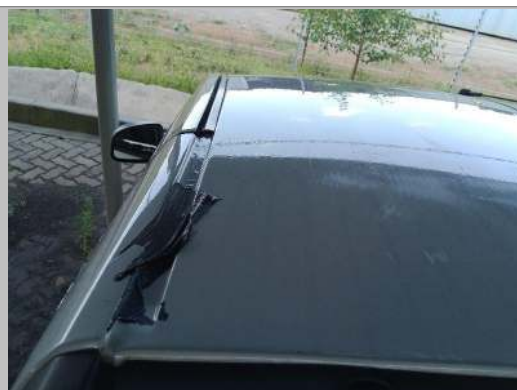
| Damage | Repair Way |
|---|---|
| Roof Residual Traces of Repair | Repair |
