CONDITION REPORT

Report No: 2016207091

Vehicle Type	LIGHT LOAD VEHICLE	Registered Owner	MFC
Manufacturer	FORD	Registration Number	HNL870FS
Model	RANGER	Register Number	
VIN	AFAGXXMJ2GHU44411	Date Of First Licensing	
Engine Number		Last COR	
Doors	2	License Expiry Date	31/12/2023
Color	WHITE	Power / Displacement	
Year Model		Paint Finish	C - COMMON
Km Reading	211,942 KM	Fuel	DIESEL
Cab / Body Type	SUPER CAB	Transmission	MANUAL

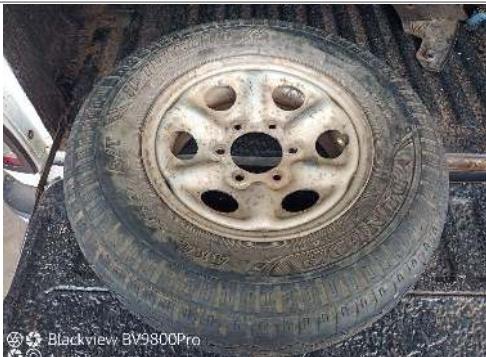
Spare wheel

Size	Load/Speed Index	Manufacture	Model	Type*	Production Date	Tread Depth (mm)
Front Left	275/70R16	114T	Lanigator	Catchfors	V	1821	3 mm
Front Right	275/70R16	114T	Lanigator	Catchfors	V	1821	3 mm
Rear Left	275/70R16	114T	Lanigator	Catchfors	V	1821	4 mm
Rear Right	275/70R16	114T	Lanigator	Catchfors	V	1821	4 mm
Spare	215R15	109/107S	Dunlop	Sp sport	V	1317	1 mm

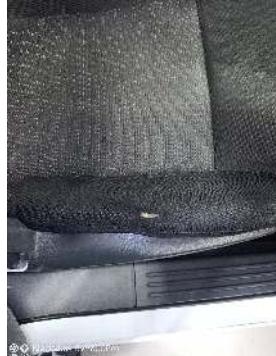
Damage	Repair Way
Engine Oil Leak	Repair
Dim Light Right Malfunction	Repair
Seat Front Right Torn / Cut	Repair
Door Handle Rear Left Damaged	Replace
Door Handle Rear Right Damaged	Replace
Number Plate Rear Missing	Replace
Side Mirror Right Cracked	Repair
Front Bumper Paintwork • Scratched	Repair
Front Fender Right Dented	Repair
Rear Fender Left Paintwork • Scratched	Repair
Rear Fender Right Dented	Repair
Door Front Left Paintwork • Scratched	Repair
Door Front Right Dented	Repair
Door Rear Left Dented	Repair
Door Rear Right Paintwork • Scratched	Repair
Tailgate Paintwork • Scratched	Repair
Rear bumper Paintwork • Scratched	Repair
Windscreen Chipped	Repair
Brake Drum 2. Axle left Defective	Repair
Rebound Rubber Front Axle Left Damaged	Replace
Rebound Rubber Front Axle Right Damaged	Replace
Gearbox Oil Leak	Repair
Differential Defective	Repair
CV Joint(s) Boot(s) Front Right (inner/outer) Damaged	Replace
