CONDITION REPORT

Report No: 2016201940

Vehicle Type	LIGHT LOAD VEHICLE	Registered Owner	MFC
Manufacturer	FORD	Registration Number	KMB957MP
Model	RANGER	Register Number	
VIN	AFANXXMJ2NJM08832	Date Of First Licensing	
Engine Number		Last COR	
Doors	2	License Expiry Date	31/12/2022
Color	WHITE	Power / Displacement	
Year Model		Paint Finish	TWO COAT METALLIC
Km Reading	168,094 KM	Fuel	PETROL
Cab / Body Type	SINGLE CAB	Transmission	MANUAL

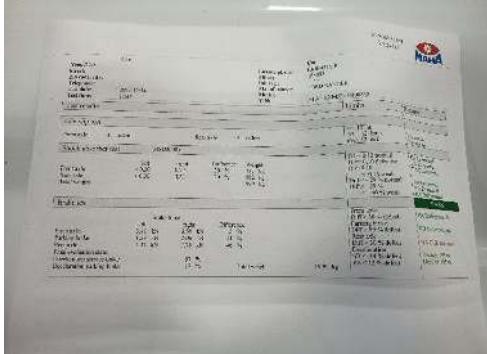
Brake and shock test

Left	Right	Axle Weight [KG]	Deceleration [m/s ²]
	Braking Force [KN]	Braking Force [KN]		
Front	3.41	3.59	-	
Rear	1.47	2.75	-	
Emergency / Parking	1.23	2.06	-

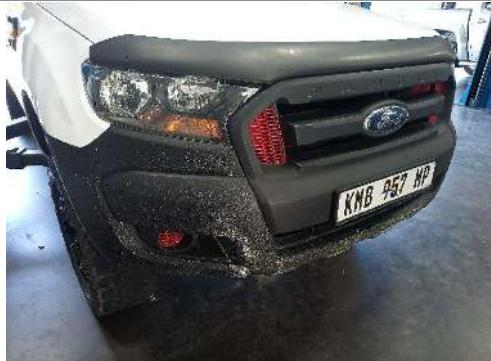
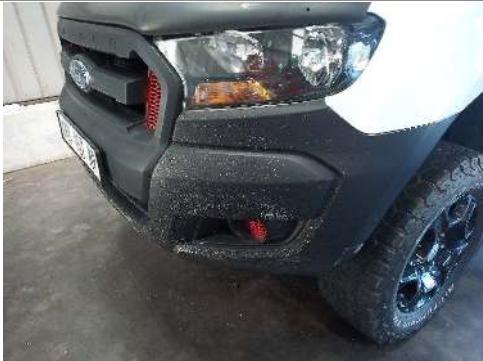
Damage	Repair Way
Seat Front Right Damaged	Repair
Front Bumper Damaged	Repair
Bonnet Damaged	Repair
Front Fender Left Damaged	Repair
Front Fender Right Damaged	Repair
Rear Fender Left Damaged	Repair
Rear Fender Right Damaged	Repair
Door Front Left Damaged	Repair
Door Front Right Damaged	Repair
Tailgate Damaged	Repair
Rear bumper Damaged	Repair
Wheel Cylinder / Caliper 2. Axle left Leak	Repair
Tyre Front Right Worn	Replace
Tyre Rear Right Worn	Replace
Engine to silencer pipe Welded	Replace
Differential Oil Leak	Repair

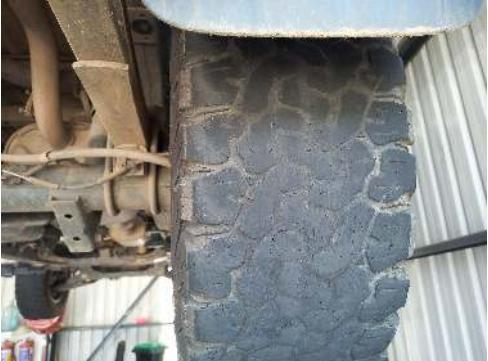
Tyre Rear Right

Size	Load/Speed Index	Manufacture	Model	Type*	Production Date	Tread Depth (mm)
Front Left	265/65R17	120S	BFGOODRICH	Radial	V	1120	1 mm
Front Right	265/65R17	112S	BFGoodrich	Radial	V	3620	0 mm
Rear Left	265/65R17	112S	BFGoodrich	Radial	V	1120	2 mm
Rear Right	265/65R17	112S	BFGoodrich	Radial	V	3620	0 mm
