MFC Auction House  
M57 Pretoria Rd, Glenmarais, KEMPTON PARK  
Gauteng

| Vehicle Type | PASSENGER VEHICLE | Registered Owner | MFC |
| Manufacturer | TOYOTA | Registration Number | JMP505MP |

## VEHICLE INSPECTION

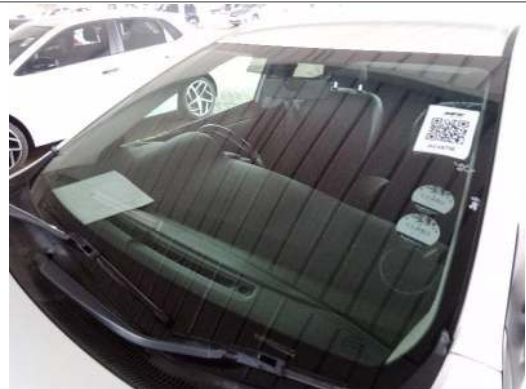
LICENSE DISC MISSING

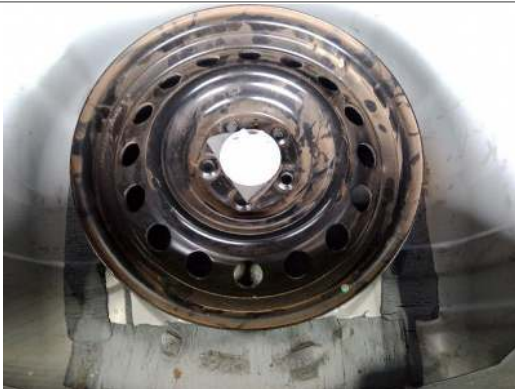
ONLY RIM NO SPARE TYRE

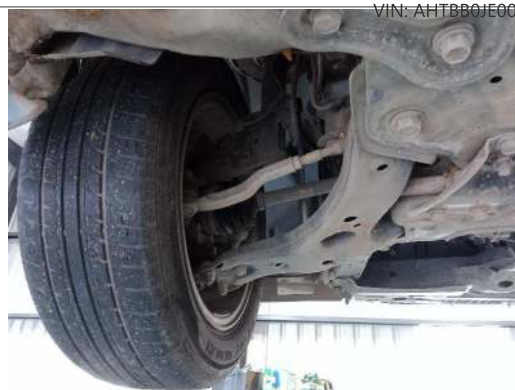
LF TYRE TREAD

| | Size | Load/Speed Index | Manufacture | Model | Type* | Production Date | Tread Depth (mm) |
|---|---|---|---|---|---|---|---|
| Front Left | 205/55 R16 | 91V | Tracmax | Radial | V | 2919 | 0 mm |

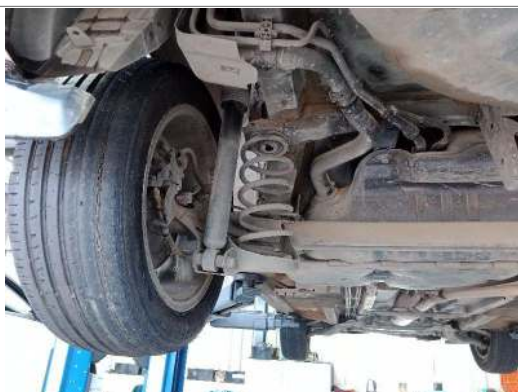
LR TYRE TREAD

| | Size | Load/Speed Index | Manufacture | Model | Type* | Production Date | Tread Depth (mm) |
|---|---|---|---|---|---|---|---|
| Rear Left | 205/55 R16 | 91V | Windforce | Catchfors | V | 1623 | 0 mm |

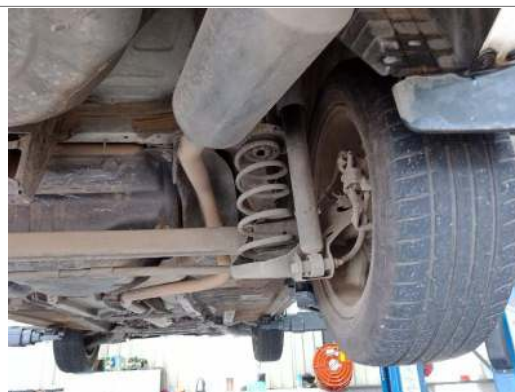
RR TYRE TREAD

| | Size | Load/Speed Index | Manufacture | Model | Type* | Production Date | Tread Depth (mm) |
|---|---|---|---|---|---|---|---|
| Rear Right | 205/55 R16 | 91V | Goodyear | Efficient | V | 0518 | 3 mm |

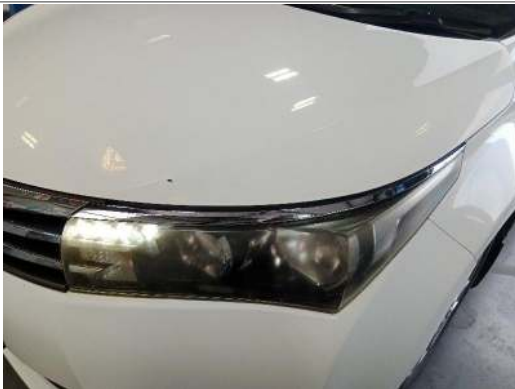
| Damage | Repair Way |
|---|---|
| Headlight Left Defective | Replace |

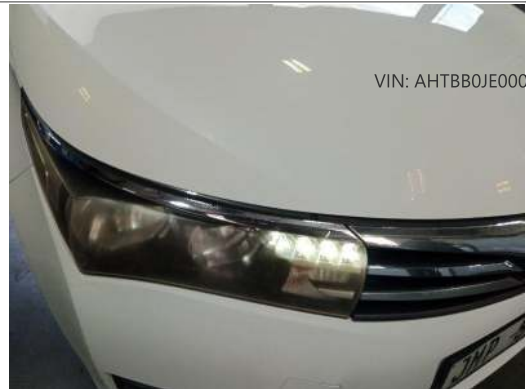
| Damage | Repair Way |
|---|---|
| Headlight Right Defective | Replace |

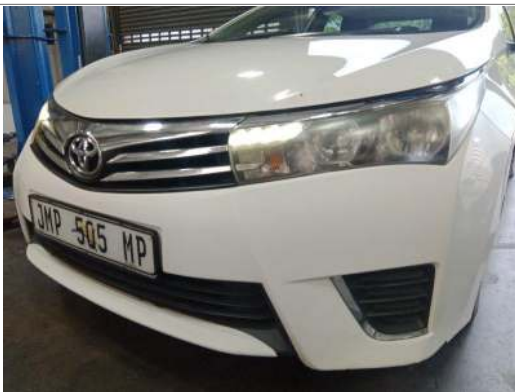
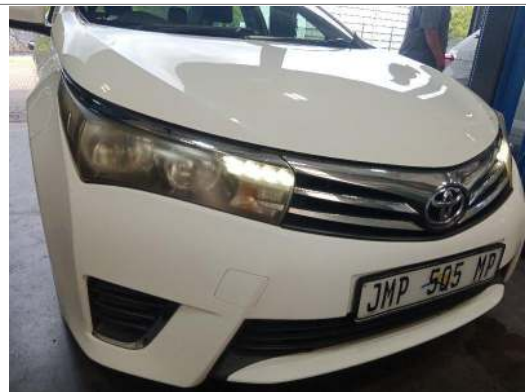
| Damage | Repair Way |
|---|---|
| Front Bumper Damaged | Repair |

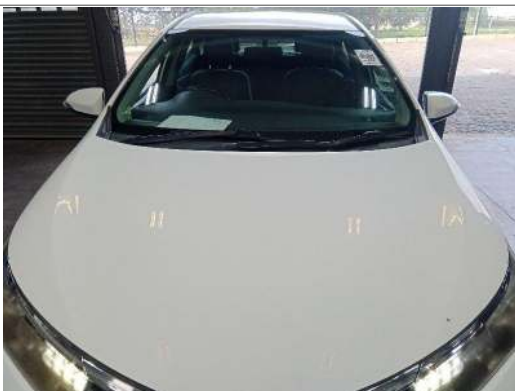
| Damage | Repair Way |
|---|---|
| Bonnet Paintwork • Discoloured | Repair |

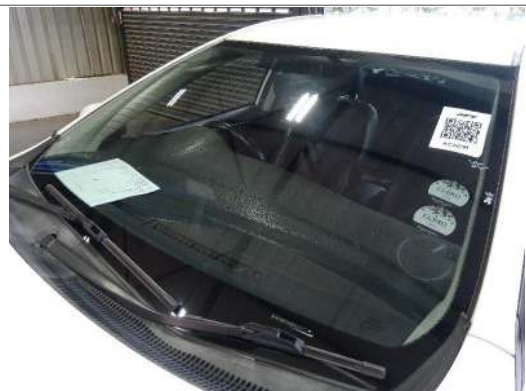
| Damage | Repair Way |
|---|---|
| Windscreen Chipped | Repair |

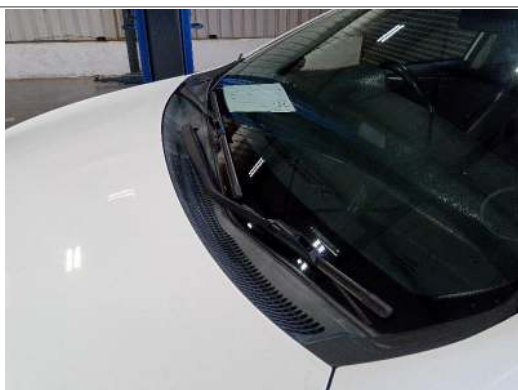
| Damage | Repair Way |
|---|---|
| Windscreen Wiper Damaged | Replace |

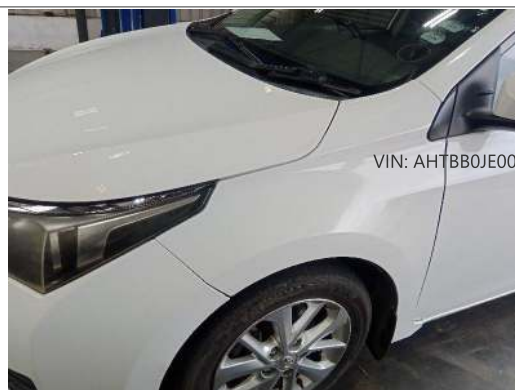
| Damage | Repair Way |
|---|---|
| Front Fender Left Residual Traces of Repair | Repair |

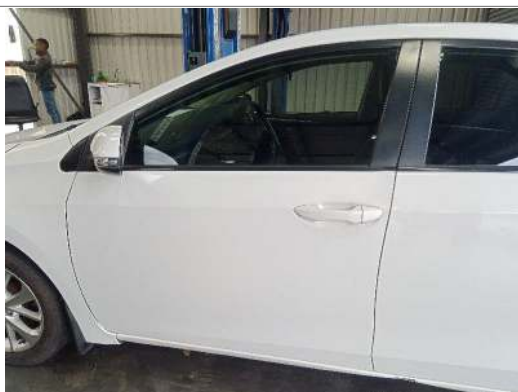
| Damage | Repair Way |
|---|---|
| Door Front Left Paintwork • Chipmarks | Repair |

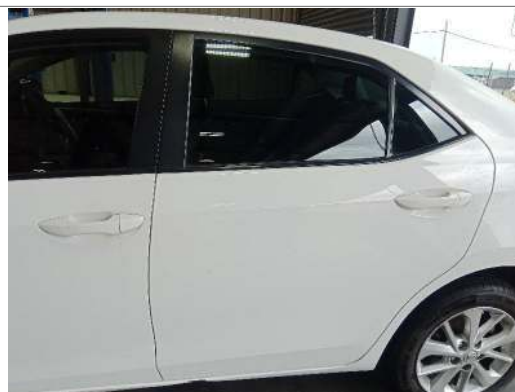
| Damage | Repair Way |
|---|---|
| Door Rear Left Paintwork • Scratched | Repair |

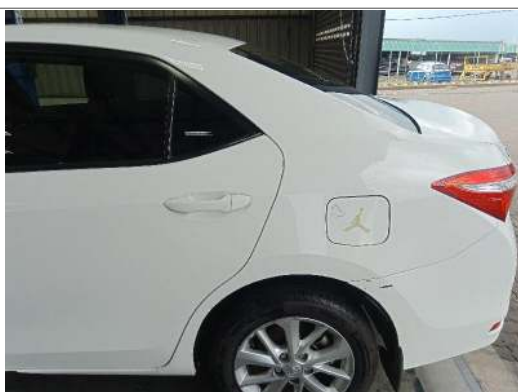
| Damage | Repair Way |
|---|---|
| Rear Fender Left Paintwork • Scratched | Repair |

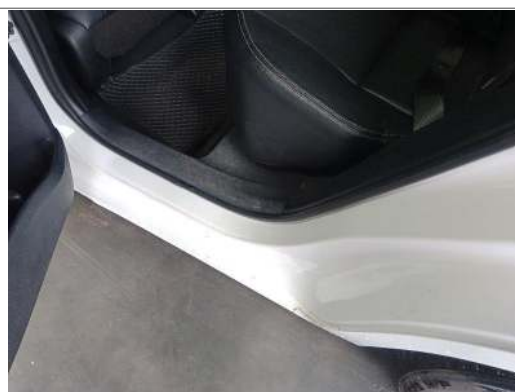
| Damage | Repair Way |
|---|---|
| Sill Panel Left Paintwork • Scratched | Repair |

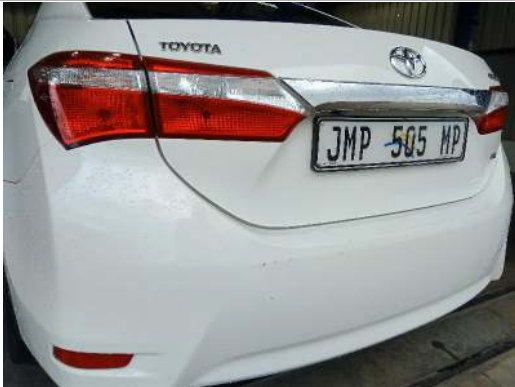
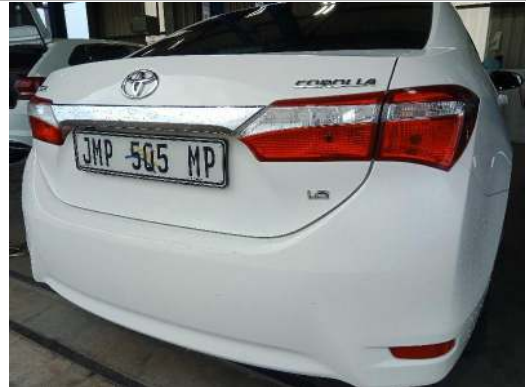
| Damage | Repair Way |
|---|---|
| Rear bumper Paintwork • Scratched | Repair |

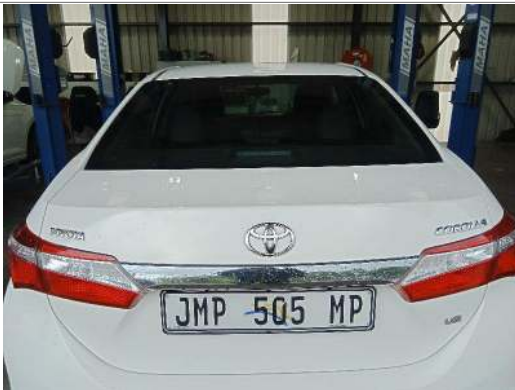
| Damage | Repair Way |
|---|---|
| Boot Lid / Hatch door Paintwork • Scratched | Repair |

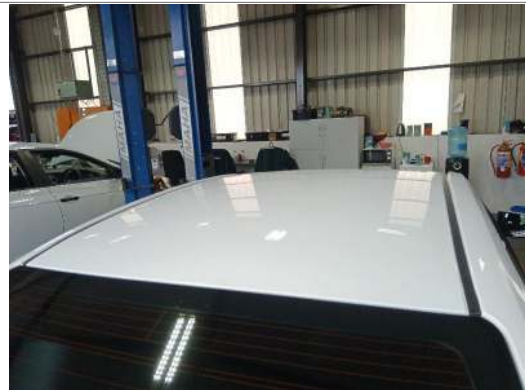
| Damage | Repair Way |
|---|---|
| Roof Dented | Repair |

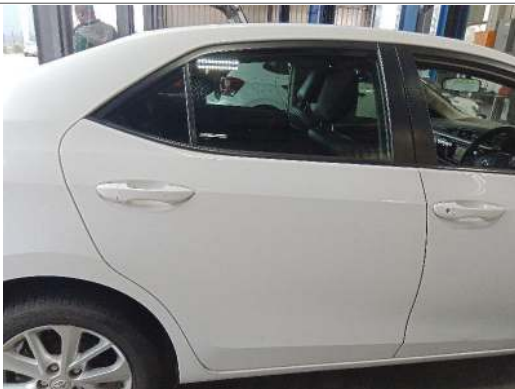
| Damage | Repair Way |
|---|---|
| Door Rear Right Paintwork • Scratched | Repair |

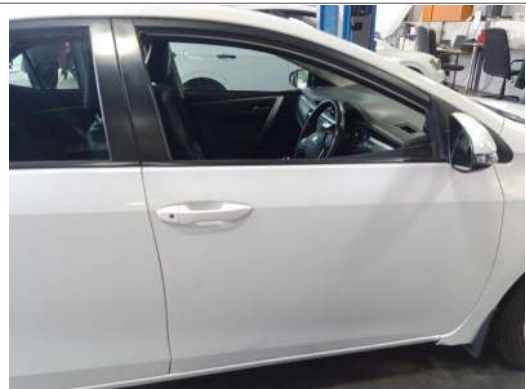
| Damage | Repair Way |
|---|---|
| Door Front Right Dented | Repair |

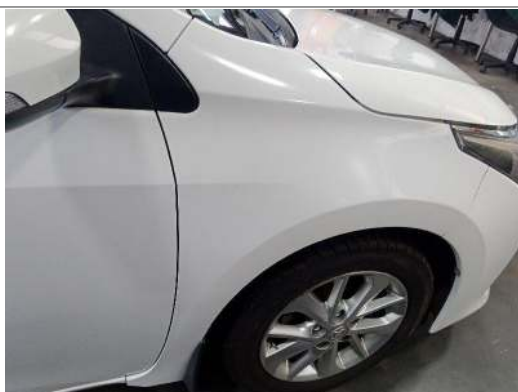
| Damage | Repair Way |
|---|---|
| Front Fender Right Residual Traces of Repair | Repair |

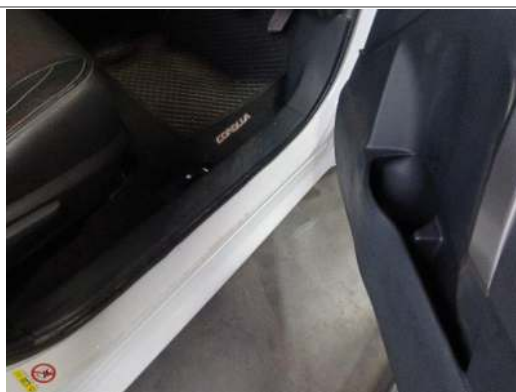
| Damage | Repair Way |
|---|---|
| Sill Panel Right Paintwork • Scratched | Repair |

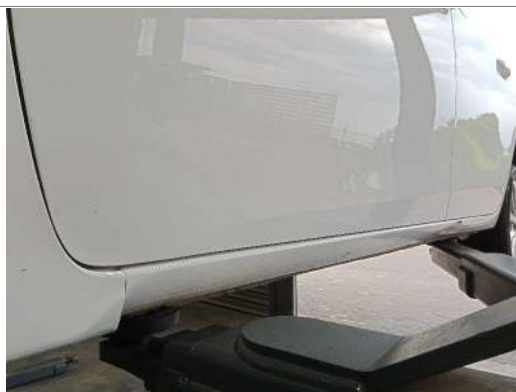
| Damage | Repair Way |
|---|---|
| Rocker Panel Left Damaged | Repair |

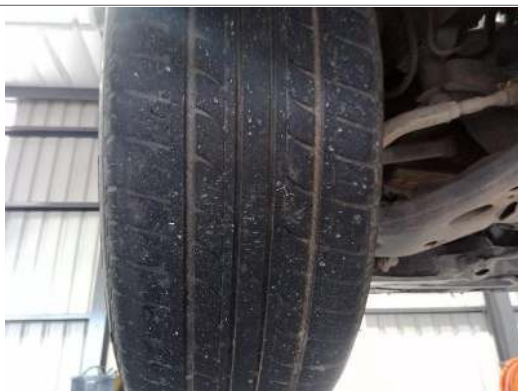
| Damage | Repair Way |
|---|---|
| Tyre Front Left Worn | Replace |

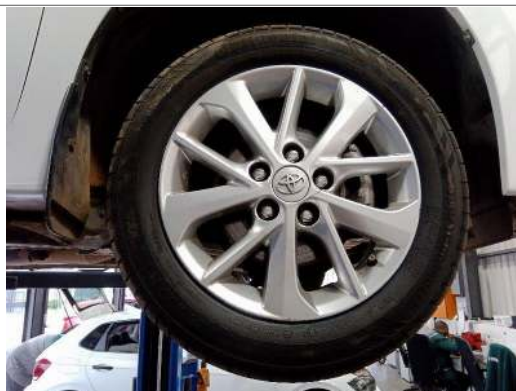
| Damage | Repair Way |
|---|---|
| Tyre Front Right Defective | Replace |

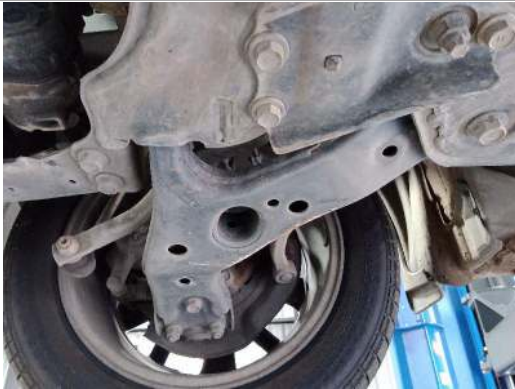
| Damage | Repair Way |
|---|---|
| Control Arm(s) Front Axle Right Defective | Repair |

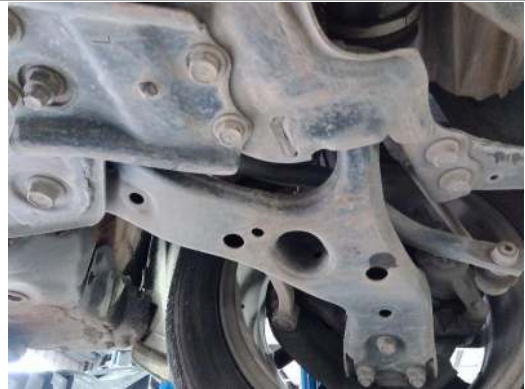
| Damage | Repair Way |
|---|---|
| Control Arm(s) Front Axle Left Defective | Repair |

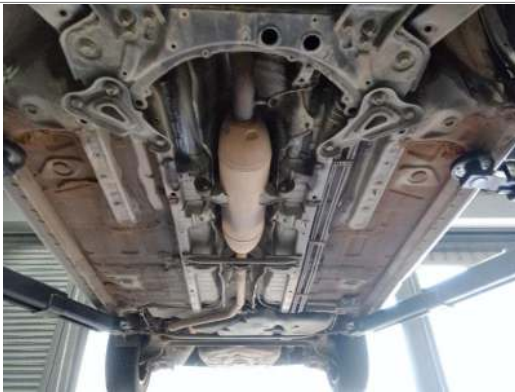
Chassis Scratched  
Engine to silencer pipe Defective  
Belly plates Defective  
Jack Missing  
Wheel Spanner Missing  
Triangle Missing

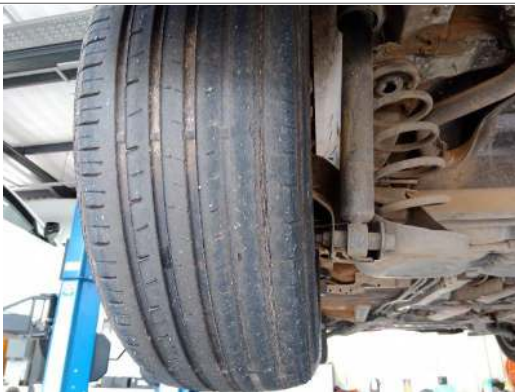
| Damage | Repair Way |
|---|---|
| Tyre Rear Left Damaged | Replace |

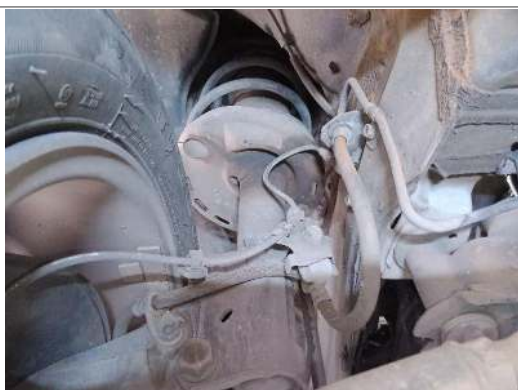
| Damage | Repair Way |
|---|---|
| Shock Absorber Front Left Sweat | Replace |

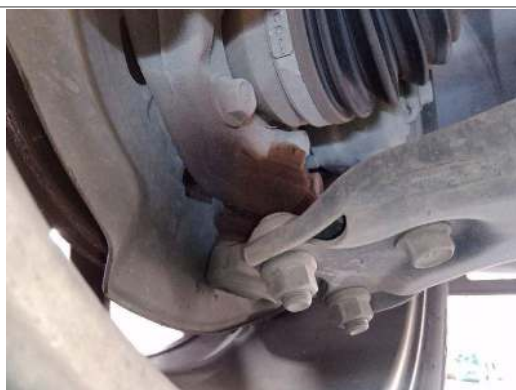
| Damage | Repair Way |
|---|---|
| Ball Joint(s) Front Axle Left Defective | Replace |

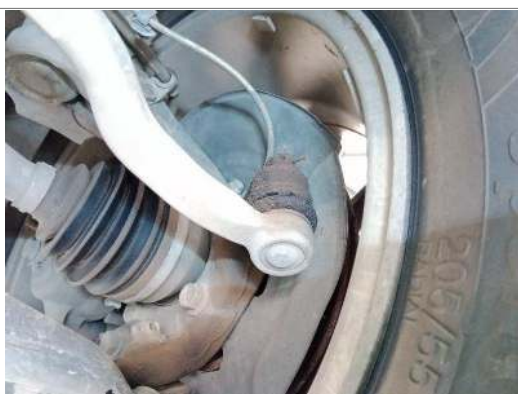
| Damage | Repair Way |
|---|---|
| Tie Rod End right Defective | Replace |

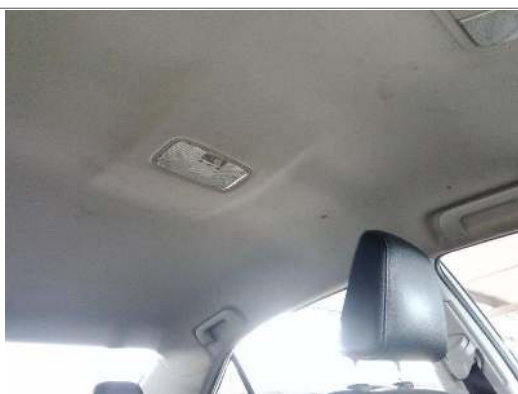
| Damage | Repair Way |
|---|---|
| Hood Lining Dirty | Repair |

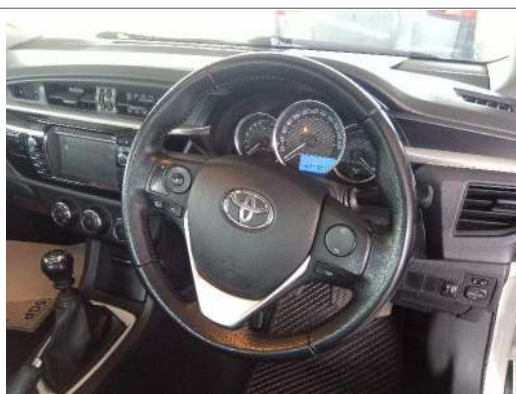
| Damage | Repair Way |
|---|---|
| Steering Wheel Trim Defective | Repair |
