MFC Auction House  
M57 Pretoria Rd, Glenmarais, KEMPTON PARK  
Gauteng

DEKRA MFC  
M57 Pretoria Rd - 1619  
KEMPTON PARK - GT  
08610 33572

## VEHICLE INSPECTION

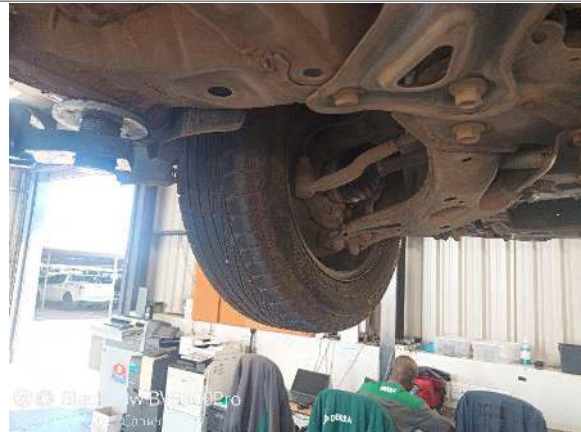
LF TYRE TREAD

| | Size | Load/Speed Index | Manufacture | Model | Type* | Production Date | Tread Depth (mm) |
|---|---|---|---|---|---|---|---|
| Front Left | 195/65R15 | 91H | Goodyear | Excellence | V | 2318 | 3 mm |

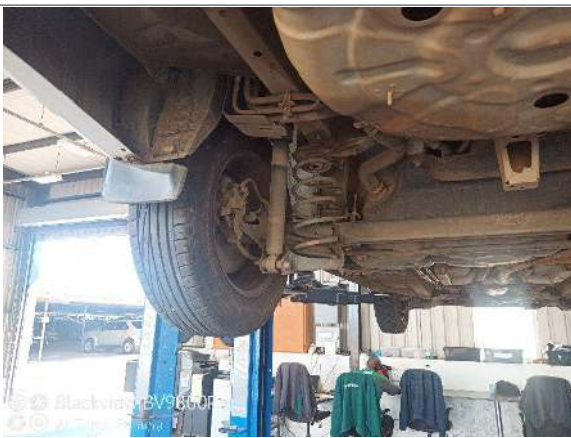
LR TYRE TREAD

| | Size | Load/Speed Index | Manufacture | Model | Type* | Production Date | Tread Depth (mm) |
|---|---|---|---|---|---|---|---|
| Rear Left | 195/65R15 | 91H | Goodyear | Excellence | V | 1818 | 4 mm |

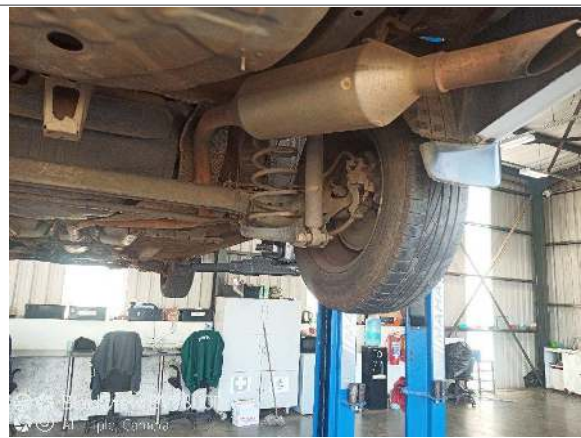
RR TYRE TREAD

| | Size | Load/Speed Index | Manufacture | Model | Type* | Production Date | Tread Depth (mm) |
|---|---|---|---|---|---|---|---|
| Rear Right | 195/65R15 | 91H | Goodyear | Excellence | V | 2918 | 3 mm |

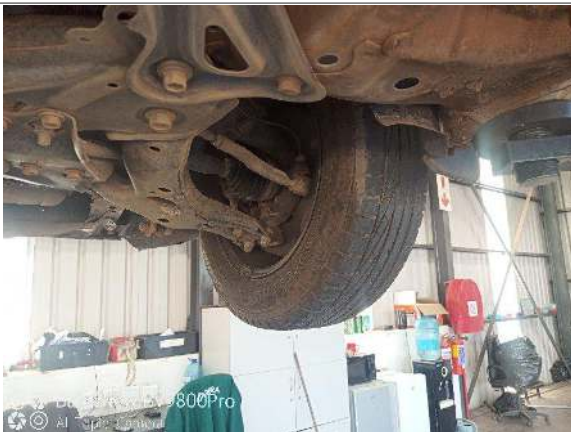
RF TYRE TREAD

| | Size | Load/Speed Index | Manufacture | Model | Type* | Production Date | Tread Depth (mm) |
|---|---|---|---|---|---|---|---|
| Front Right | 195/65R15 | 91H | Goodyear | Excellence | V | 0519 | 3 mm |

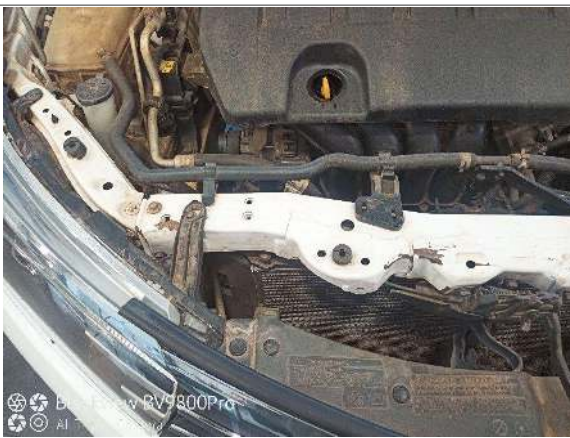
| Damage | Repair Way |
|---|---|
| Bonnet slam plate (Shock tower/ Inner tray) Corrosion | Repair |

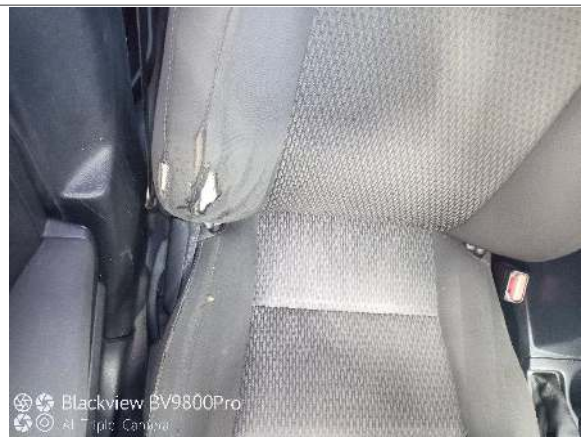
| Damage | Repair Way |
|---|---|
| Seat Front Right Torn / Cut | Repair |

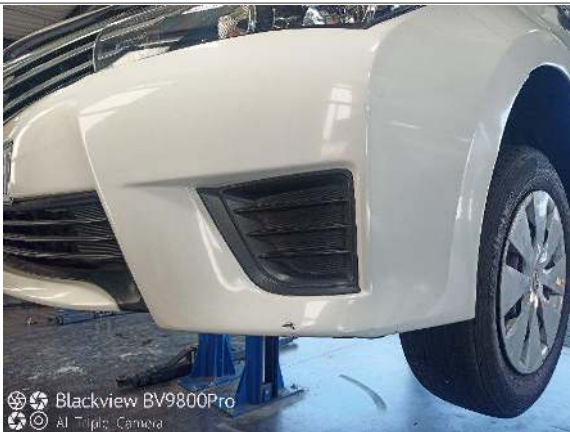
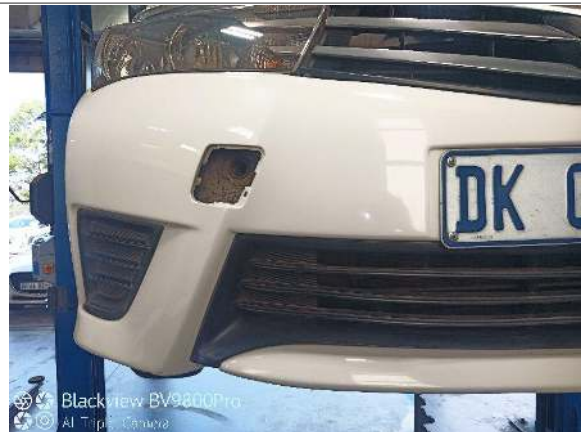
| Damage | Repair Way |
|---|---|
| Front Bumper Paintwork • Scratched | Repair |

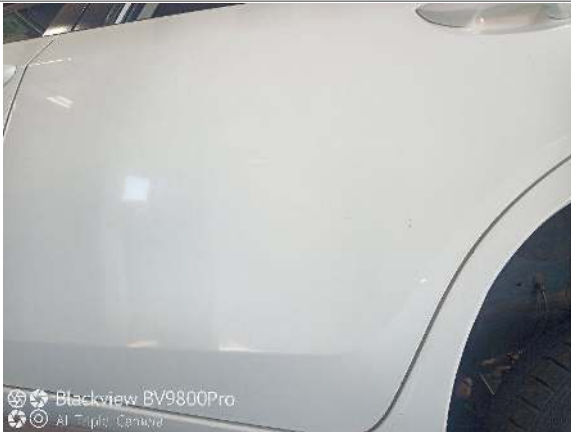
| Damage | Repair Way |
|---|---|
| Door Rear Left Paintwork • Scratched | Repair |

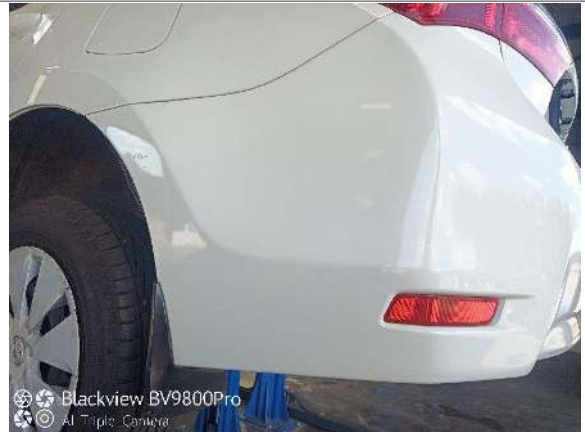
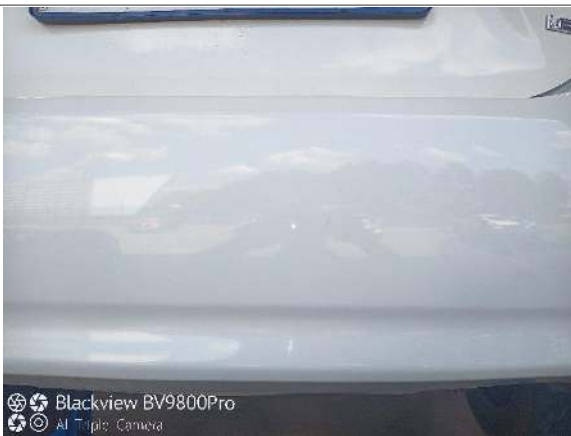
| Damage | Repair Way |
|---|---|
| Rear bumper Paintwork • Scratched | Repair |

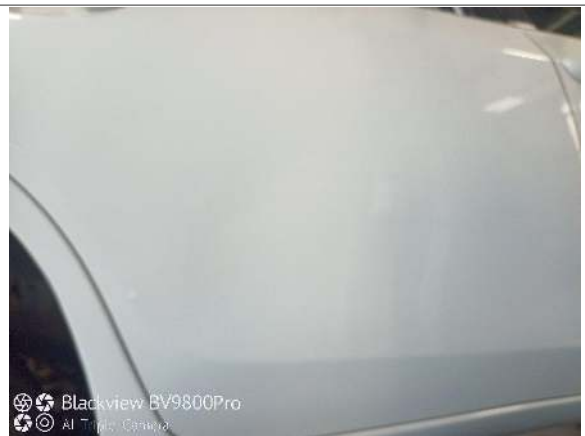
| Damage | Repair Way |
|---|---|
| Door Rear Right Paintwork • Pitmarks | Repair |

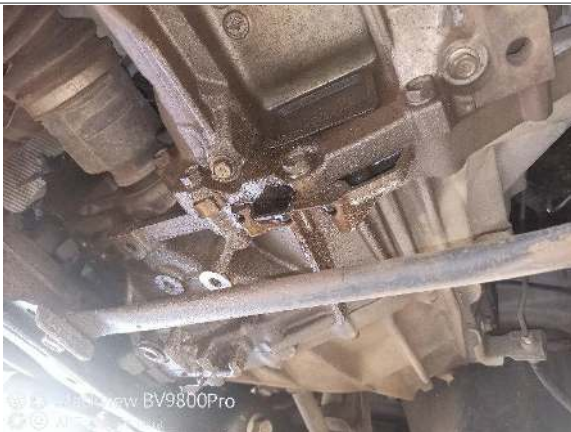
| Damage | Repair Way |
|---|---|
| Gearbox Oil Leak | Repair |

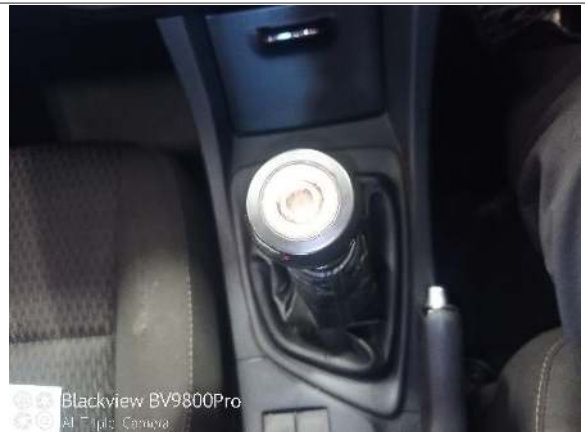
| Damage | Repair Way |
|---|---|
| Gear Lever Dust Boot Defective | Repair |
