CONDITION REPORT

Report No: 2016202109

| Manufacturer | TOYOTA | Registration Number | JK80RGGP |
| Model | COROLLA | Register Number | |

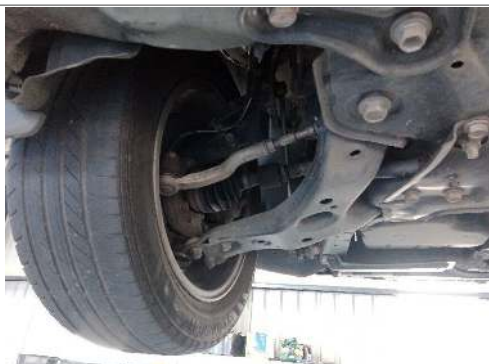
LF TYRE TREAD

| | Size | Load/Speed Index | Manufacture | Model | Type* | Production Date | Tread Depth (mm) |
|---|---|---|---|---|---|---|---|
| Front Left | 205/55 R16 | 91V | Continental | Sport | V | 3717 | 2 mm |

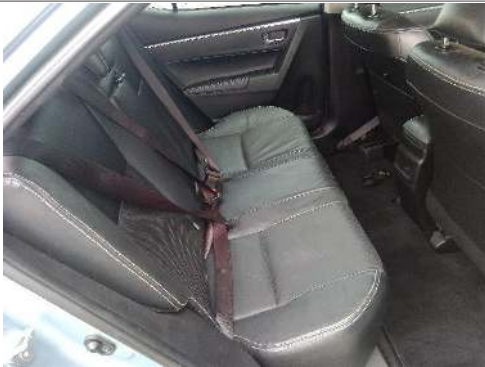
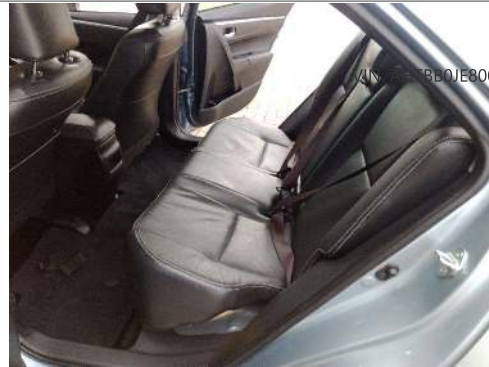
| Damage | Repair Way |
|---|---|
| Seat Rear Defective | Repair |

Interior: Vehicle interior dirty and some interior panels scratched. Rear left panic handle missing.

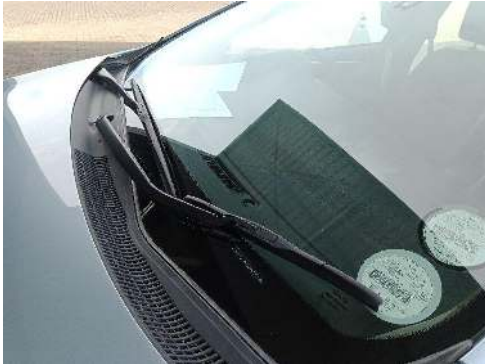
| Damage | Repair Way |
|---|---|
| Windscreen Wiper Defective | Replace |

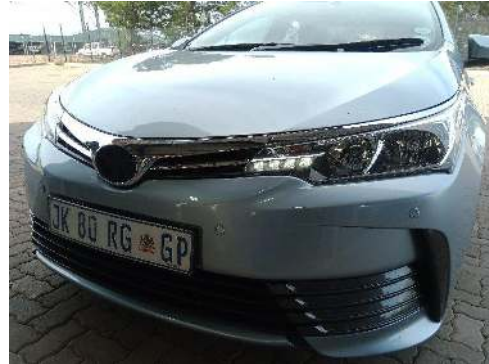
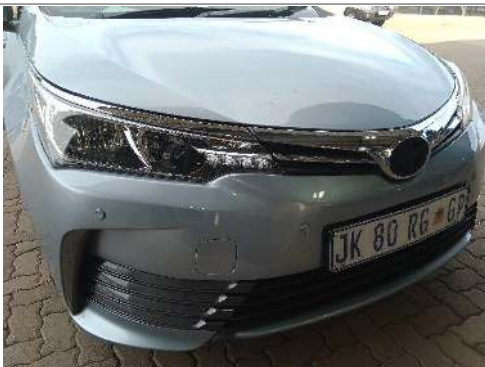
| Damage | Repair Way |
|---|---|
| Front Bumper Paintwork • Scratched | Repair |

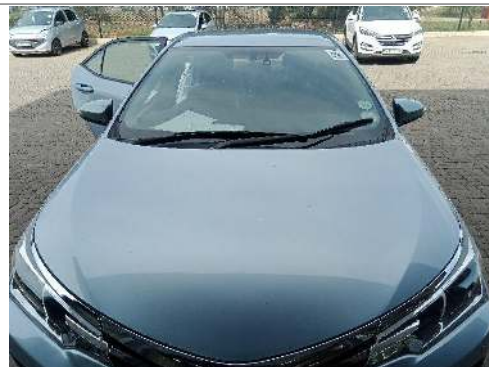
| Damage | Repair Way |
|---|---|
| Bonnet Paintwork • Chipmarks | Repair |

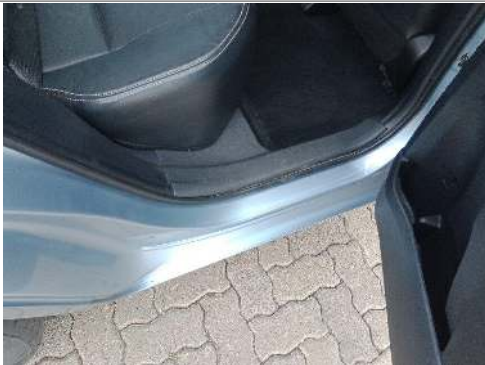
| Damage | Repair Way |
|---|---|
| Sill Panel Right Dented | Repair |

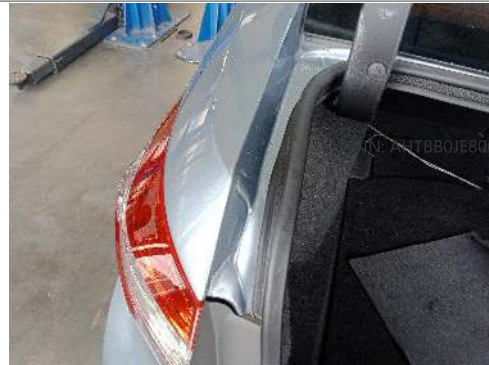
| Damage | Repair Way |
|---|---|
| C • Pillar Left Residual Traces of Repair | Repair |

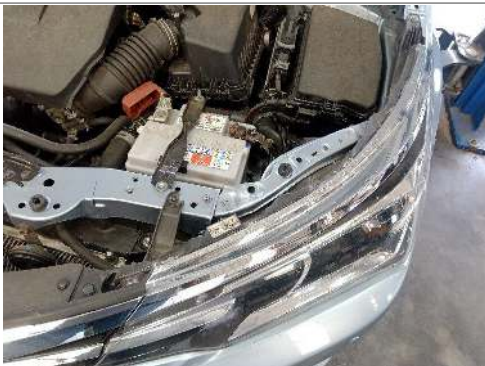
| Damage | Repair Way |
|---|---|
| Headlight Left Broken | Replace |

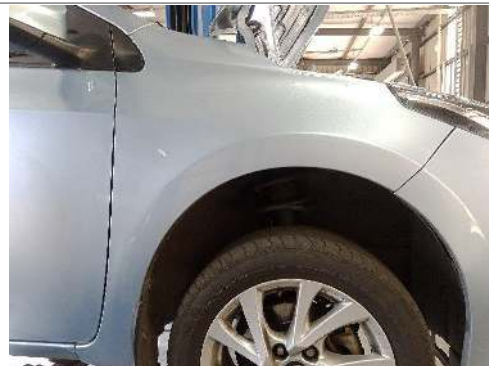
| Damage | Repair Way |
|---|---|
| Front Fender Right Residual Traces of Repair | Repair |

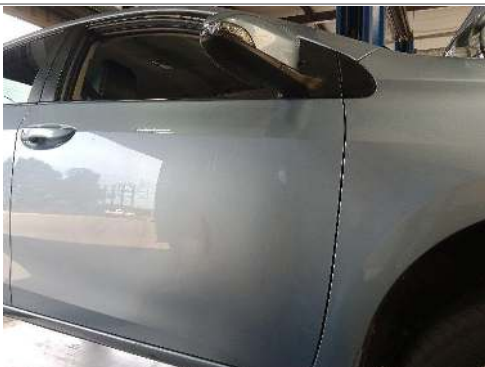
| Damage | Repair Way |
|---|---|
| Door Front Right Paintwork • Scratched | Repair |

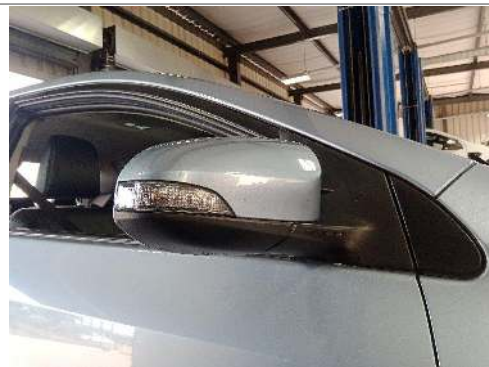
| Damage | Repair Way |
|---|---|
| Side Mirror Right Paintwork • Scratched | Repair |

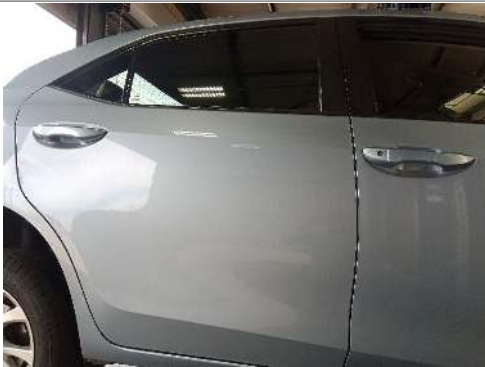
| Damage | Repair Way |
|---|---|
| Door Rear Right Paintwork • Scratched | Repair |

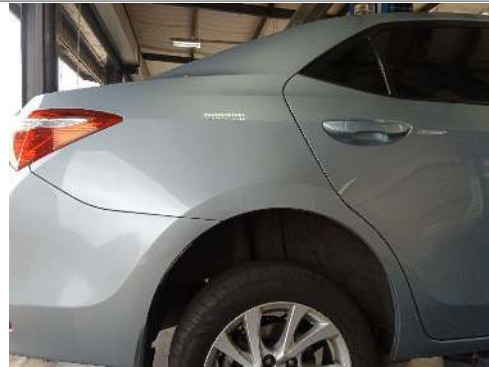
| Damage | Repair Way |
|---|---|
| Rear Fender Right Paintwork • Scratched | Repair |

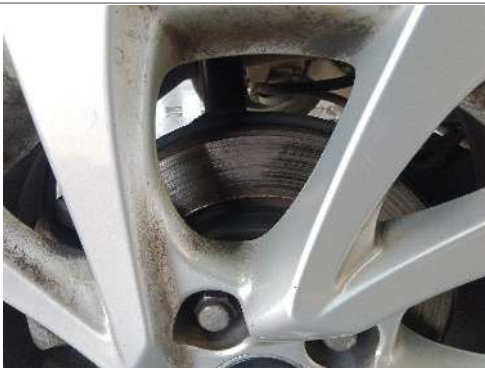
| Damage | Repair Way |
|---|---|
| Brake disc 2. Axle right Defective | Replace |

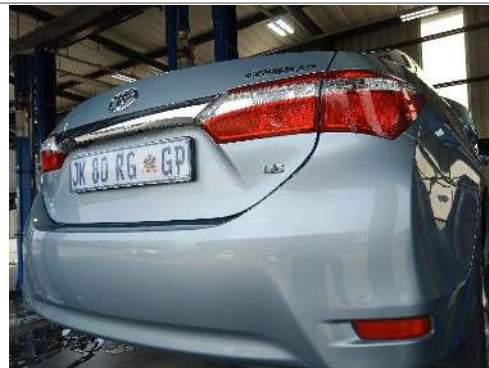
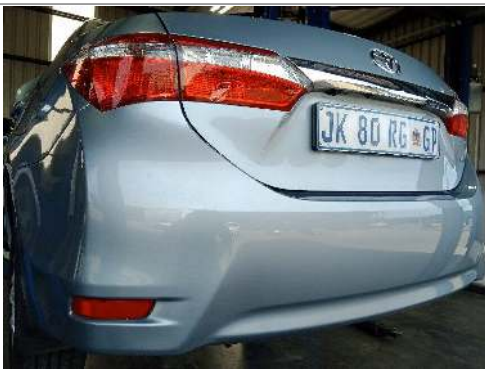
| Damage | Repair Way |
|---|---|
| Rear bumper Paintwork • Scratched | Repair |

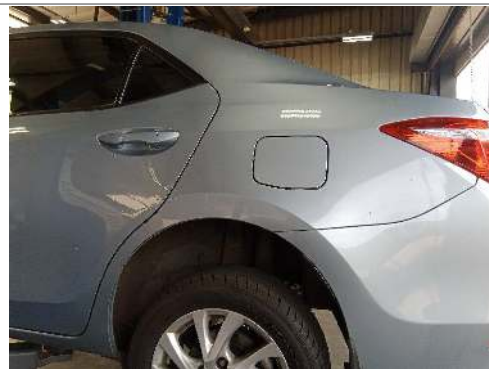
| Damage | Repair Way |
|---|---|
| Rear Fender Left Residual Traces of Repair | Repair |

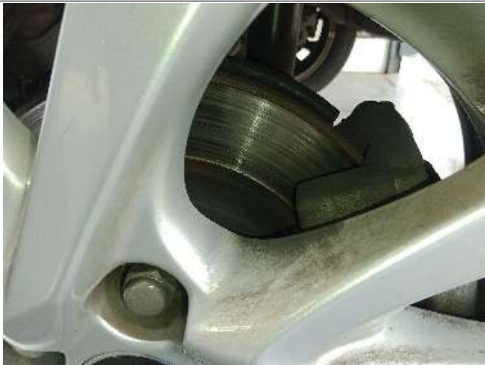
| Damage | Repair Way |
|---|---|
| Brake disc 2. Axle left Defective | Replace |

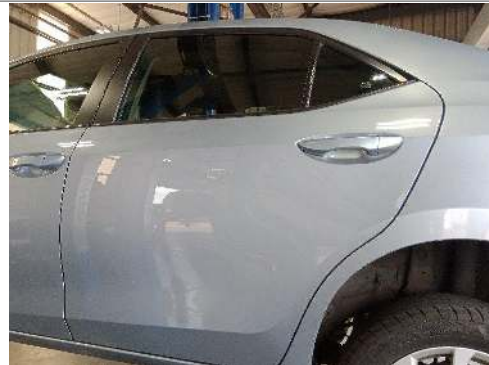
| Damage | Repair Way |
|---|---|
| Door Rear Left Residual Traces of Repair | Repair |

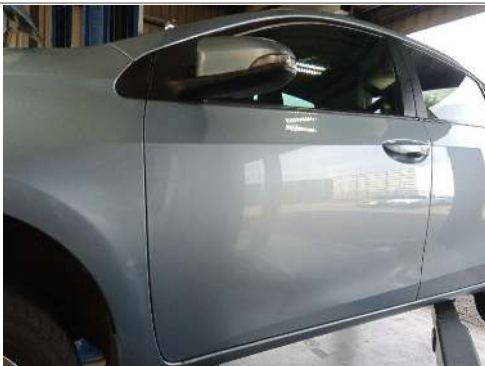
| Damage | Repair Way |
|---|---|
| Door Front Left Paintwork • Scratched | Repair |

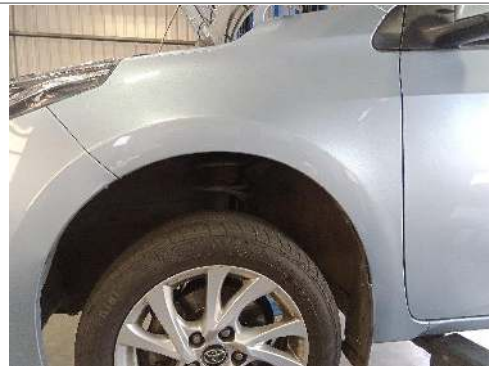
| Damage | Repair Way |
|---|---|
| Front Fender Left Residual Traces of Repair | Repair |

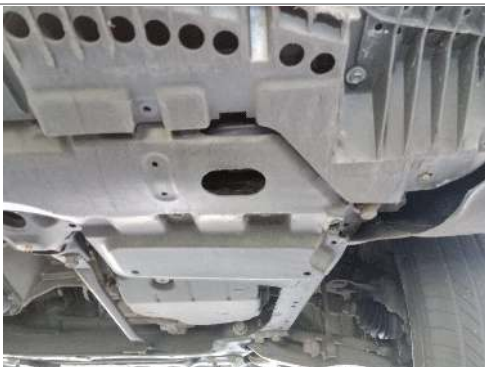
| Damage | Repair Way |
|---|---|
| Belly plates Damaged | Replace |

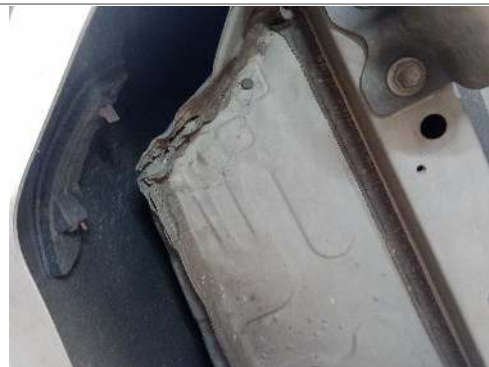
| Damage | Repair Way |
|---|---|
| Rear Fender Left / Inner Tray Dented | Repair |

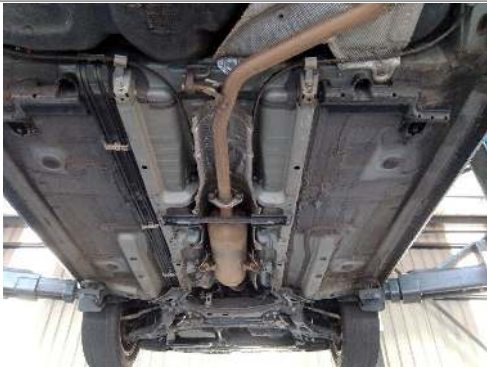
| Damage | Repair Way |
|---|---|
| Chassis Scratched | Repair |

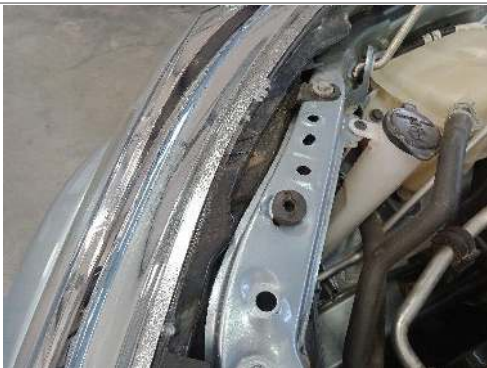
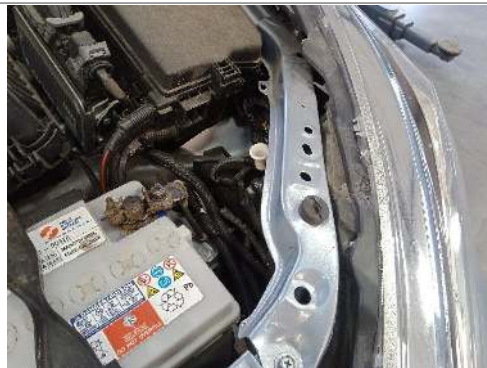
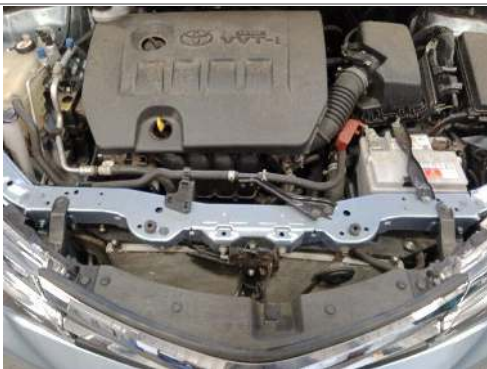
| Damage | Repair Way |
|---|---|
| Bonnet slam plate (Shock tower/ Inner tray) Residual Traces of Repair | Repair |

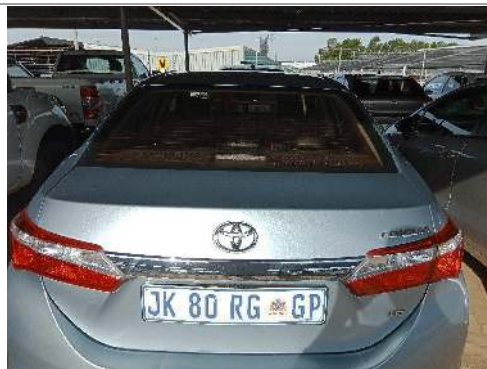
| Damage | Repair Way |
|---|---|
| Boot Lid / Hatch door Paintwork • Scratched | Repair |

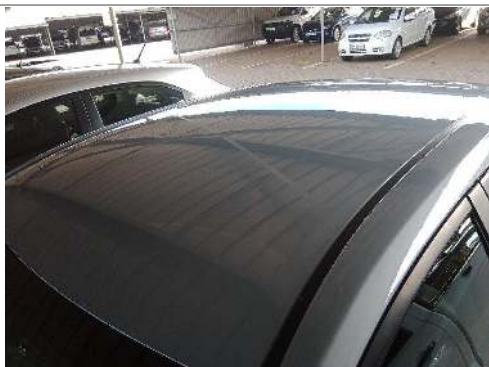
| Damage | Repair Way |
|---|---|
| Roof Dented | Repair |

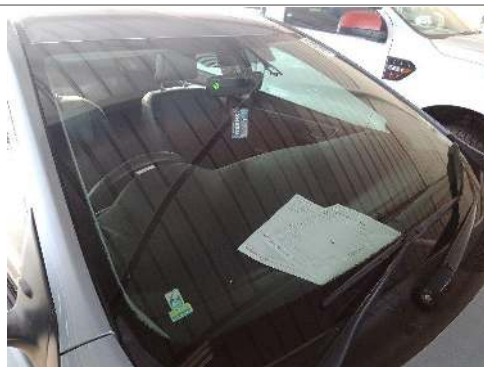
| Damage | Repair Way |
|---|---|
| Windscreen Defective | Repair |
