MFC Auction House  
M57 Pretoria Rd, Glenmarais, KEMPTON PARK  
Gauteng

| Manufacturer | TOYOTA | Registration Number | JVW818NW |

## CONDITION REPORT

Report No: 2016664530

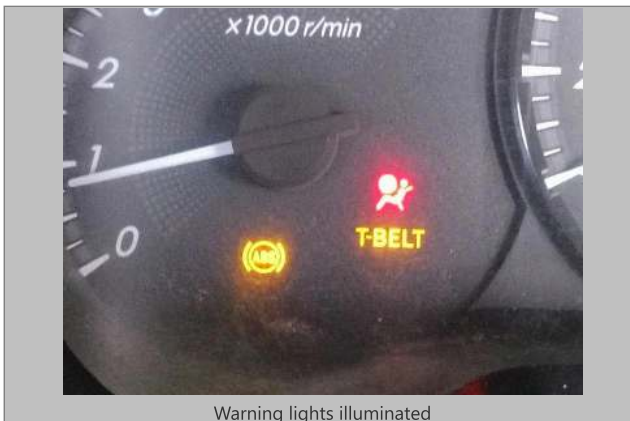
| Damage | Repair Way |
|---|---|
| Warning lights illuminated | Replace |

Warning lights illuminated

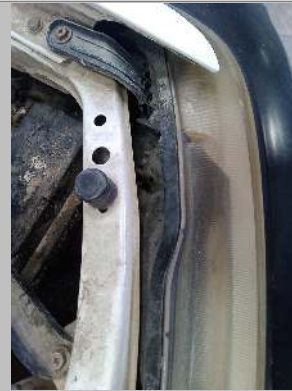
L/F headlight clips broken

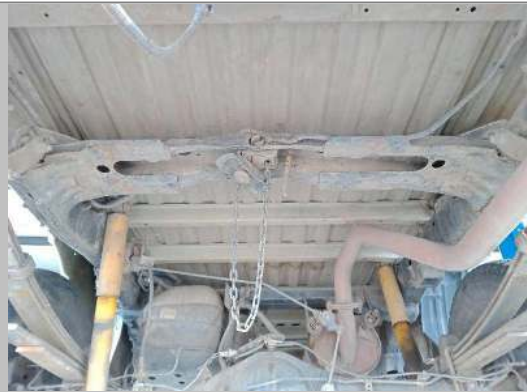
No sparewheel

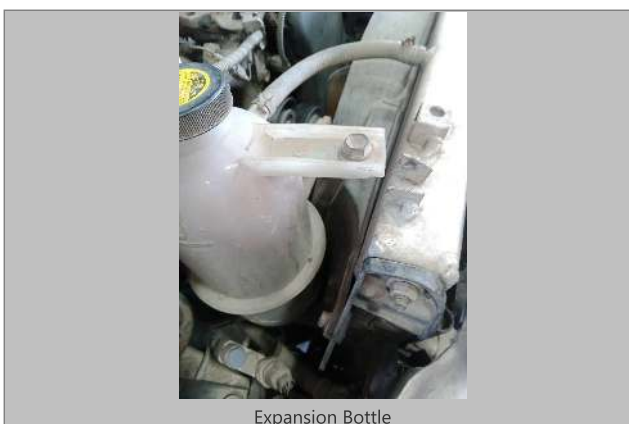
| Damage | Repair Way |
|---|---|
| Expansion Bottle Damaged | Repair |

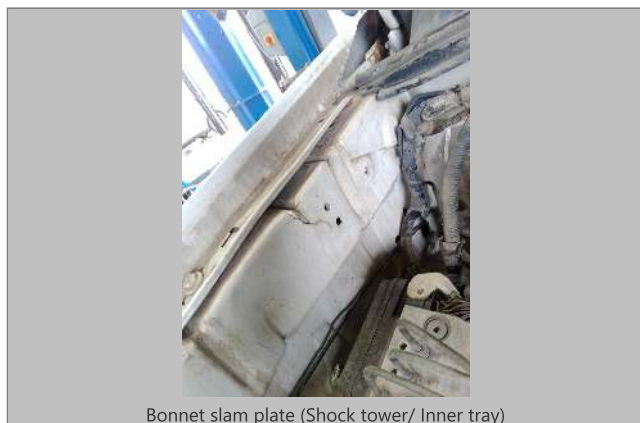
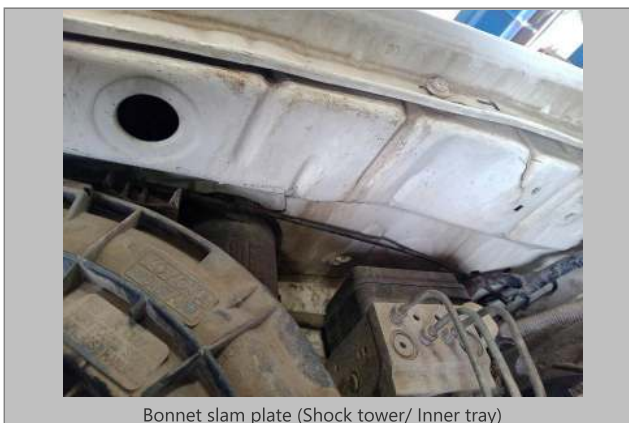
| Damage | Repair Way |
|---|---|
| Bonnet slam plate (Shock tower/ Inner tray) Damaged | Repair |

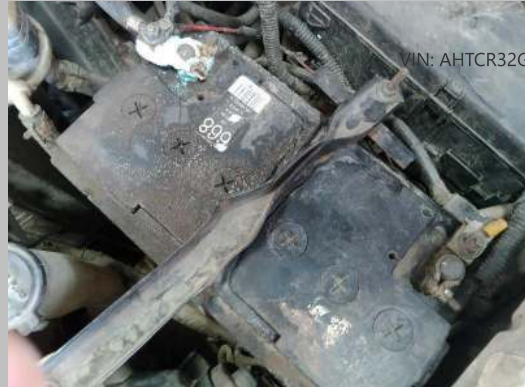
| Damage | Repair Way |
|---|---|
| Battery clamps Defective | Repair |

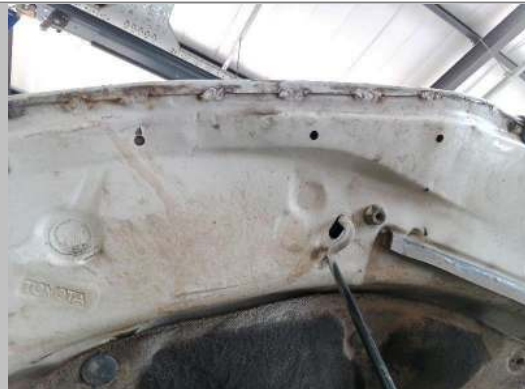
| Damage | Repair Way |
|---|---|
| Bonnet Welded | Repair |

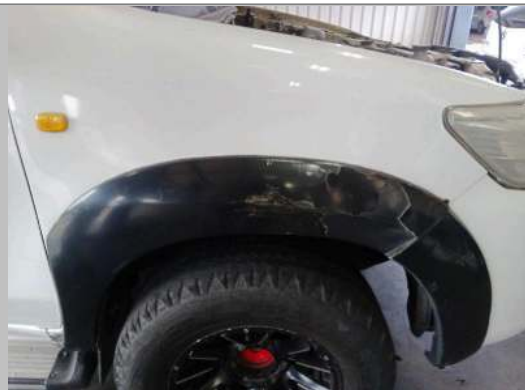
| Damage | Repair Way |
|---|---|
| Front Fender Right Residual Traces of Repair | Repair |

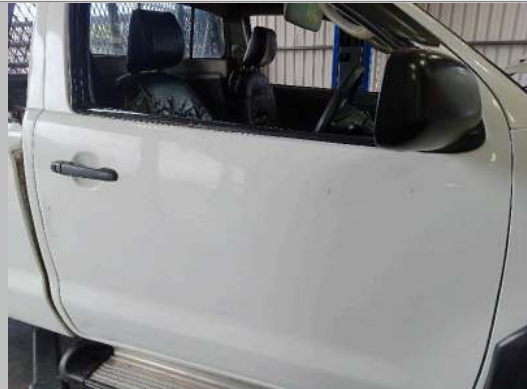
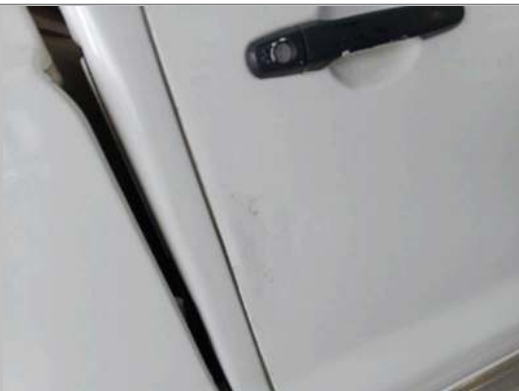
| Damage | Repair Way |
|---|---|
| Door Front Right Residual Traces of Repair | Repair |

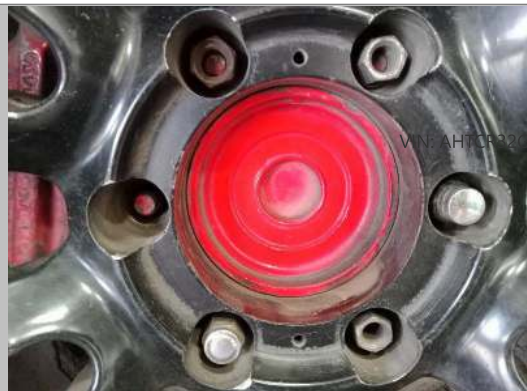
| Damage | Repair Way |
|---|---|
| Bolt(s) / Nut(s) Front Wheel Right Missing | Replace |

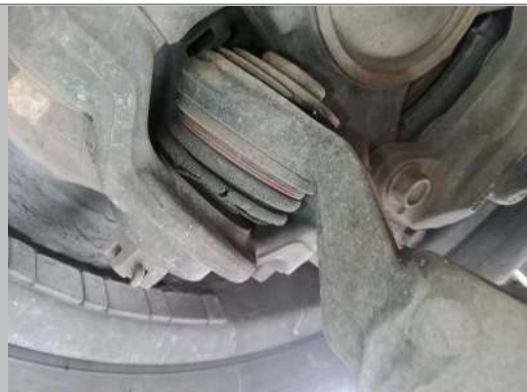
| Damage | Repair Way |
|---|---|
| Ball Joint(s) Front Axle Right Damaged | Replace |

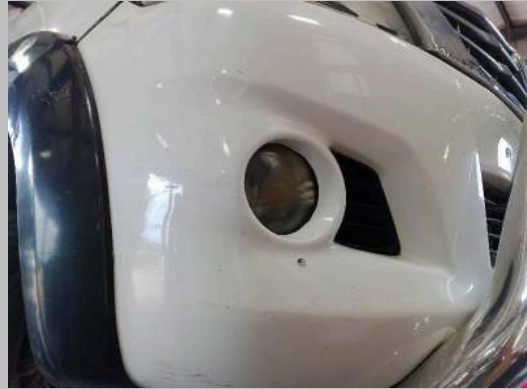
| Damage | Repair Way |
|---|---|
| Front Bumper Paintwork • Scratched | Repair |

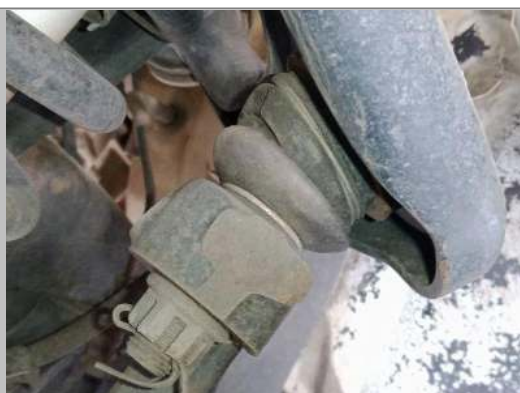
| Damage | Repair Way |
|---|---|
| Ball Joint(s) Front Axle Left Damaged | Replace |

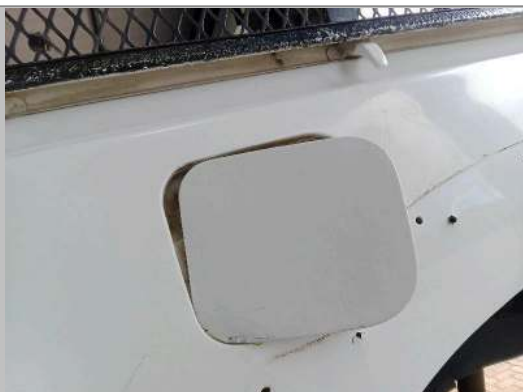
| Damage | Repair Way |
|---|---|
| Fuel Flap Damaged | Replace |

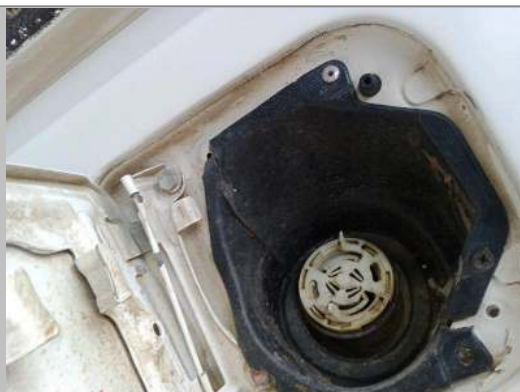
| Damage | Repair Way |
|---|---|
| Fuel Cap Damaged | Replace |

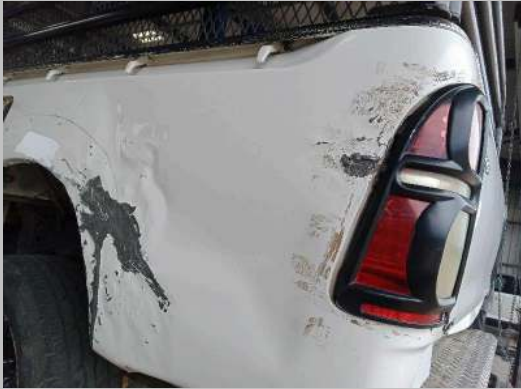
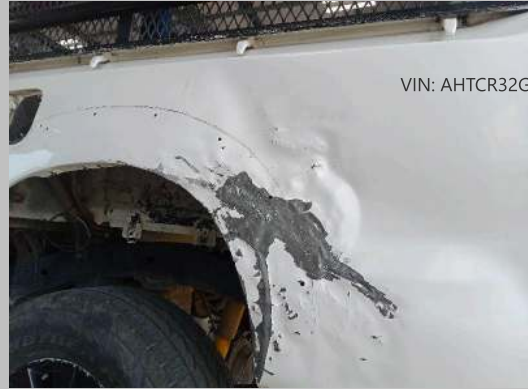
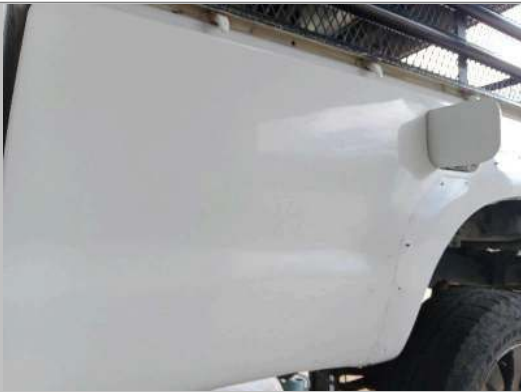
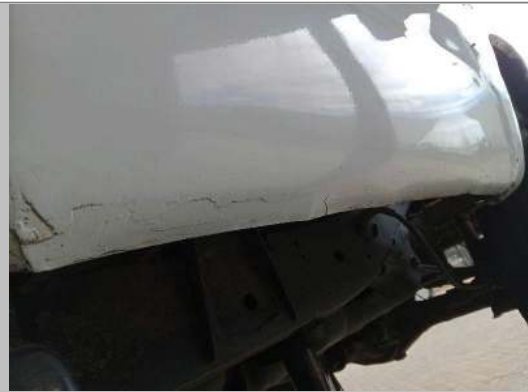
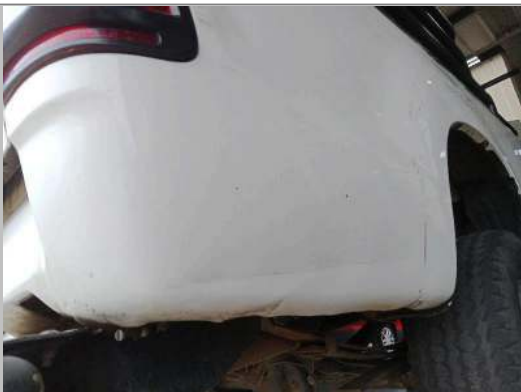
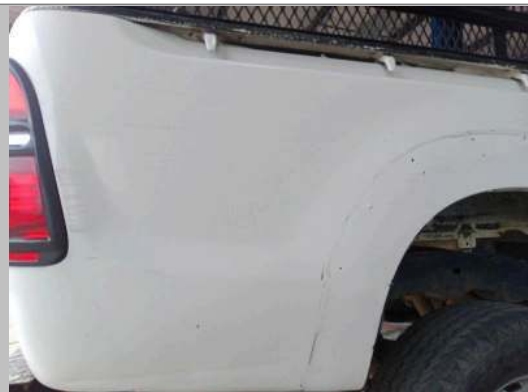
| Damage | Repair Way |
|---|---|
| Load Body Damaged | Repair |

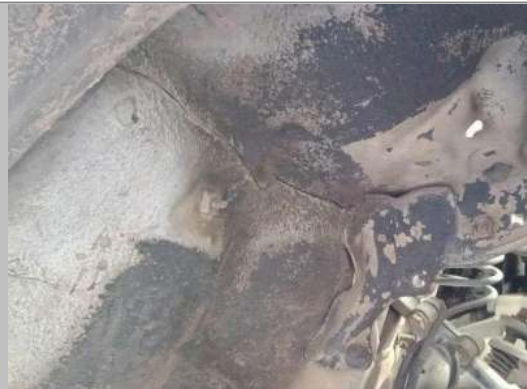
| Damage | Repair Way |
|---|---|
| Front Fender Right / Inner Tray Cracked | Replace |

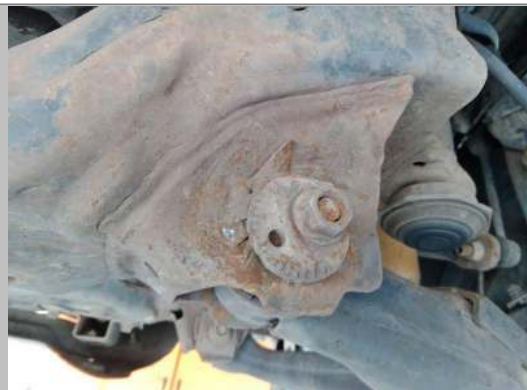
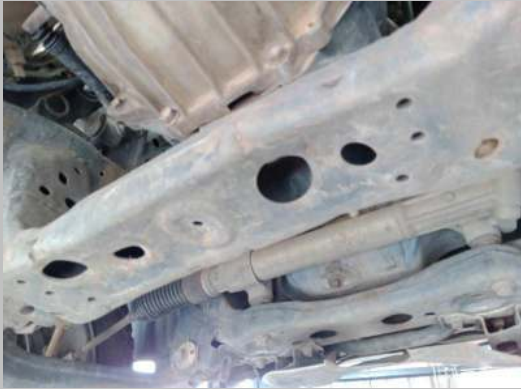
| Damage | Repair Way |
|---|---|
| Sub Frame Welded | Replace |
| Vehicle is a cut and join | Replace |

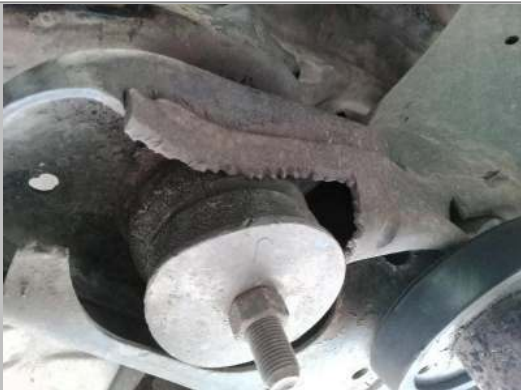
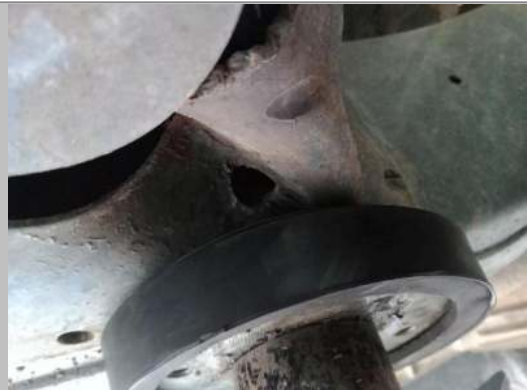
| Damage | Repair Way |
|---|---|
| Main Beam Right Dented | Repair |

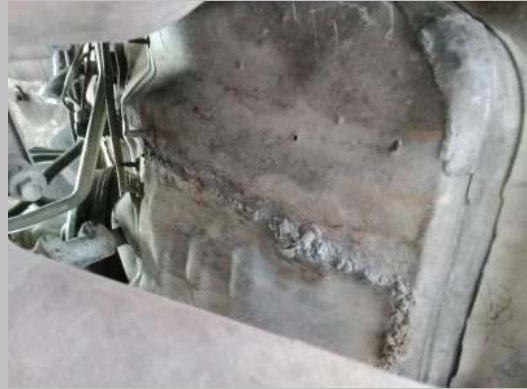
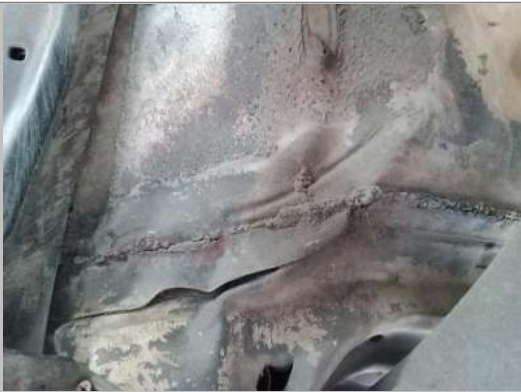
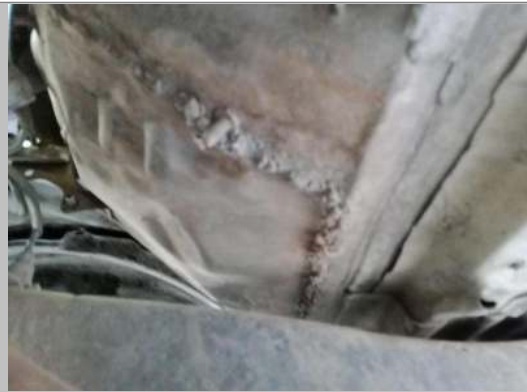
| Damage | Repair Way |
|---|---|
| Firewall Welded | Repair |

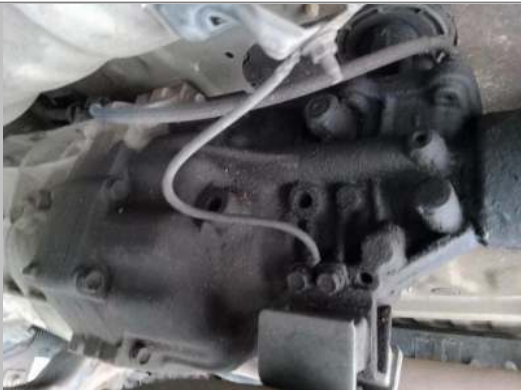
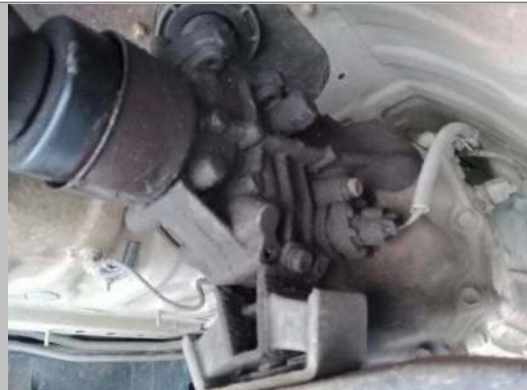
| Damage | Repair Way |
|---|---|
| Gearbox Oil Leak | Repair |

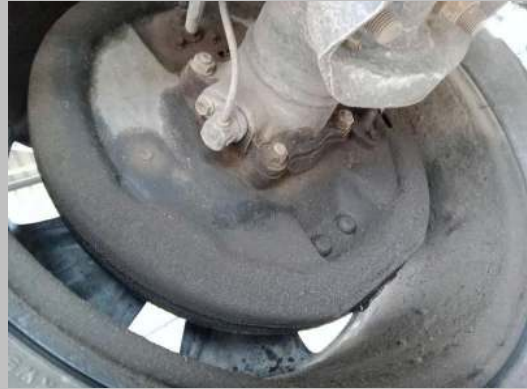
| Damage | Repair Way |
|---|---|
| Brake Drum 2. Axle left Damaged | Repair |

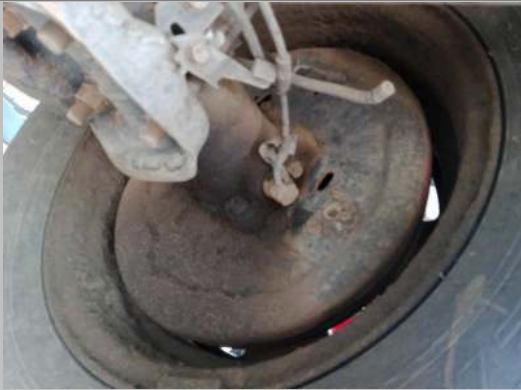
| Damage | Repair Way |
|---|---|
| Brake Drum 2. Axle right Damaged | Repair |

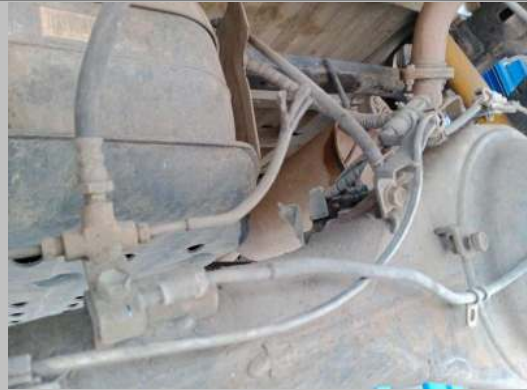
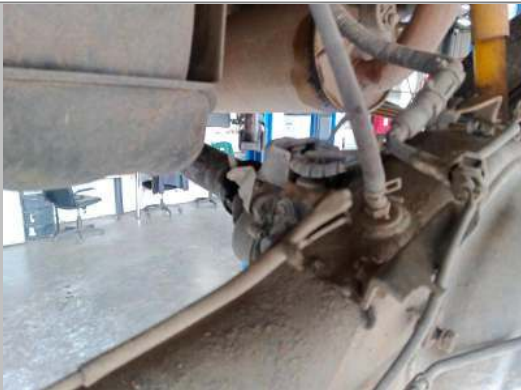
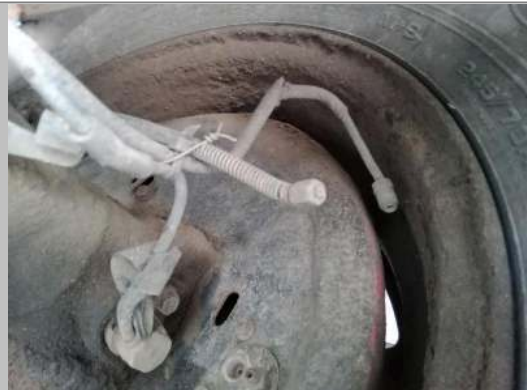
| Damage | Repair Way |
|---|---|
| Brake Piping Torn / Cut | Replace |

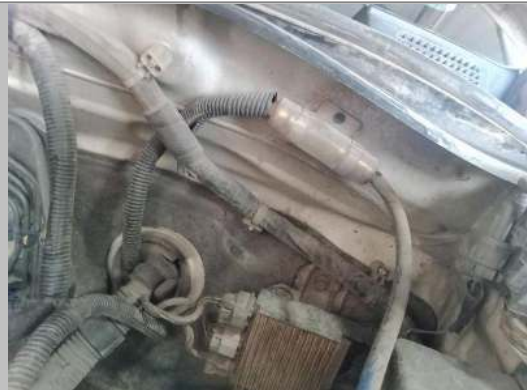
| Damage | Repair Way |
|---|---|
| Engine Wiring Defective | Repair |

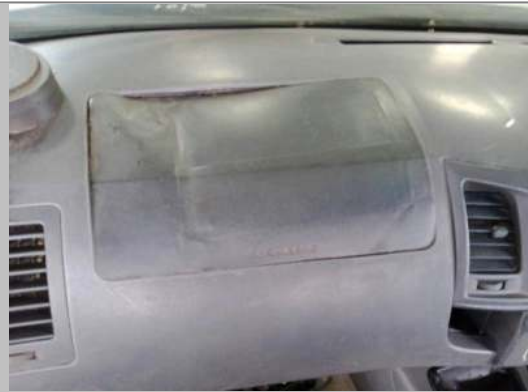
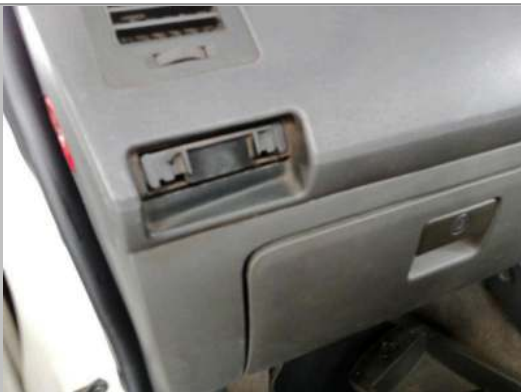
| Damage | Repair Way |
|---|---|
| Dash Padding Damaged | Repair |
