**CONDITION REPORT**

Report No: 2016803774

DATE  
17/03/2025

| Manufacturer | TOYOTA | Registration Number | JZG046MP |

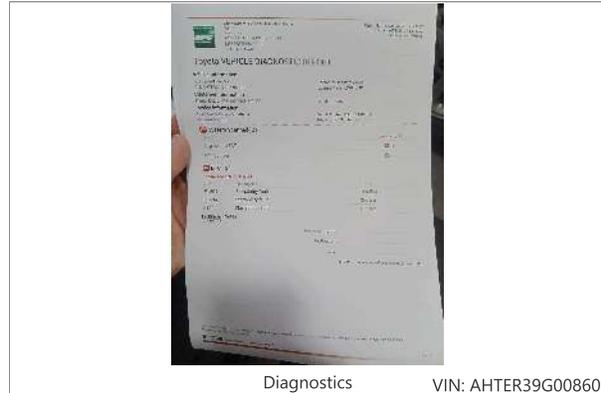
Diagnostics

| No | System | Code | Description | Status |
|---|---|---|---|---|
| 1 | ENGINE AND ECT | P1604 | STARTABILITY FAULT | |

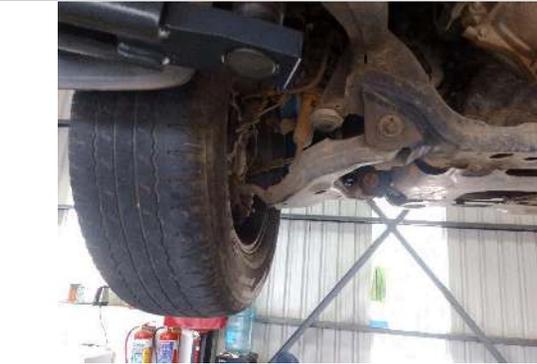
LF TYRE TREAD

| | Size | Load/Speed Index | Manufacture | Model | Type* | Production Date | Tread Depth (mm) |
|---|---|---|---|---|---|---|---|
| Front Left | 265/65R17 | 112S | Bridgestone | Radial | V | 1521 | 0 mm |

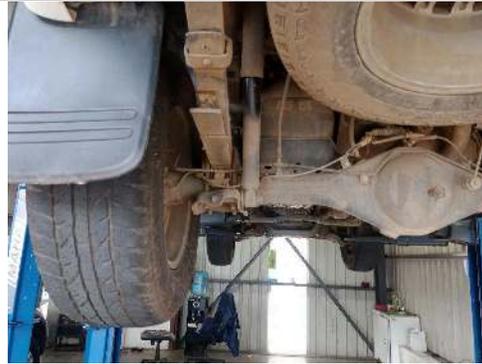
LR TYRE TREAD

| | Size | Load/Speed Index | Manufacture | Model | Type* | Production Date | Tread Depth (mm) |
|---|---|---|---|---|---|---|---|
| Rear Left | 265/65R17 | 112H | Yokohama | Radial | V | 3619 | 1 mm |

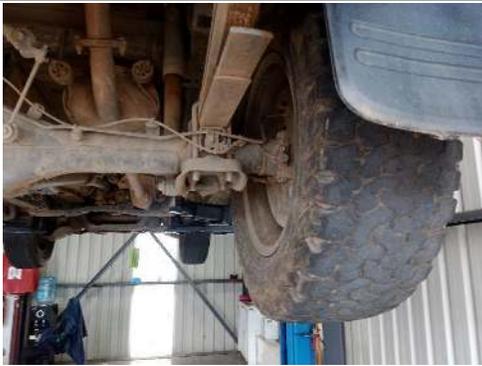
RR TYRE TREAD

| | Size | Load/Speed Index | Manufacture | Model | Type* | Production Date | Tread Depth (mm) |
|---|---|---|---|---|---|---|---|
| Rear Right | 265/65R17 | 120S | BFGoodrich | Radial | V | 3119 | 0 mm |

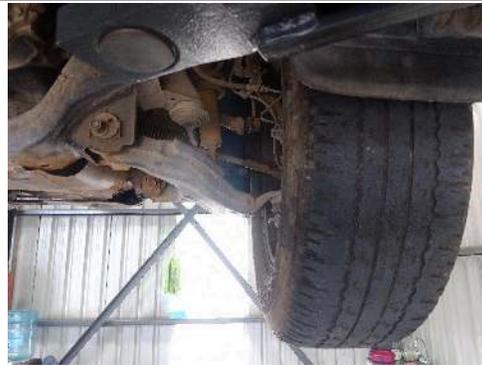
RF TYRE TREAD

| | Size | Load/Speed Index | Manufacture | Model | Type* | Production Date | Tread Depth (mm) |
|---|---|---|---|---|---|---|---|
| Front Right | 265/65R17 | 112S | Bridgestone | Radial | V | 4321 | 0 mm |

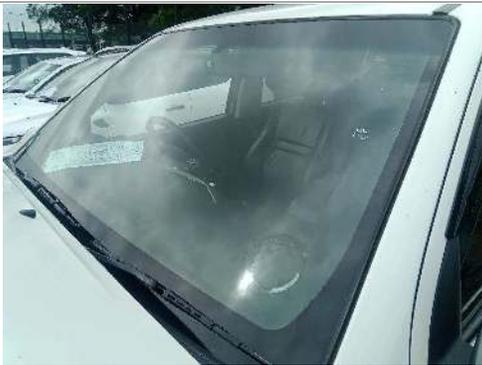
NO LICENSE DISC

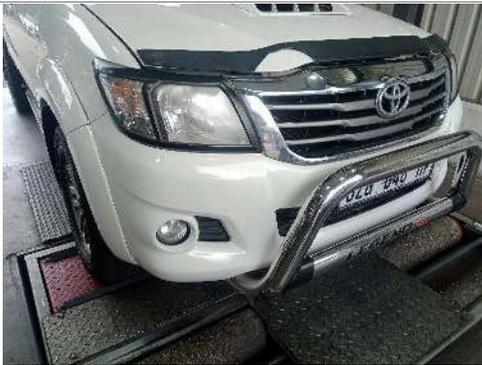
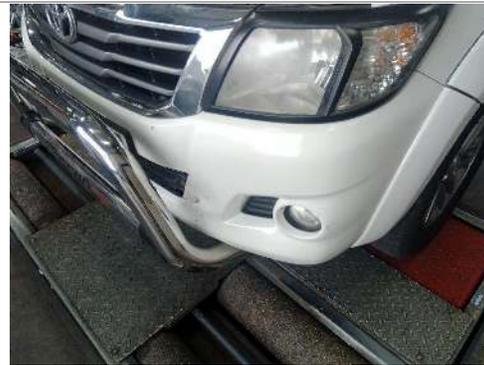
| | Damage | Repair Way |
|---|--|---|
| | Front Bumper Damaged | Repair |

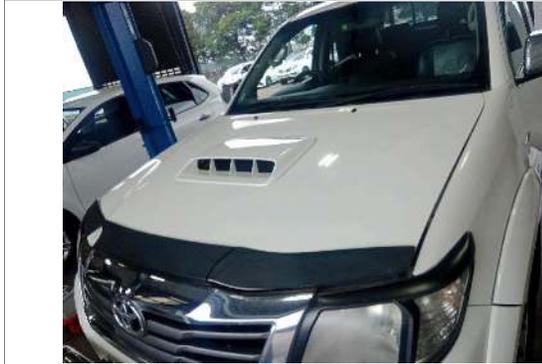
| | Damage | Repair Way |
|---|--|---|
| | Bonnet Damaged | Repair |

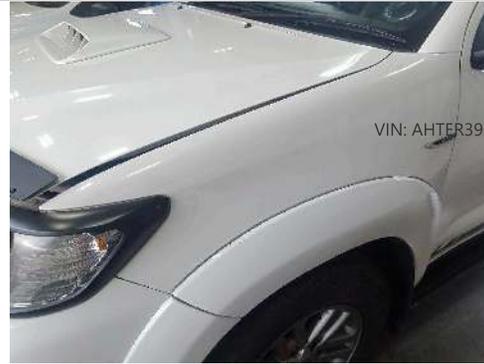
| | Damage | Repair Way |
|---|--|---|
| | Front Fender Left Damaged | Repair |

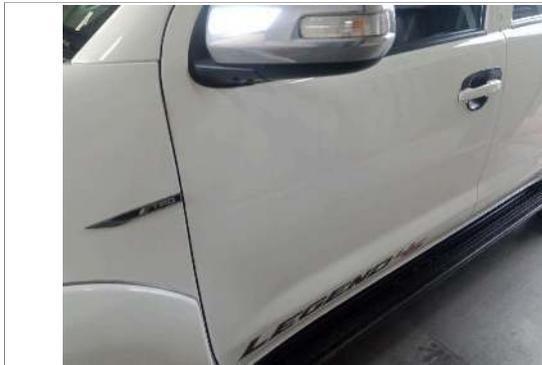
| | Damage | Repair Way |
|---|--|---|
| | Door Front Left Damaged | Repair |

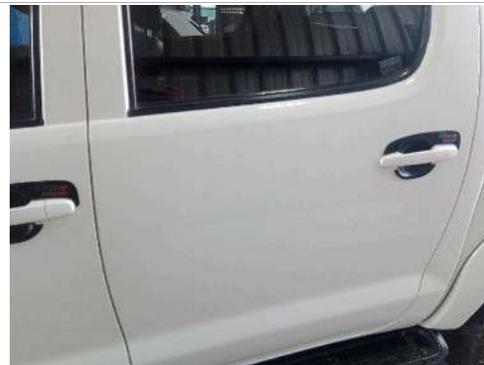
| | Damage | Repair Way |
|---|--|---|
| | Door Rear Left Damaged | Repair |

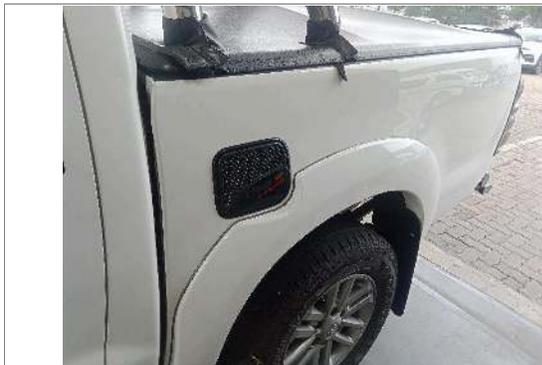
| | Damage | Repair Way |
|---|--|---|
| | Rear Fender Left Damaged | Repair |

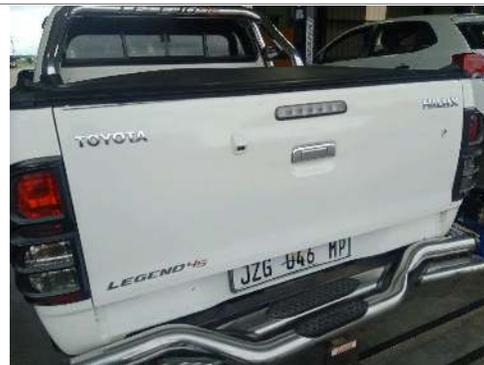
| | Damage | Repair Way |
|---|--|---|
| | Tailgate Damaged | Repair |

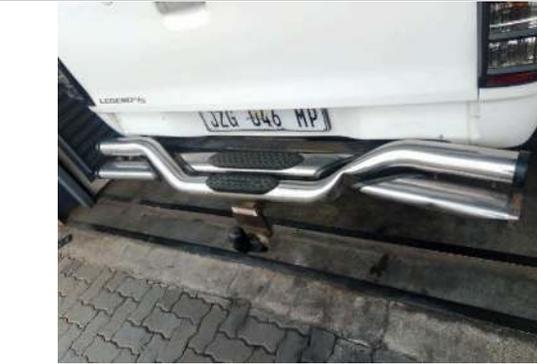
| | Damage | Repair Way |
|---|--|---|
| | Rear bumper Damaged | Repair |

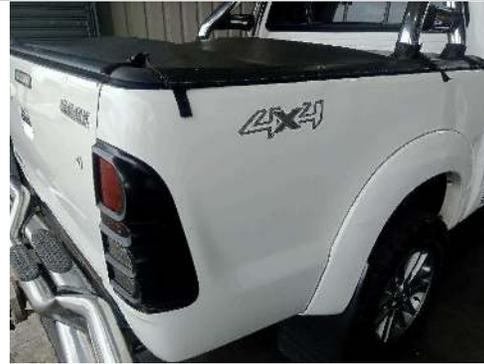
| | Damage | Repair Way |
|---|--|---|
| | Rear Fender Right Damaged | Repair |

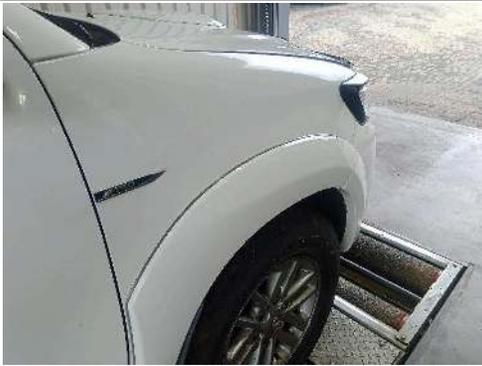
| | Damage | Repair Way |
|---|--|---|
| | Front Fender Right Damaged | Repair |

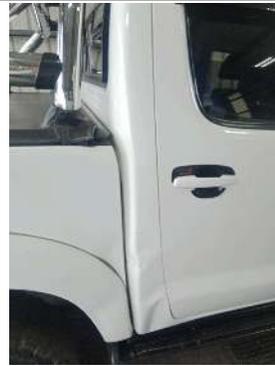
| | Damage | Repair Way |
|---|--|---|
| | C • Pillar Right Damaged | Repair |

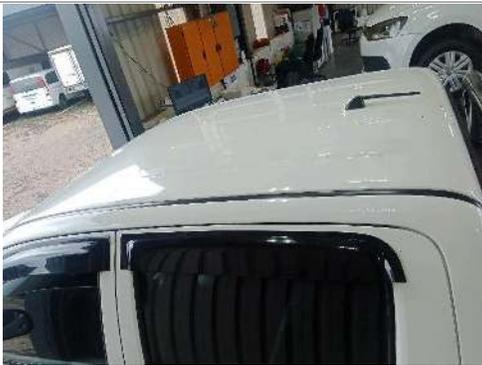
| | Damage | Repair Way |
|---|--|---|
| | Roof Damaged | Repair |

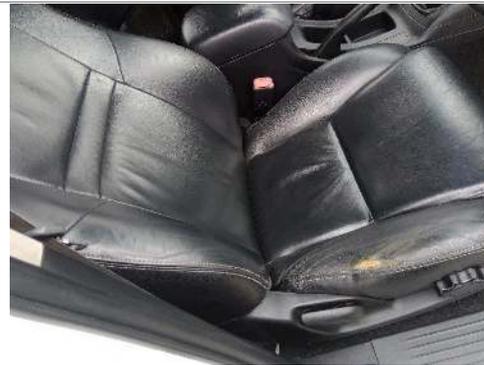
| | Damage | Repair Way |
|---|--|---|
| | Seat Front Right Damaged | Repair |

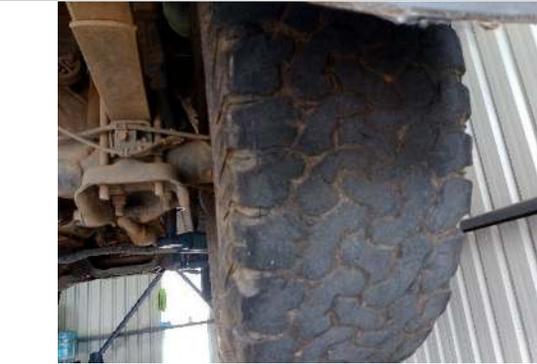
| Damage | Repair Way |
|---|---|
| Tyre Rear Right Worn | Replace |

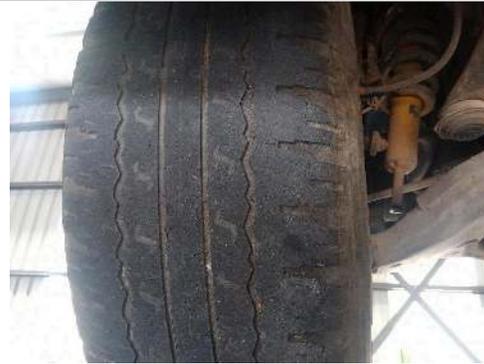
| | Damage | Repair Way |
|---|--|---|
| Tyre Front Left Worn | Replace | |

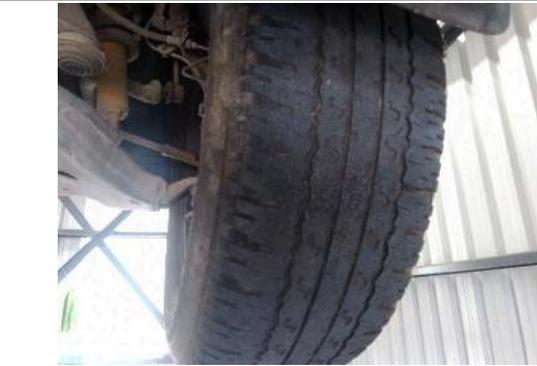
| | Damage | Repair Way |
|---|--|---|
| Tyre Front Right Worn | Replace | |

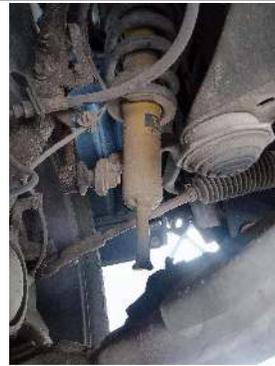
| | Damage | Repair Way |
|---|--|---|
| | Shock Absorber Front Left Damaged | Replace |

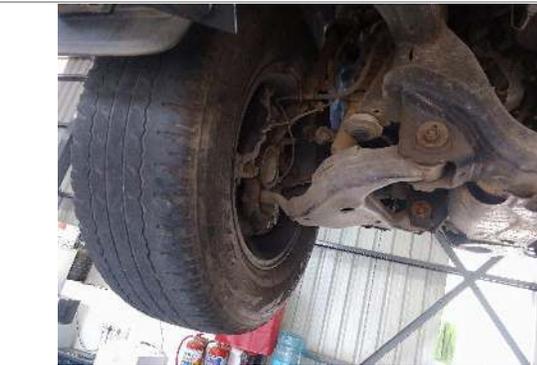
| | Damage | Repair Way |
|---|--|---|
| | Control Arm Bush(es) Front Axle Left Worn | Repair |

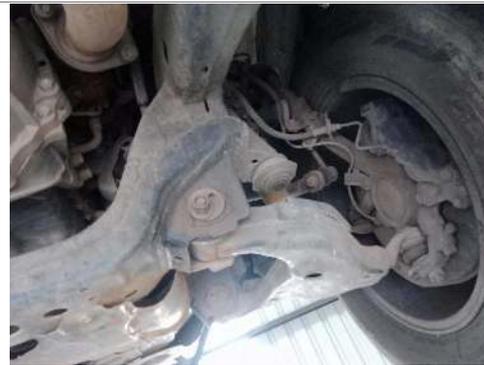
| | Damage | Repair Way |
|---|--|---|
| | Control Arm Bush(es) Front Axle Right Worn | Replace |
