## CONDITION REPORT

Report No:  
2016903257  
DATE  
05/06/2025

| Manufacturer | TOYOTA | Registration Number | FZT446L |
| Model | HILUX 2.8 GD-6 RB RAIDER D-CAB DSL PU AT [2016-2018] | Register Number | |

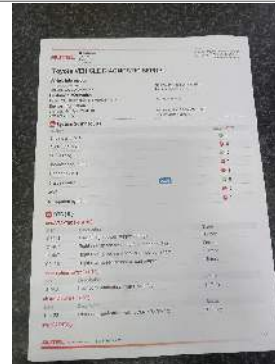
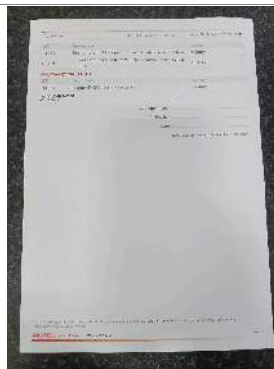
Diagnostic report

| No | System | Code | Description | Status |
|---|---|---|---|---|
| 1 | ABS/VSR/TRC | C1407 | RIGHT REAR SPEED SENSOR CIRCUIT OPEN OR SHORT | |

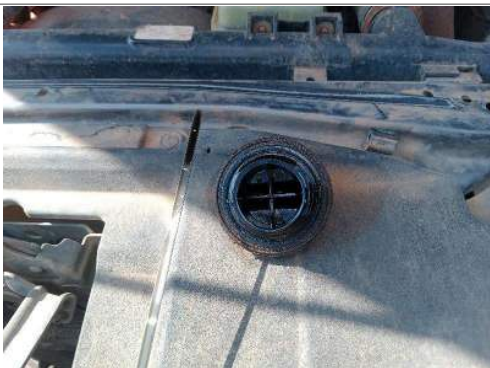
Oil cap and dipstick

| Oil cap damage | Replace |

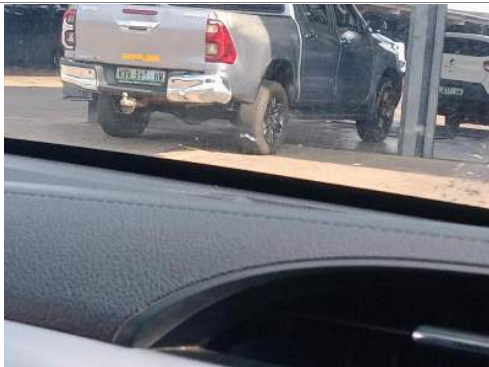
| Windscreen Chipped | Repair |

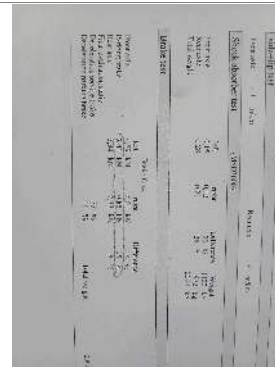
| Parking Brake Performance Left / Right Difference out of legal range | Repair |

| | Left | Right | | |
|---|---|---|---|---|
| Emergency / Parking | 2.4 | 0.8 | - | |

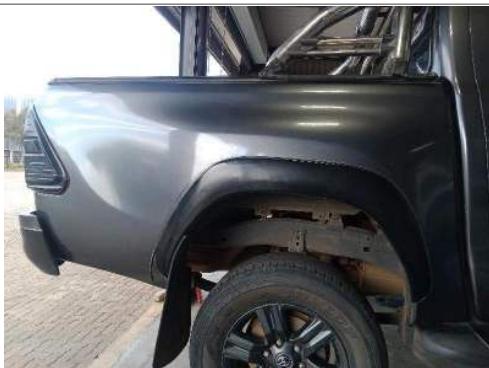
| Rear Fender Right Paintwork • Scratched | Repair |

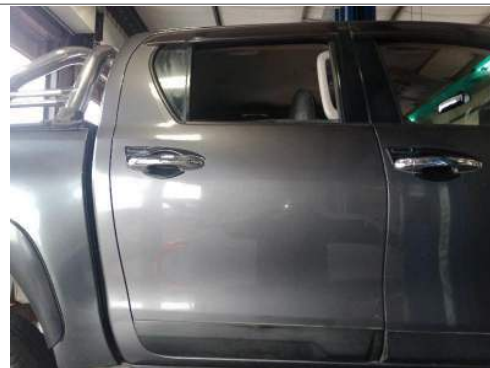
| Door Rear Right Paintwork • Scratched | Repair |

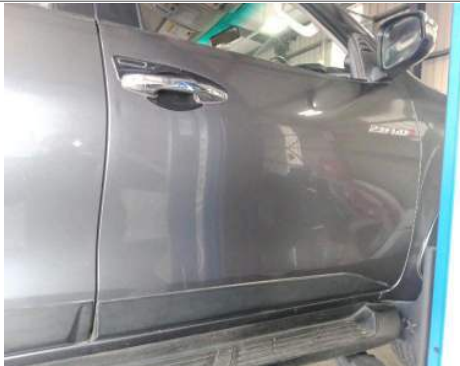
| Door Front Right Paintwork • Scratched | Repair |

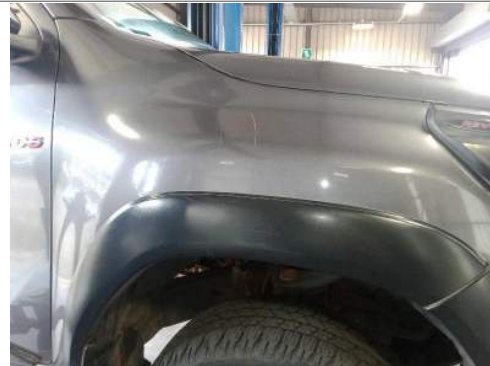
| Front Fender Right Paintwork • Scratched | Repair |

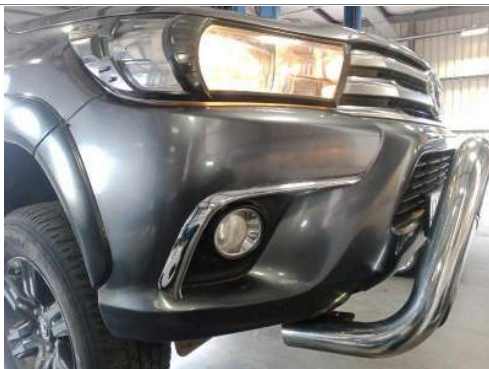
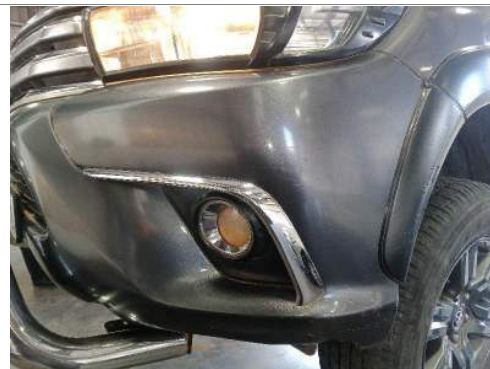
| Front Bumper Paintwork • Scratched | Repair |

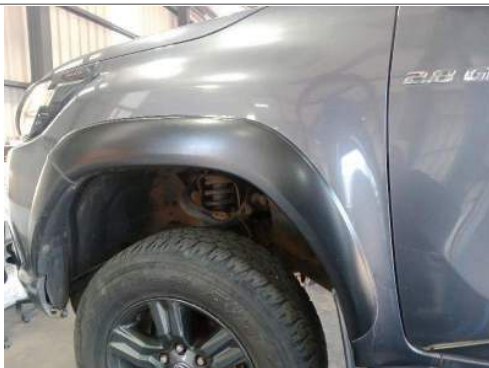
| Front Fender Left Paintwork • Scratched | Repair |

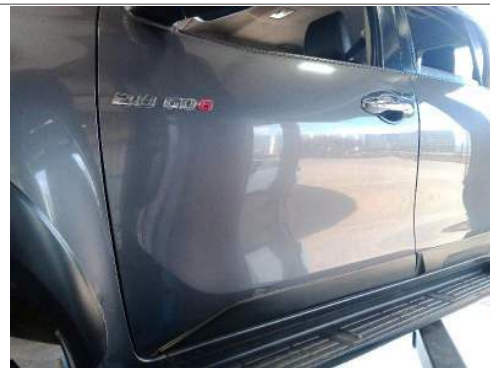
| Door Front Left Paintwork • Scratched | Repair |

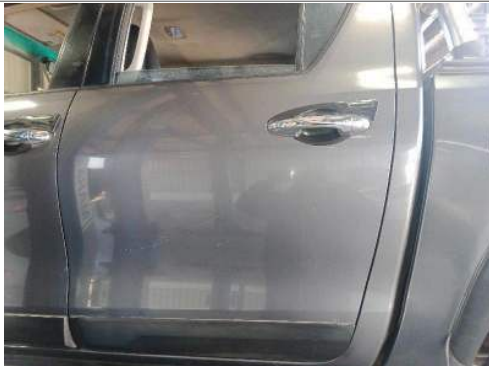
| Door Rear Left Paintwork • Scratched | Repair |

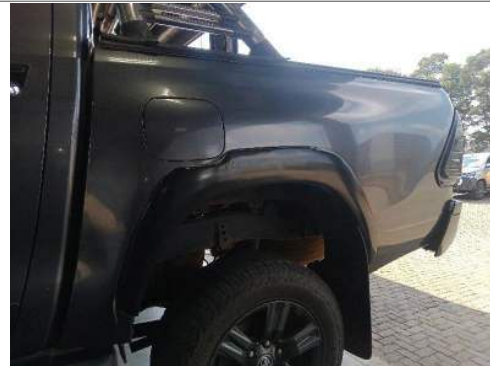
| Rear Fender Left Paintwork • Scratched | Repair |

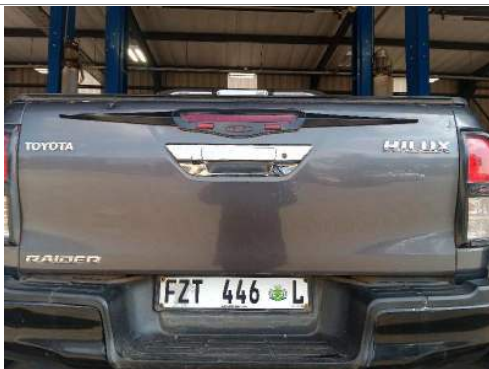
| Tailgate Paintwork • Scratched | Repair |

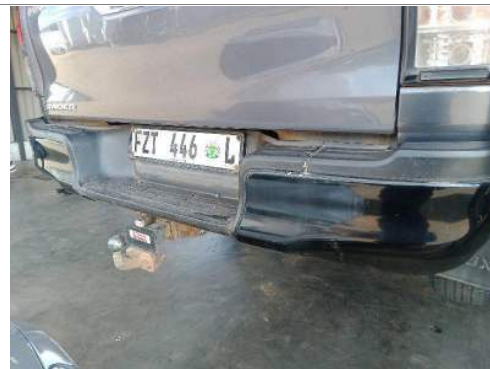
| Rear bumper Paintwork • Scratched | Repair |

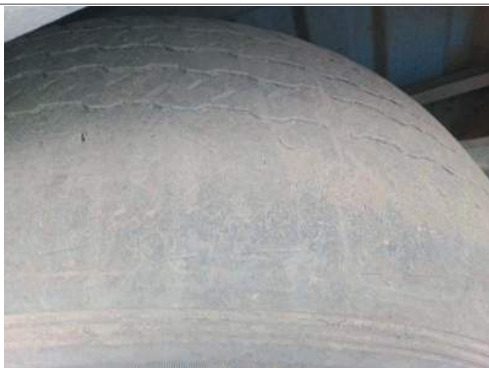
| Spare Tyre Smooth | Replace |

| | Size | Load/Speed Index | Manufacture | Model | Type* | Production Date | Tread Depth (mm) |
|---|---|---|---|---|---|---|---|
| Spare | 265/65R17 | 112S | Dunlop | Grandtrek | V | 0718 | 0 mm |

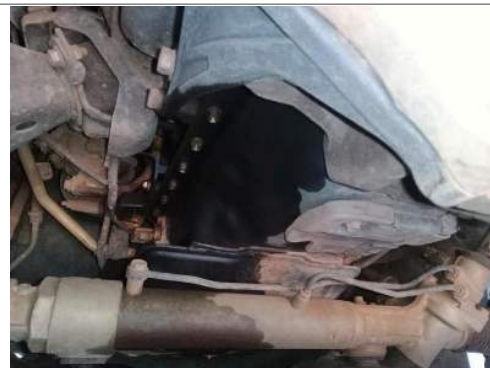
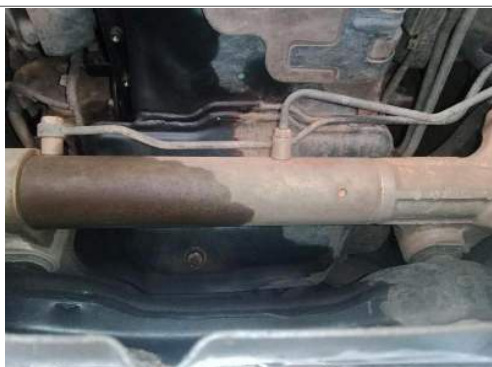
| Engine Oil Sweat | Repair |

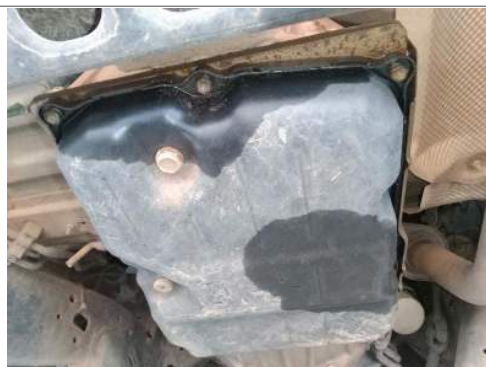
| Gearbox Oil Sweat | Repair |

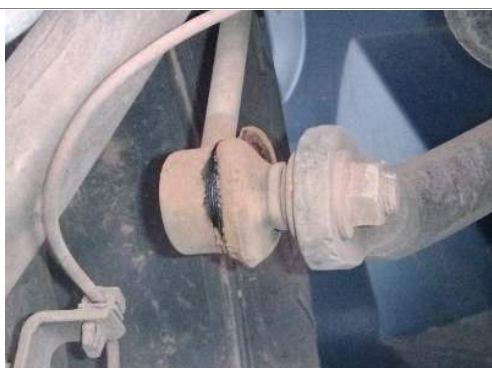
| Stabilizer Mounting Front Left Damaged | Repair |

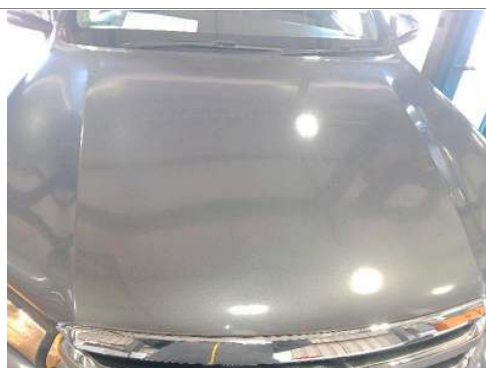
| Bonnet Paintwork • Scratched | Repair |

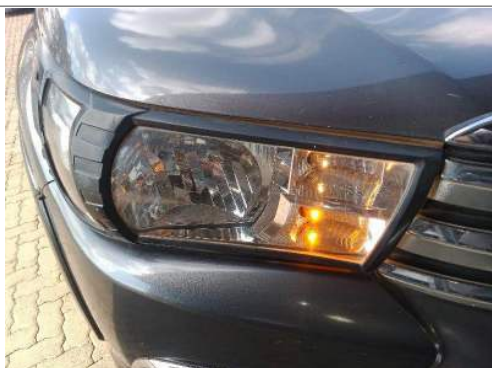
| Dim and Bright Indicator Light Malfunction | Repair |

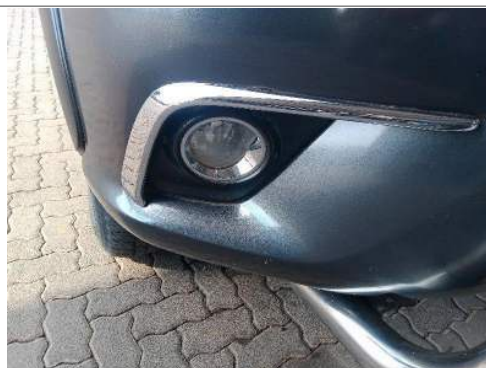
| Fog Light Front Right Malfunction | Repair |
