MFC Auction House  
M57 Pretoria Rd, Glenmarais, KEMPTON PARK  
Gauteng

## Assignment

Report No: 2016322467

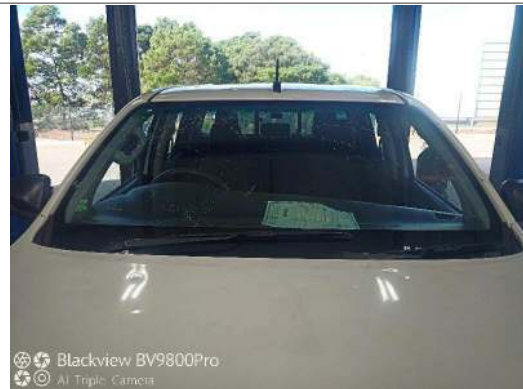
| Damage | Repair Way |
|---|---|
| No license dice | Replace |

LICENSE DISC MISSING

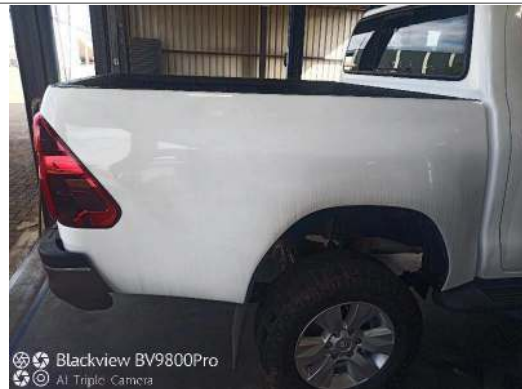
| Damage | Repair Way |
|---|---|
| Rear Fender Left Dented | Repair |

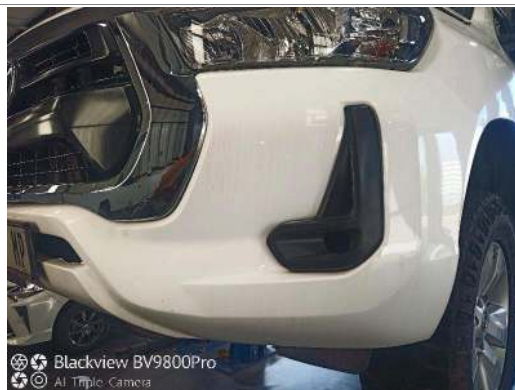
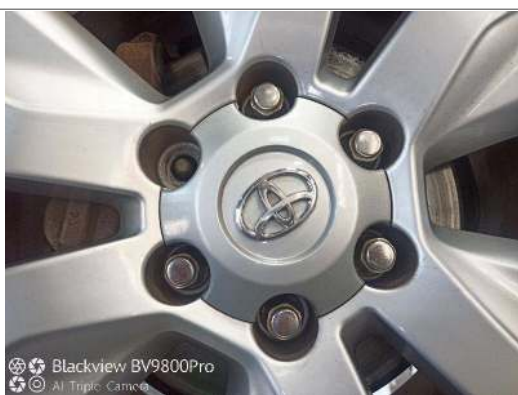
| Damage | Repair Way |
|---|---|
| Front Bumper Paintwork • Scratched | Repair |

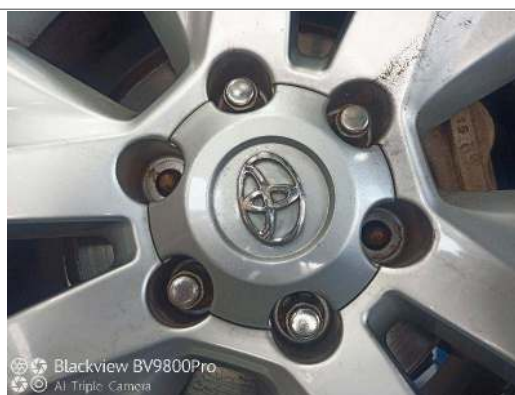
| Damage | Repair Way |
|---|---|
| Bolt(s) / Nut(s) Front Wheel Right Missing | Replace |

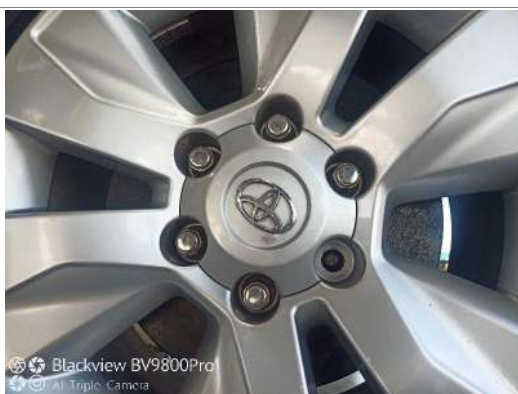
| Damage | Repair Way |
|---|---|
| Bolt(s) / Nut(s) Front Wheel Left Missing | Replace |

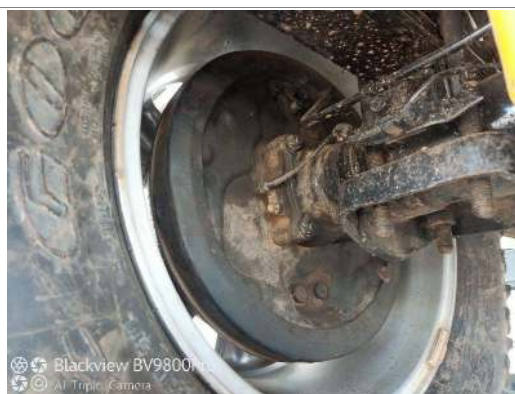
| Damage | Repair Way |
|---|---|
| Bolt(s) / Nut(s) Rear Wheel Left Missing | Replace |

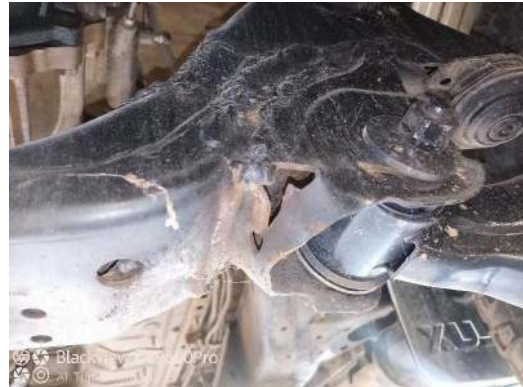
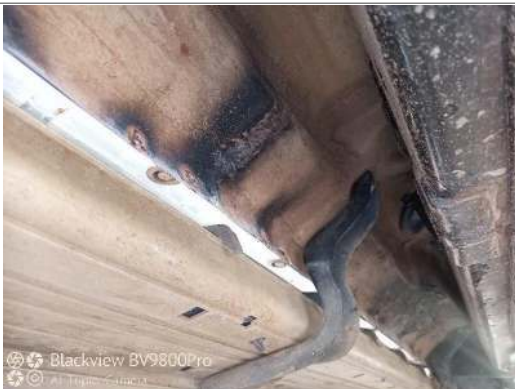
| Damage | Repair Way |
|---|---|
| Sub Frame Welded | Repair |

| Damage | Repair Way |
|---|---|
| Vehicle is cut and join on sub frame | |

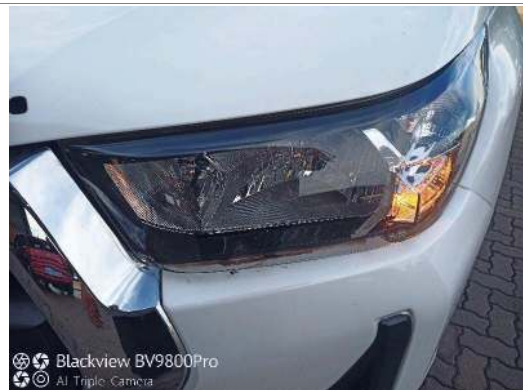
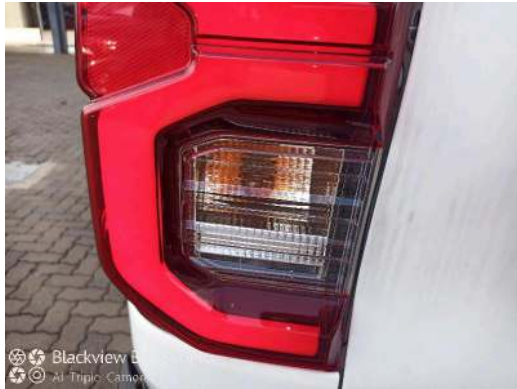
| Damage | Repair Way |
|---|---|
| Dim and Bright Indicator Light Malfunction | Repair |
