## CONDITION REPORT

Report No:  
2016927884  
DATE  
27/06/2025

| Manufacturer | TOYOTA | Registration Number | JPG682MP |
| Model | HILUX 2.4 GD-6 RB SRX D-CAB DSL PU [2018-2020] | Register Number | |

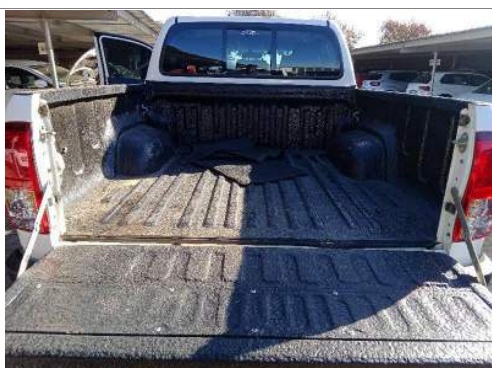
| Damage | Repair Way |
|---|---|
| Load Body Dented | Repair |

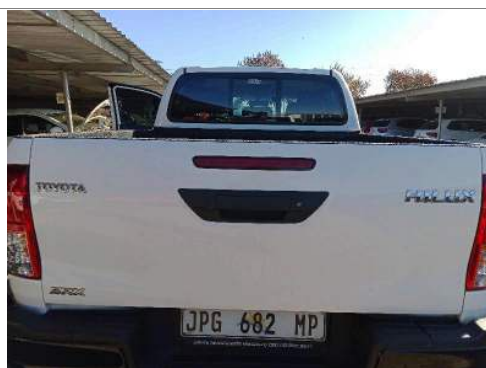
| Damage | Repair Way |
|---|---|
| Tailgate Paintwork • Scratched | Repair |

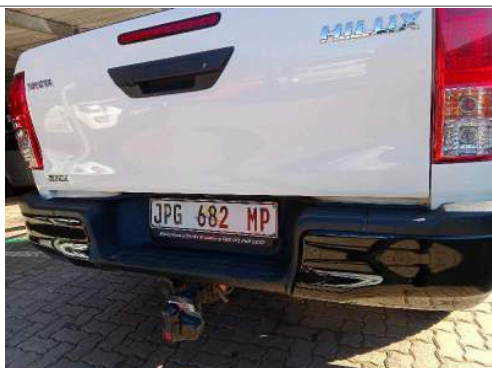
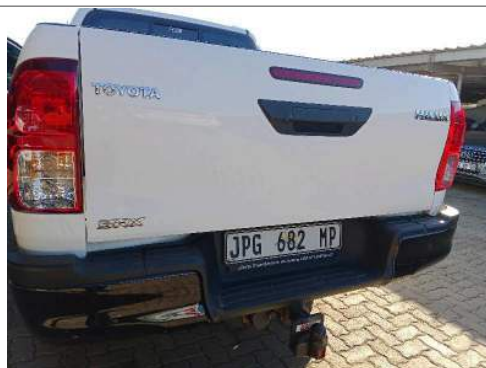
| Damage | Repair Way |
|---|---|
| Rear bumper Paintwork • Scratched | Repair |

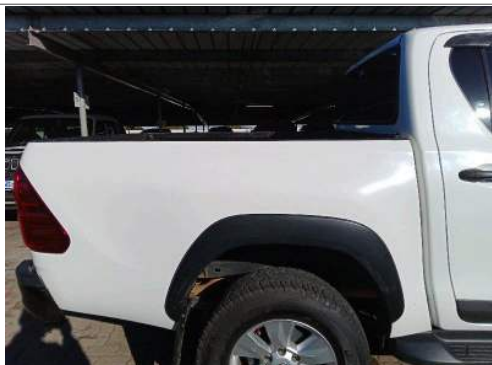
| Damage | Repair Way |
|---|---|
| Rear Fender Right Paintwork • Scratched | Repair |

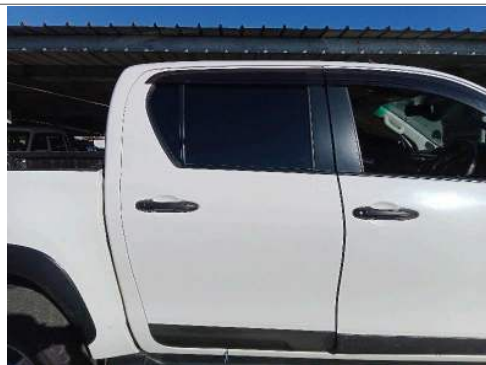
| Damage | Repair Way |
|---|---|
| Door Rear Right Paintwork • Scratched | Repair |

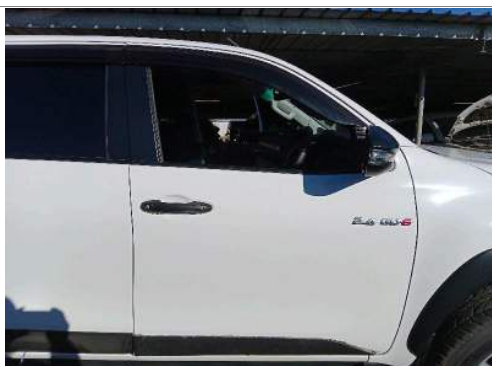
| Damage | Repair Way |
|---|---|
| Door Front Right Residual Traces of Repair | Repair |

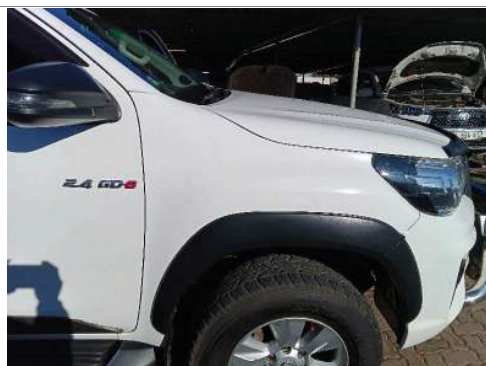
| Damage | Repair Way |
|---|---|
| Front Fender Right Paintwork • Scratched | Repair |

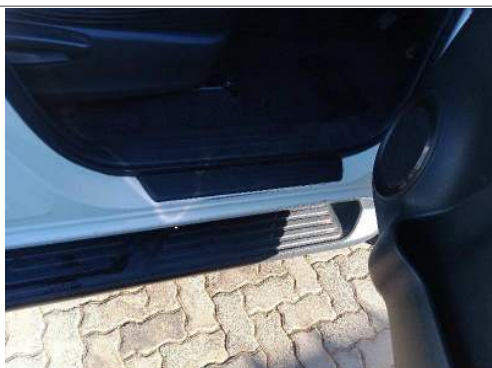
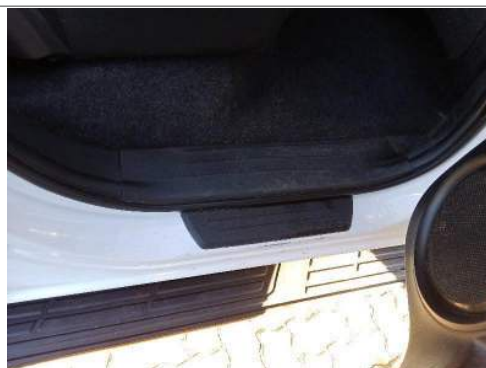
| Damage | Repair Way |
|---|---|
| Sill Panel Right Paintwork • Scratched | Repair |

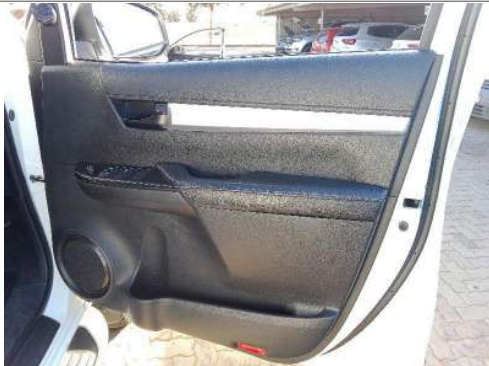
| Damage | Repair Way |
|---|---|
| Door Panel Front Right Damaged | Repair |

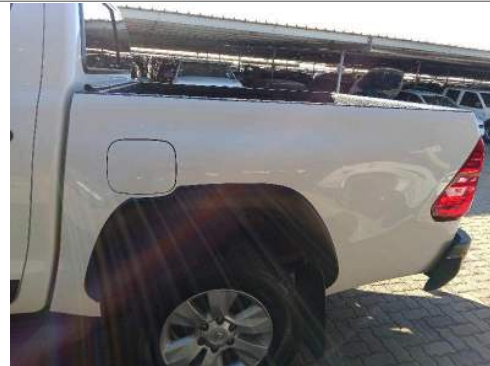
| Damage | Repair Way |
|---|---|
| Rear Fender Left Residual Traces of Repair | Repair |

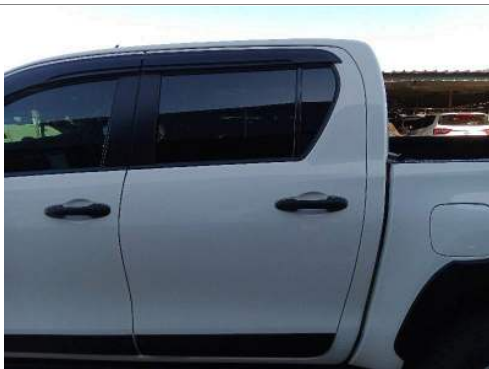
| Damage | Repair Way |
|---|---|
| Door Rear Left Residual Traces of Repair | Repair |

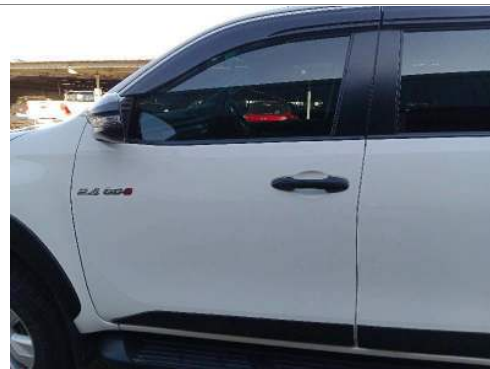
| Damage | Repair Way |
|---|---|
| Door Front Left Paintwork • Scratched | Repair |

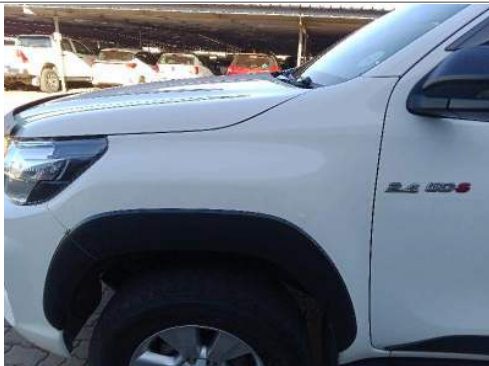
| Damage | Repair Way |
|---|---|
| Front Fender Left Paintwork • Scratched | Repair |

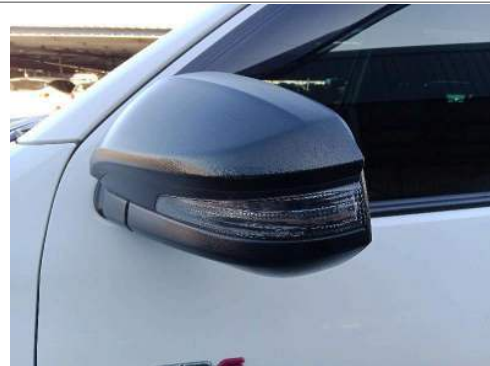
| Damage | Repair Way |
|---|---|
| Indicator Light Front Left Cracked | Replace |

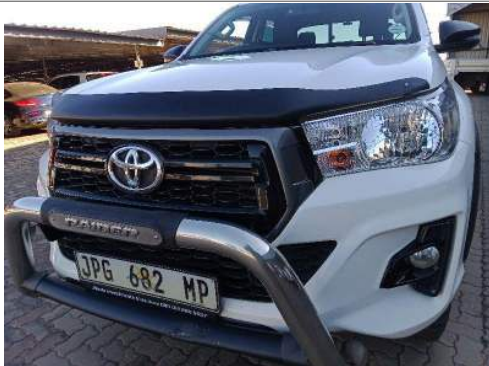
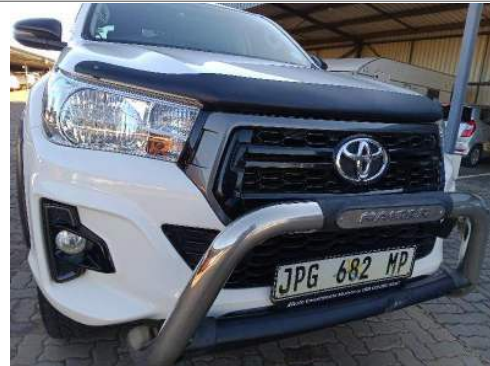
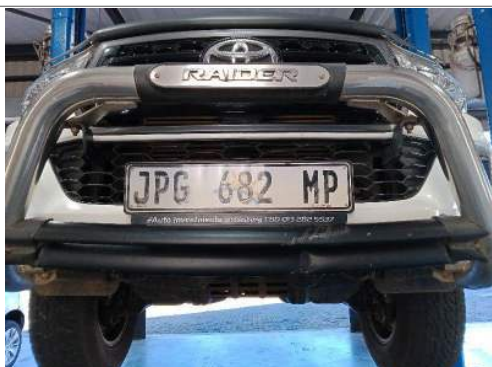
| Damage | Repair Way |
|---|---|
| Front Bumper Damaged | Repair |

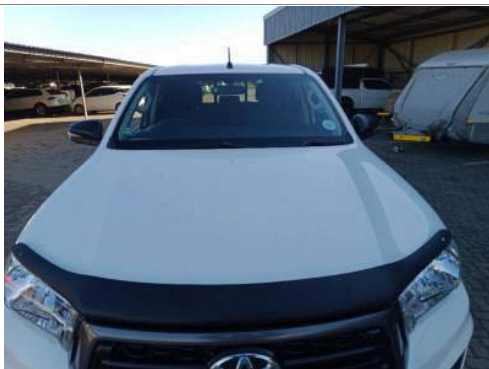
| Damage | Repair Way |
|---|---|
| Bonnet Dented | Repair |

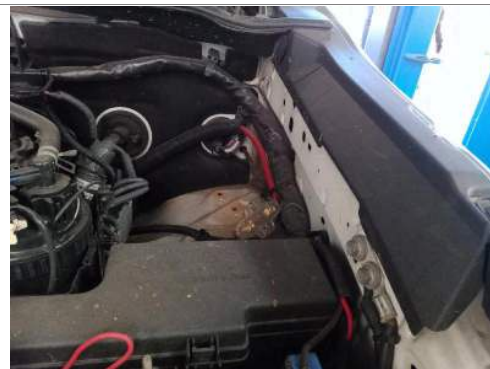
| Damage | Repair Way |
|---|---|
| Engine Wiring Defective | Repair |

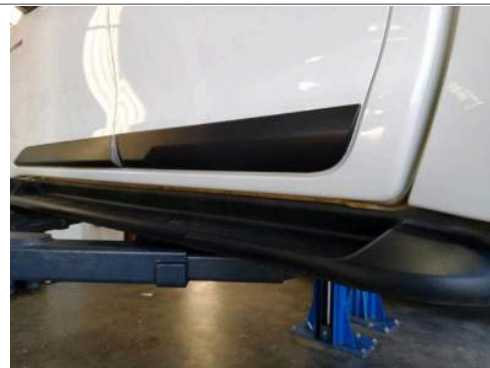
| Damage | Repair Way |
|---|---|
| Sill Panel Left Paintwork • Scratched | Repair |

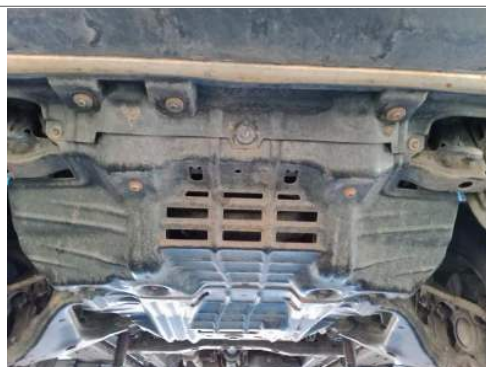
| Damage | Repair Way |
|---|---|
| Belly plates Damaged | Repair |

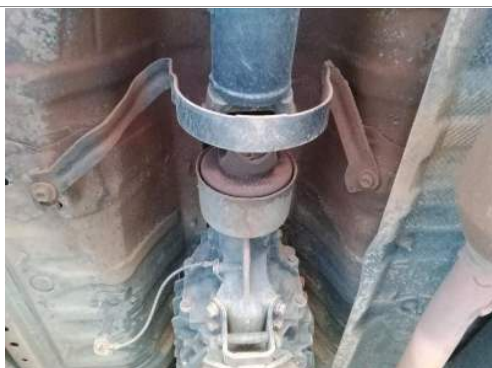
| Damage | Repair Way |
|---|---|
| Gearbox Oil Sweat | Repair |

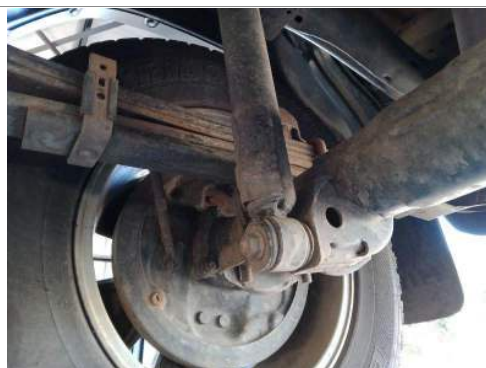
| Damage | Repair Way |
|---|---|
| Shock Absorber Mounting Rear Right Cracked | Replace |
