## CONDITION REPORT

Report No:  
2016923142  
DATE  
24/06/2025

MFC Auction House  
M57 Pretoria Rd, Glenmarais, KEMPTON PARK  
Gauteng

Vehicle Type	PASSENGER VEHICLE	Registered Owner	MFC AUCTION HOUSE
Manufacturer	TOYOTA	Registration Number	HY82LJGP
Model	COROLLA QUEST 1.6 PLUS [2016-2021]	Register Number	
VIN	AHTLB52E503140432	Date Of First Licensing	
Engine Number		Last COR	
Doors	4	License Expiry Date	31/12/2021
Color	SILVER	Power / Displacement	
Year Model	2019	Paint Finish	M - METALLIC
Km Reading	103,466 KM	Fuel	PETROL
Cab / Body Type	SEDAN	Transmission	MANUAL

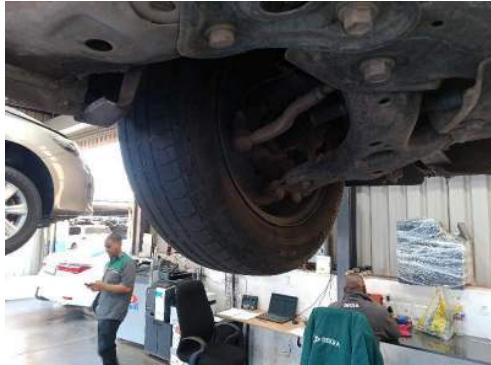
LF TYRE TREAD

Size	Load/Speed Index	Manufacture	Model	Type*	Production Date	Tread Depth (mm)
Front Left	195/65R15	91H	Continental	Contact	V	4222	1 mm
Front Right	195/65R15	91H	Continental	Contact	V	4222	1 mm
Rear Left	195/65R15	91H	Goodyear	Excellence	V	4718	2 mm
Rear Right	195/65R15	91H	Crosa 65	Radial	V	4912	3 mm
Spare	195/65R15	91H	Goodyear	Excellence	V	////	2 mm

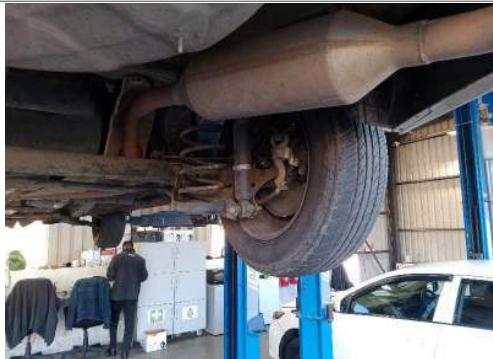
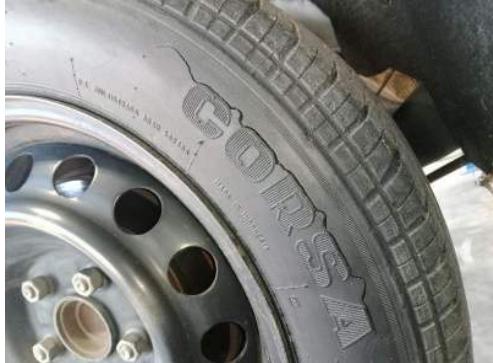
RR TYRE TREAD

Damage	Repair Way
Headlight Left Damaged	Replace
Gear Lever Dust Boot Defective	Repair
Side Mirror Left Paintwork • Scratched	Repair
Side Mirror Right Paintwork • Scratched	Repair
Front Bumper Paintwork • Scratched	Repair
Bonnet Paintwork • Chipmarks	Repair
Front Fender Left Paintwork • Scratched	Repair
Rear Fender Left Dented	Repair
Rear Fender Right Paintwork • Chipmarks	Repair
Door Front Left Dented	Repair
Door Front Right Paintwork • Scratched	Repair
Door Rear Left Paintwork • Scratched	Repair
Door Rear Right Paintwork • Scratched	Repair
Rear bumper Paintwork • Scratched	Repair
Windscreen Chipped	Repair
Tyre Rear Right Damaged	Replace
Gearbox Oil Leak	Repair
Rear hub cap missing	Replace
R/F fender liner missing	Replace
Rear tires deferred name brand	Repair
