CONDITION REPORT

Report No: 2016206319

MFC Auction House
M57 Pretoria Rd, Glenmarais, KEMPTON PARK
Gauteng

Vehicle Type	PASSENGER VEHICLE	Registered Owner	MFC
Manufacturer	TOYOTA	Registration Number	NN101-678
Model	COROLLA	Register Number	
VIN	AHTLT56E606036635	Date Of First Licensing	
Engine Number		Last COR	
Doors	4	License Expiry Date	30/06/2024
Color	SILVER	Power / Displacement	
Year Model		Paint Finish	M - METALLIC
Km Reading	88,090 KM	Fuel	PETROL
Cab / Body Type	SEDAN	Transmission	MANUAL

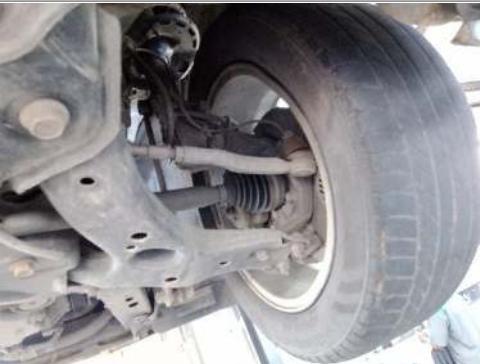
RF TYRE TREAD

Size	Load/Speed Index	Manufacture	Model	Type*	Production Date	Tread Depth (mm)
Front Left	205/55R16	91V	Continental	Contact	V	4418	5 mm
Front Right	205/55R16	91V	Continental	Contact	V	1612	0 mm
Rear Left	205/55R16	91V	Continental	Contact	V	4218	5 mm
Rear Right	205/55R16	91V	Continental	Contact	V	4218	5 mm
Spare	205/55R16	91V	Continental	Contact	V	//////////	0 mm

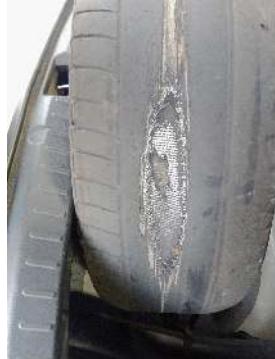
Damage	Repair Way
Park Light Front Left Defective	Repair
Seat Rear Damaged	Repair
Side Mirror Left Paintwork • Discoloured	Repair
Front Bumper Paintwork • Flaking	Repair
Windscreen Cracked	Replace
Shock Absorber Front Left Sweat	Replace
Tyre Front Right Smooth	Replace
Spare Tyre Excessive Wear & Tear	Replace
Rim Front Right Dented	Repair
CV Joint(s) Boot(s) Front Left (inner/outer) Damaged	Replace
