## CONDITION REPORT

Report No: 2016362509

MFC Auction House  
M57 Pretoria Rd, Glenmarais, KEMPTON PARK  
Gauteng

| Manufacturer | TOYOTA | Registration Number | LD48XFGP |

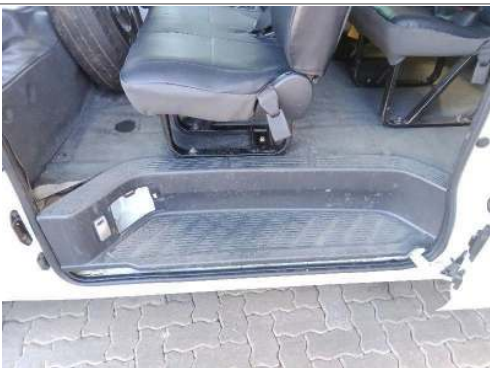
Door rear left side step

| Damage | Repair Way |
|---|---|
| Interior | Rear left door side step loose. |

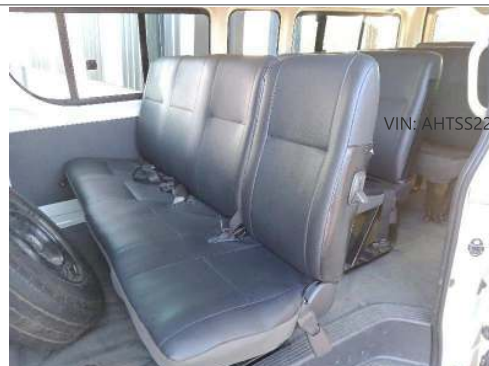
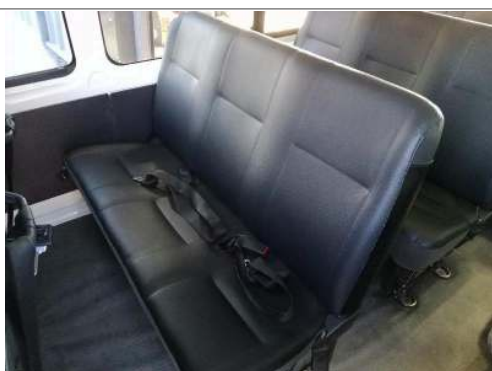
| Damage | Repair Way |
|---|---|
| Seat Rear Defective | Repair |

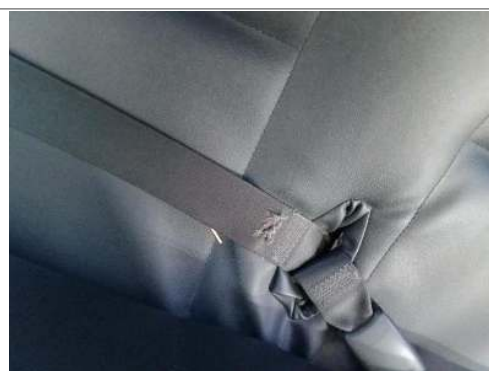
| Damage | Repair Way |
|---|---|
| Seat Belt Rear Left (2. Row) Torn / Cut | Replace |

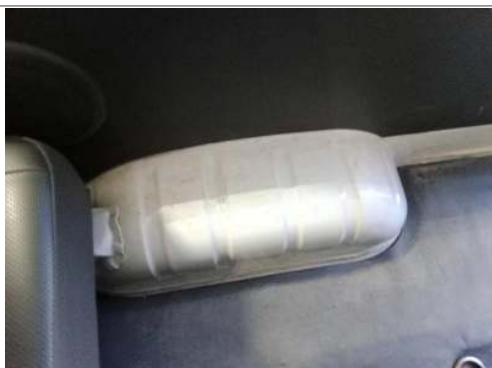
| Damage | Repair Way |
|---|---|
| Rear Fender Left / Inner Tray Residual Traces of Repair | Repair |

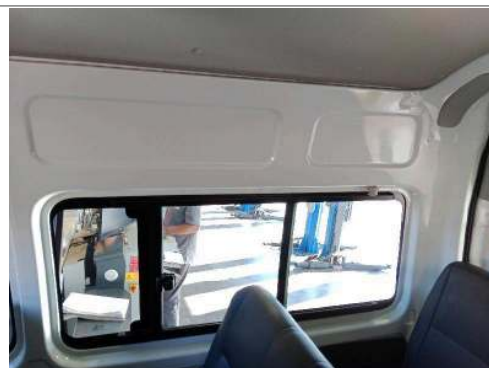
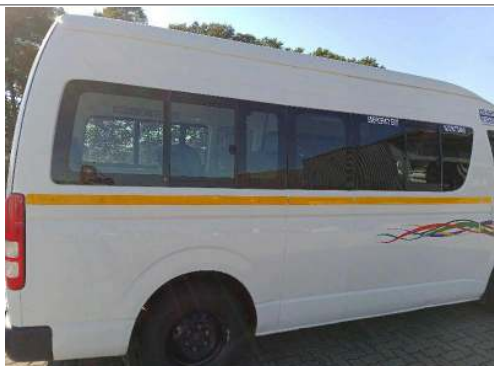
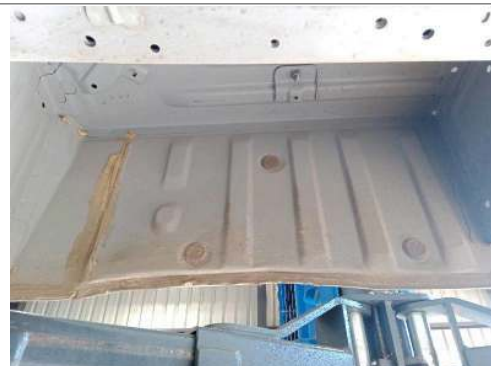
| Damage | Repair Way |
|---|---|
| Rear Fender Right Residual Traces of Repair | Repair |

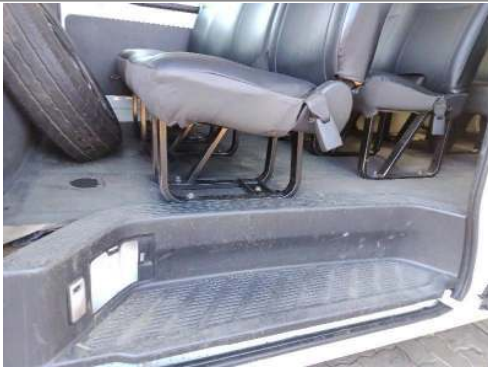
| Damage | Repair Way |
|---|---|
| Carpet Rear Defective | Repair |

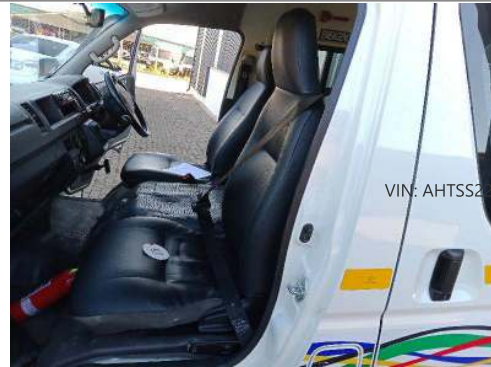
| Damage | Repair Way |
|---|---|
| Seat Front Left Torn / Cut | Repair |

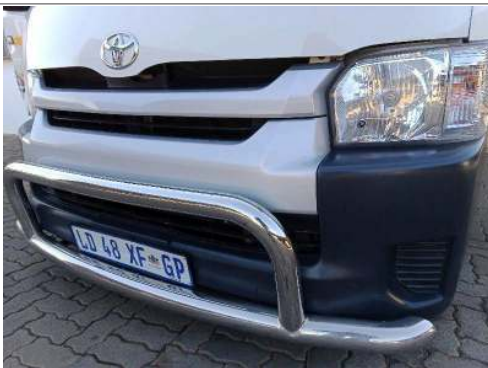
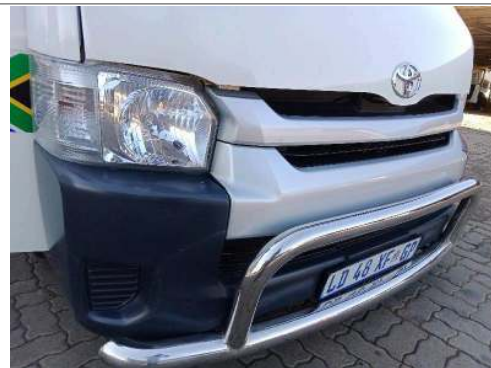
| Damage | Repair Way |
|---|---|
| Front Bumper Paintwork • Scratched | Repair |

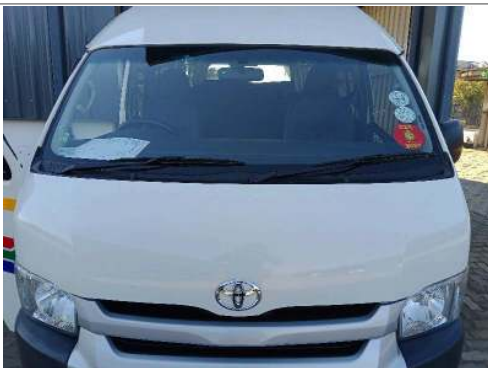
| Damage | Repair Way |
|---|---|
| Bonnet Residual Traces of Repair | Repair |

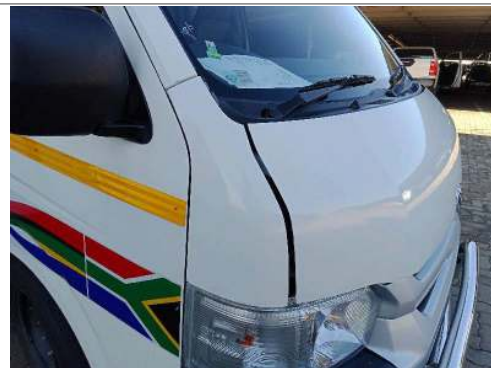
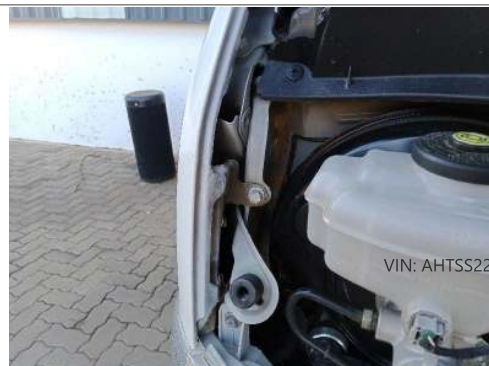
| Damage | Repair Way |
|---|---|
| Front Fender Right Residual Traces of Repair | Repair |

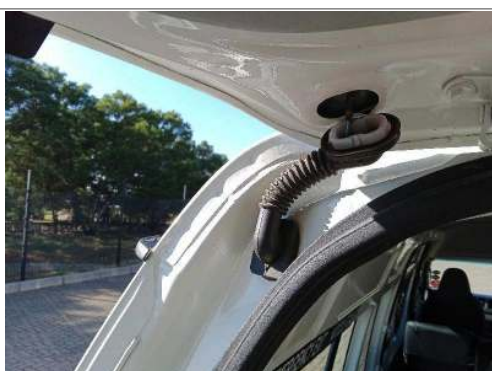
| Damage | Repair Way |
|---|---|
| C • Pillar Left Residual Traces of Repair | Repair |

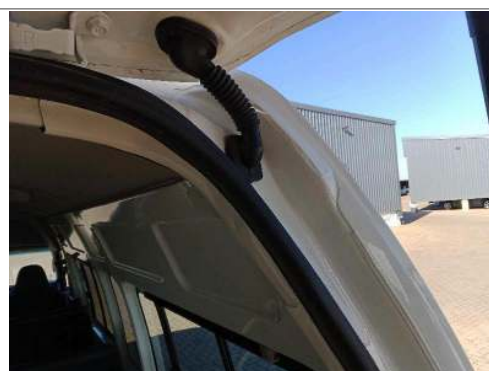
| Damage | Repair Way |
|---|---|
| C • Pillar Right Residual Traces of Repair | Repair |

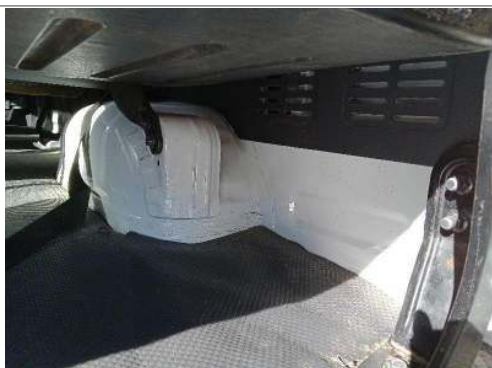
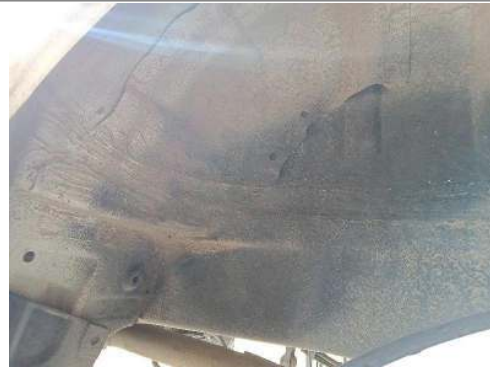
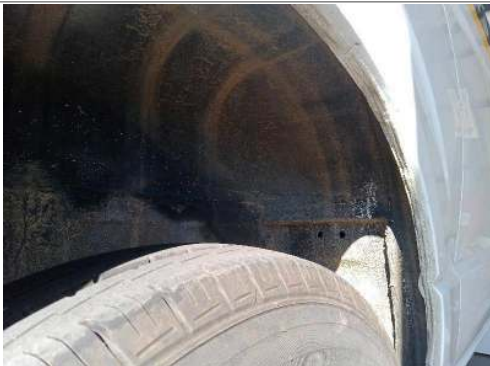
| Damage | Repair Way |
|---|---|
| Rear Fender Right / Inner Tray Residual Traces of Repair | Repair |

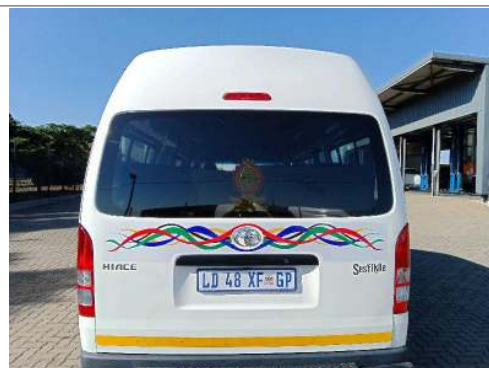
| Damage | Repair Way |
|---|---|
| Boot Lid / Hatch door Residual Traces of Repair | Repair |

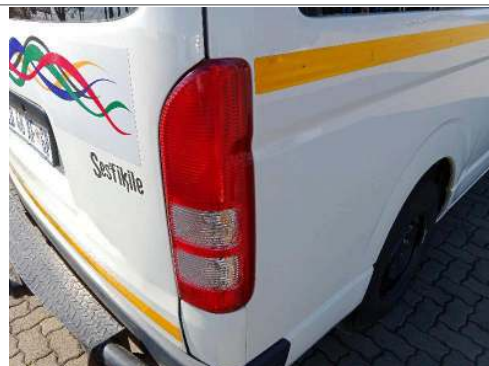
| Damage | Repair Way |
|---|---|
| Tail Light Right Defective | Repair |

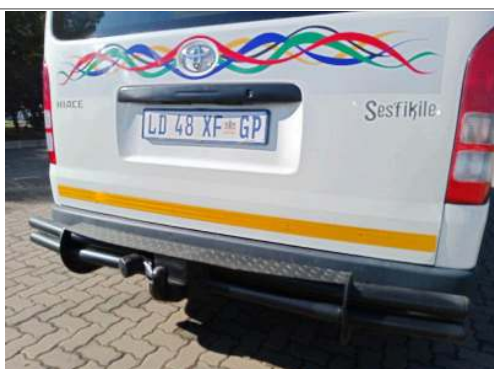
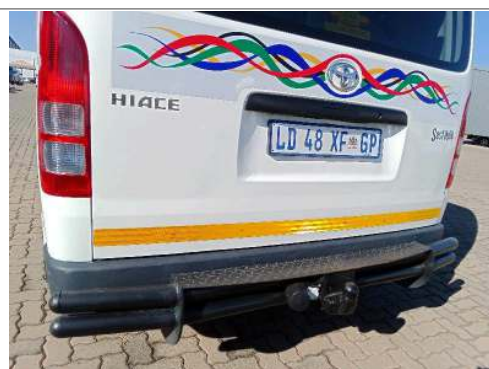
| Damage | Repair Way |
|---|---|
| Rear bumper Paintwork • Scratched | Repair |

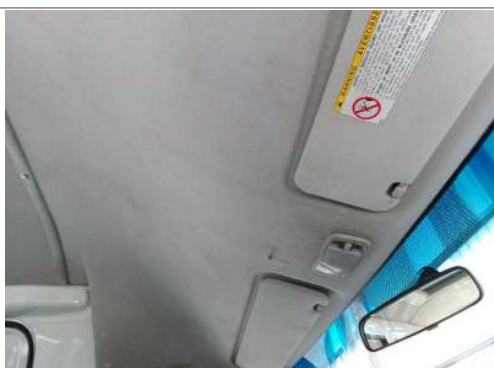
| Damage | Repair Way |
|---|---|
| Hood Lining Dirty | Repair |

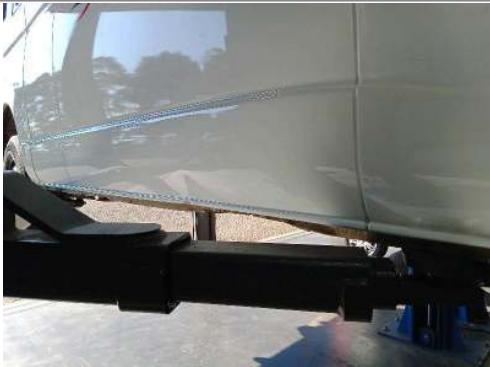
| Damage | Repair Way |
|---|---|
| Sill Panel Right Dented | Repair |

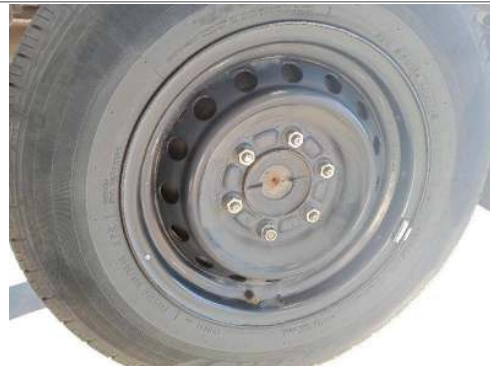
| Damage | Repair Way |
|---|---|
| Rim Rear Left Scratched | Repair |

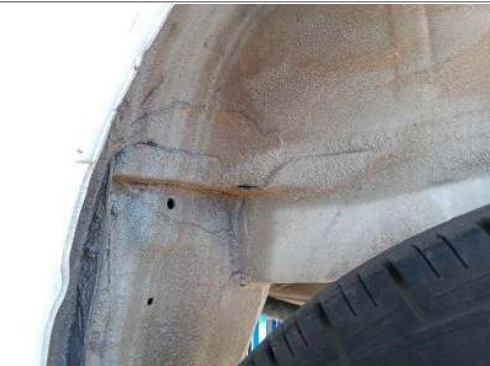
| Damage | Repair Way |
|---|---|
| Rear Fender Left Damaged | Repair |

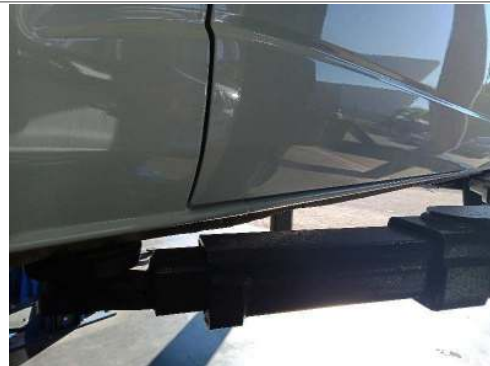
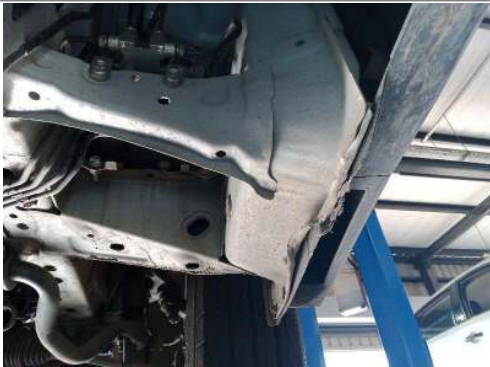
| Damage | Repair Way |
|---|---|
| Sill Panel Left Dented | Repair |

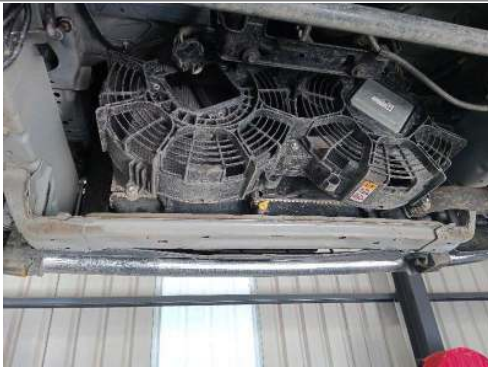
| Damage | Repair Way |
|---|---|
| Radiator Cradle Dented | Repair |

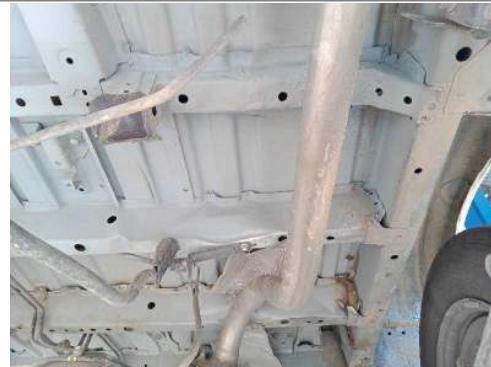
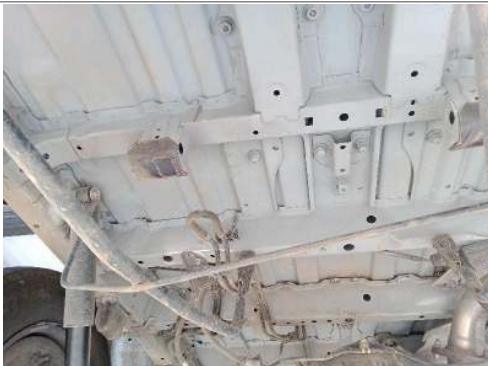
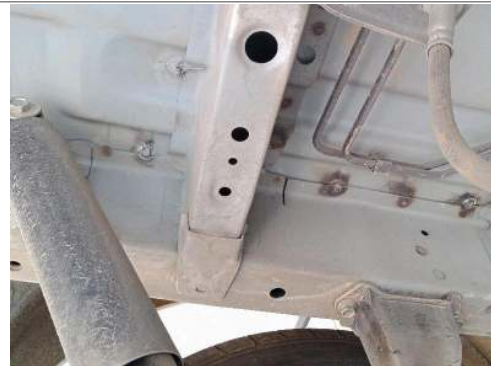
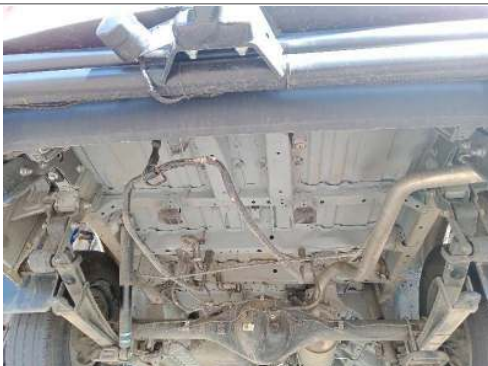
| Damage | Repair Way |
|---|---|
| Chassis Welded | Repair |

| Damage | Repair Way |
|---|---|
| Body and Exterior | Vehicle is a cut joint |

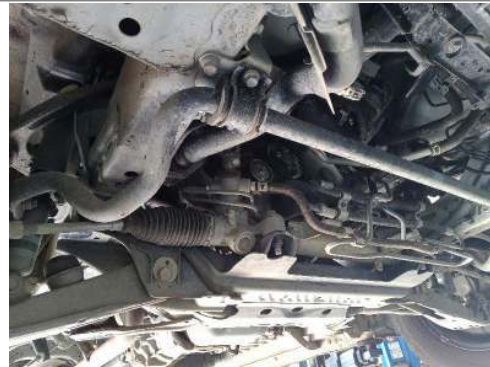
| Damage | Repair Way |
|---|---|
| Stabilizer Front Defective | Repair |

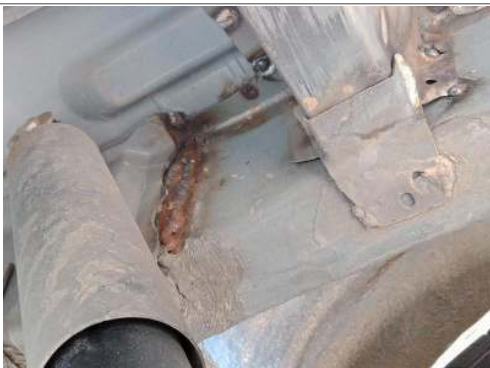
| Damage | Repair Way |
|---|---|
| Main Beam Right Welded | Repair |

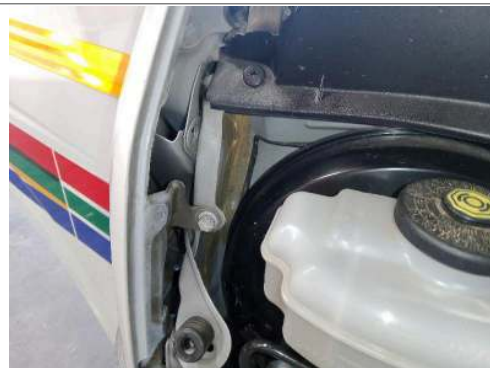
| Damage | Repair Way |
|---|---|
| Firewall Dented | Repair |
