## CONDITION REPORT

Report No: 2016390243

| Manufacturer | MAZDA | Registration Number | HWB377MP |
| VIN | JM6BL10F2C0309036 | Date Of First Licensing | |

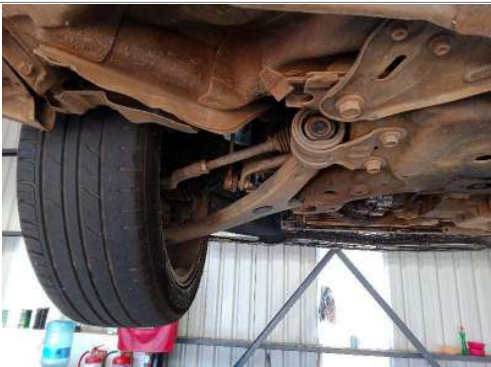
LF TYRE TREAD

| | Size | Load/Speed Index | Manufacture | Model | Type* | Production Date | Tread Depth (mm) |
|---|---|---|---|---|---|---|---|
| Front Left | 205/50R17 | 93W | Royalblack | Radial | V | 2723 | 1 mm |

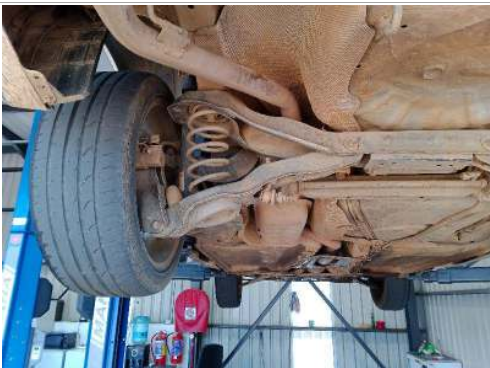
LR TYRE TREAD

| | Size | Load/Speed Index | Manufacture | Model | Type* | Production Date | Tread Depth (mm) |
|---|---|---|---|---|---|---|---|
| Rear Left | 215/40R17 | 87V | Continental | Contipremium | V | 4517 | 0 mm |

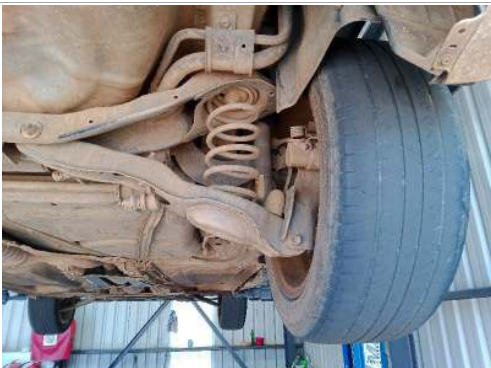
RR TYRE TREAD

| | Size | Load/Speed Index | Manufacture | Model | Type* | Production Date | Tread Depth (mm) |
|---|---|---|---|---|---|---|---|
| Rear Right | 215/50R17 | 91W | Goodride | Radial | V | 3915 | 0 mm |

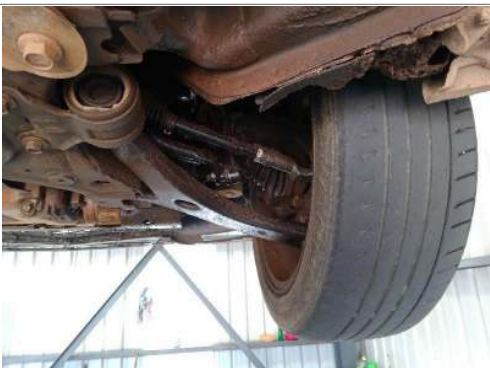
RF TYRE TREAD

| | Size | Load/Speed Index | Manufacture | Model | Type* | Production Date | Tread Depth (mm) |
|---|---|---|---|---|---|---|---|
| Front Right | 205/50R17 | 93W | Wanli | Radial | V | 0321 | 0 mm |

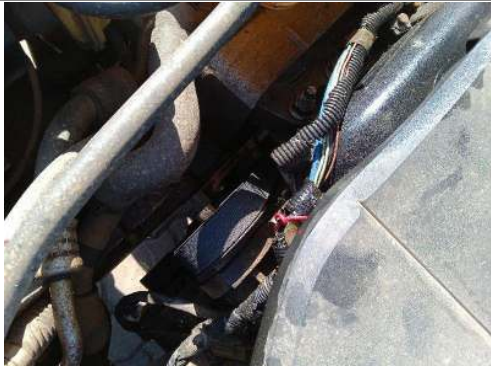
| Damage | Repair Way |
|---|---|
| Fan Belt Worn | Replace |

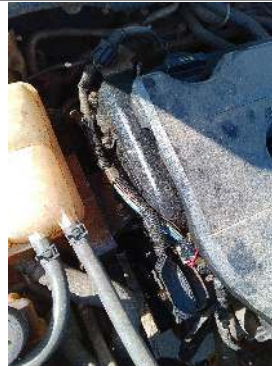
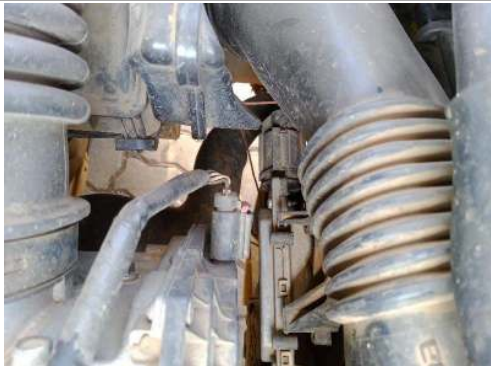
| Damage | Repair Way |
|---|---|
| Engine Wiring Damaged | Repair |

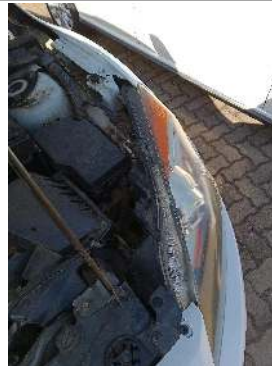
| Damage | Repair Way |
|---|---|
| Headlight Left Damaged | Replace |

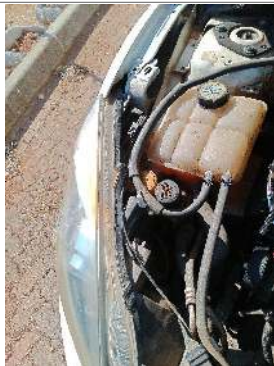
| Damage | Repair Way |
|---|---|
| Headlight Right Damaged | Replace |

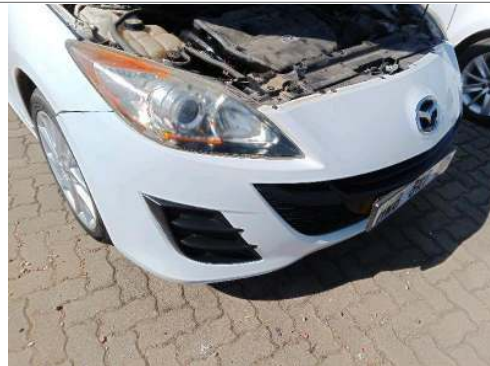
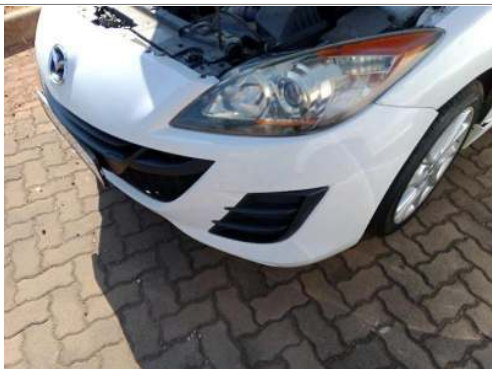
| Damage | Repair Way |
|---|---|
| Front Bumper Damaged | Repair |

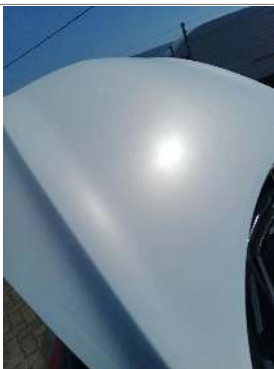
| Damage | Repair Way |
|---|---|
| Bonnet Damaged | Repair |

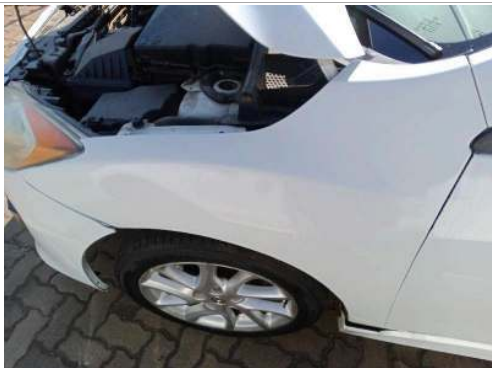
| Damage | Repair Way |
|---|---|
| Front Fender Left Damaged | Repair |

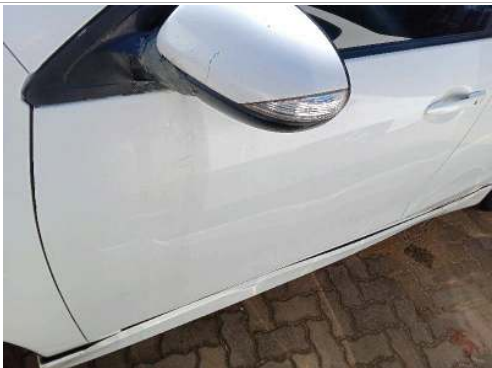
| Damage | Repair Way |
|---|---|
| Door Front Left Damaged | Repair |

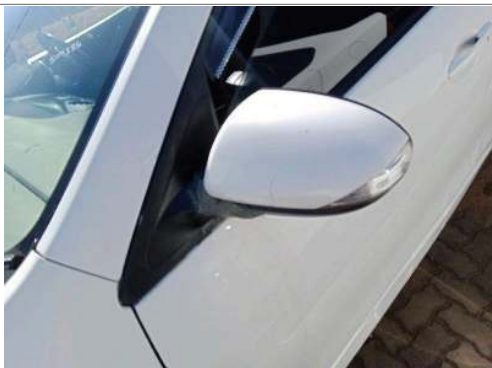
| Damage | Repair Way |
|---|---|
| Side Mirror Left Damaged | Replace |

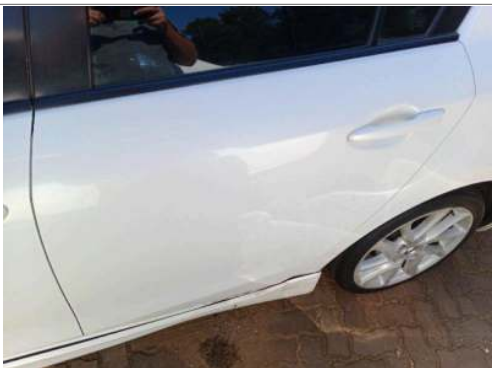
| Damage | Repair Way |
|---|---|
| Door Rear Left Damaged | Repair |

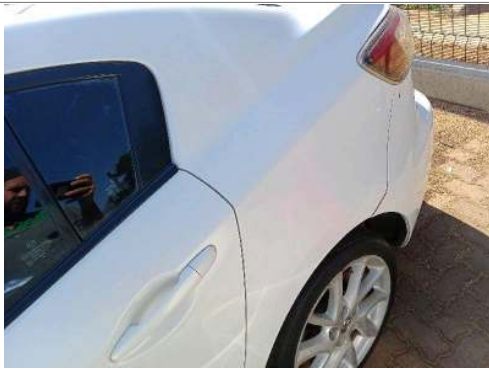
| Damage | Repair Way |
|---|---|
| Rear Fender Left Damaged | Repair |

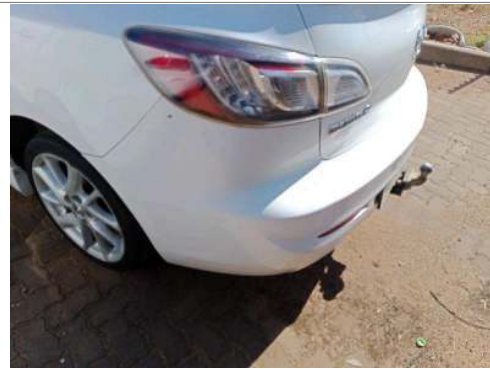
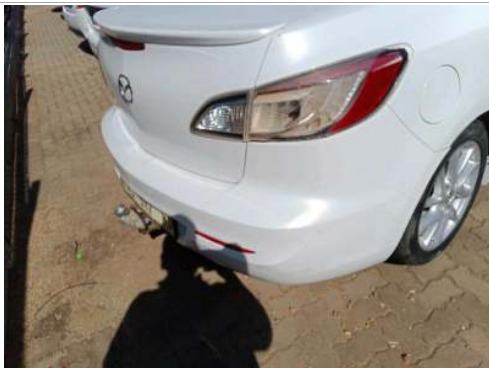
| Damage | Repair Way |
|---|---|
| Rear bumper Damaged | Repair |

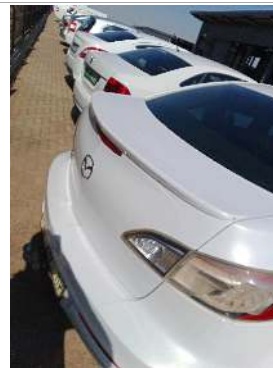
| Damage | Repair Way |
|---|---|
| Boot Lid / Hatch door Damaged | Repair |

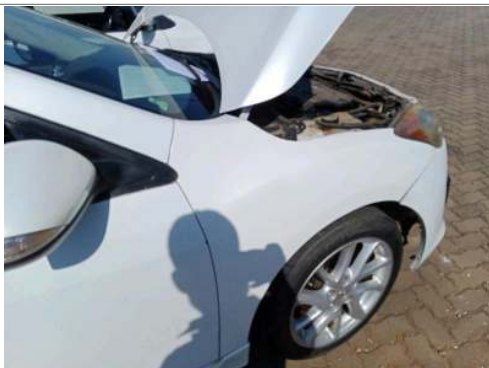
| Damage | Repair Way |
|---|---|
| Front Fender Right Damaged | Repair |

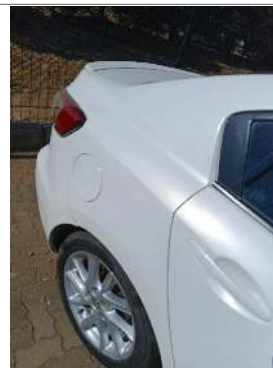
| Damage | Repair Way |
|---|---|
| Rear Fender Right Damaged | Repair |

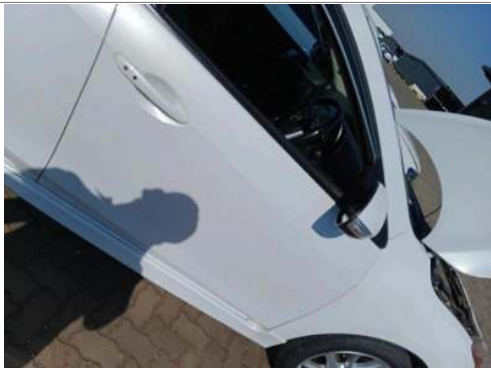
| Damage | Repair Way |
|---|---|
| Door Front Right Damaged | Repair |

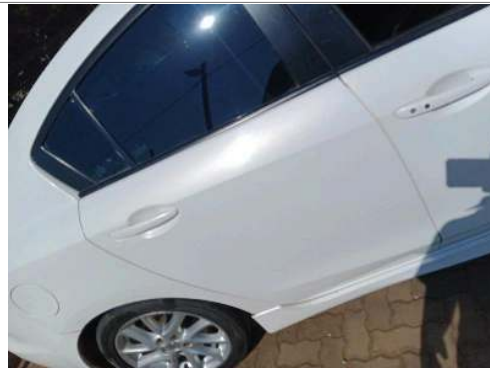
| Damage | Repair Way |
|---|---|
| Door Rear Right Damaged | Repair |

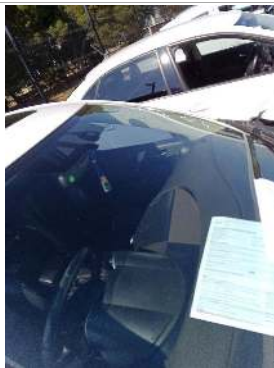
| Damage | Repair Way |
|---|---|
| Windscreen Damaged | Replace |

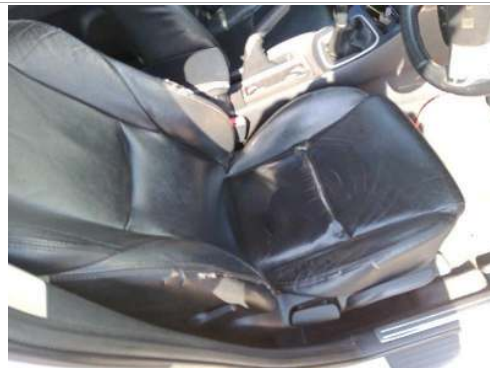
| Damage | Repair Way |
|---|---|
| Seat Front Right Damaged | Repair |

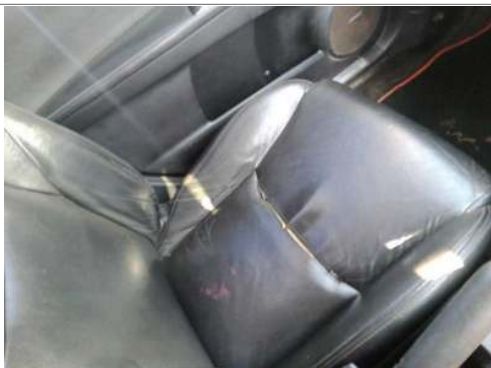
| Damage | Repair Way |
|---|---|
| Seat Front Left Damaged | Repair |

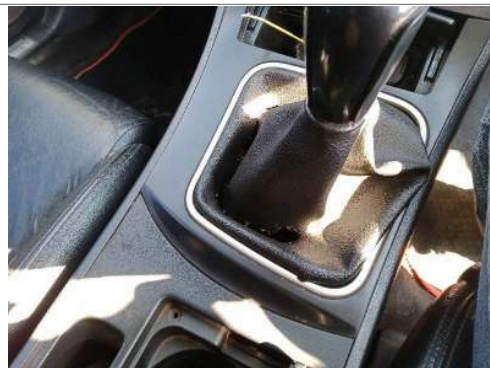
| Damage | Repair Way |
|---|---|
| Gear Lever Dust Boot Damaged | Replace |

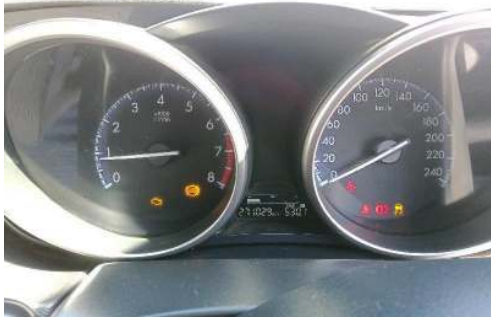
| Damage | Repair Way |
|---|---|
| Engine Management Lights Set | Repair |

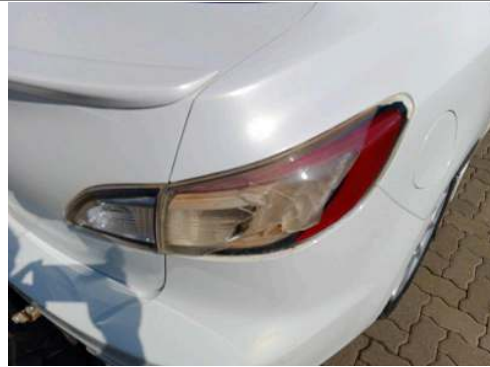
| Damage | Repair Way |
|---|---|
| Tail Light Right Damaged | Replace |

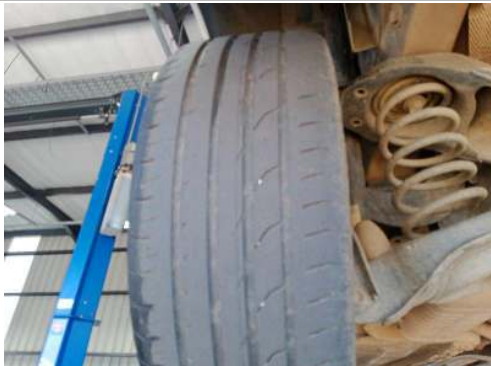
| Damage | Repair Way |
|---|---|
| Tyre Rear Left Worn | Replace |

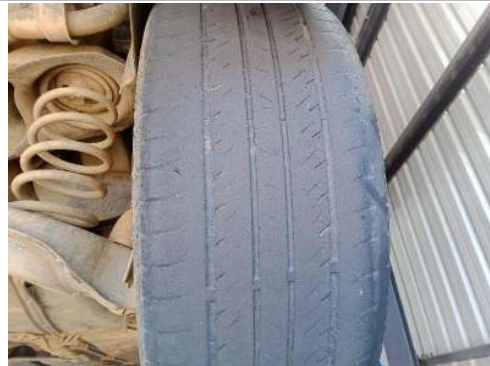
| Damage | Repair Way |
|---|---|
| Tyre Rear Right Worn | Replace |

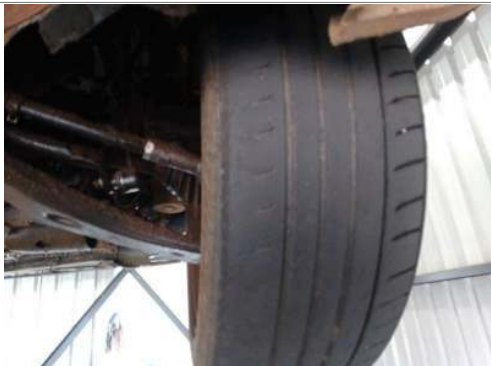
| Damage | Repair Way |
|---|---|
| Tyre Front Right Worn | Replace |

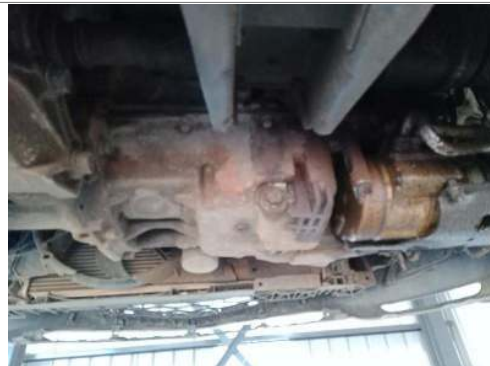
| Damage | Repair Way |
|---|---|
| Engine Oil Leak | Repair |

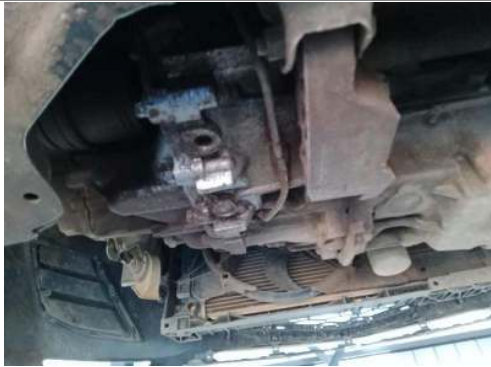
| Damage | Repair Way |
|---|---|
| Gearbox Oil Leak | Repair |

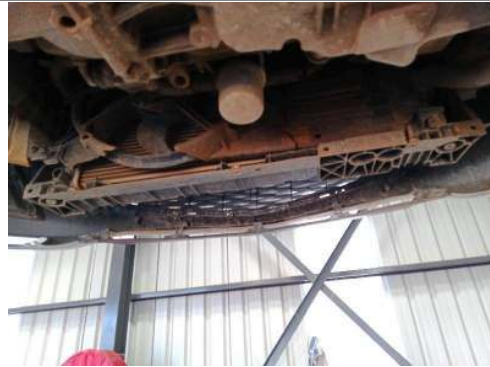
| Damage | Repair Way |
|---|---|
| Radiator Cradle Damaged | Repair |
