## CONDITION REPORT

Report No: 2016353244

| Manufacturer | MAZDA | Registration Number | JH82BKGP |
| Model | MAZDA 3 | Register Number | |

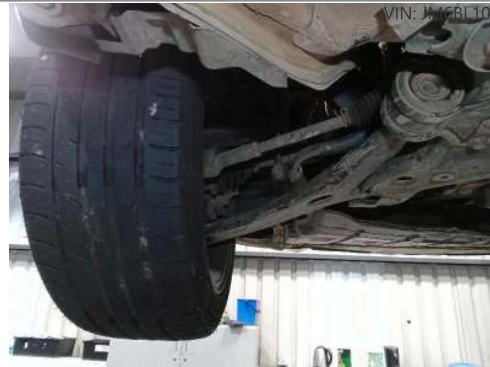
LF TYRE TREAD

| | Size | Load/Speed Index | Manufacture | Model | Type* | Production Date | Tread Depth (mm) |
|---|---|---|---|---|---|---|---|
| Front Left | 225/45 R17 | 94W | Dunlop | Sp-Sport | V | 3421 | 2 mm |

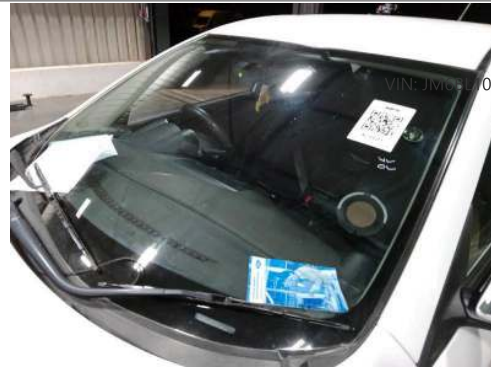
LICENSE DISC

| Damage | Repair Way |
|---|---|
| Body and Exterior | Vehicle license disk missing |

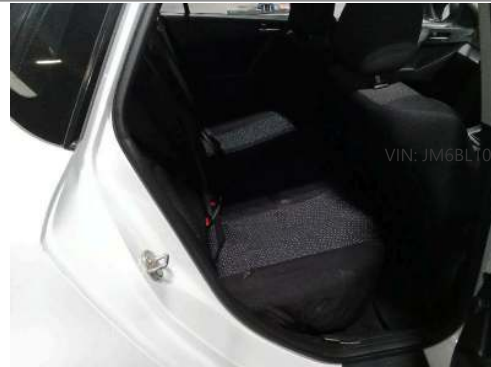
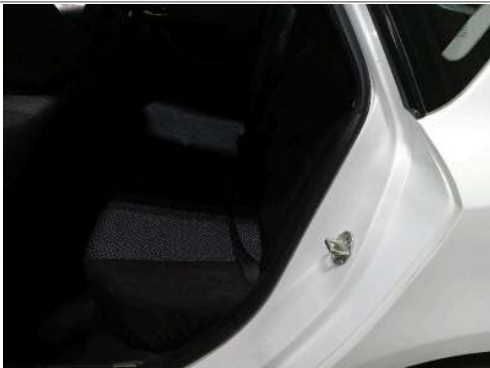
| Damage | Repair Way |
|---|---|
| Seat Rear Defective | Repair |

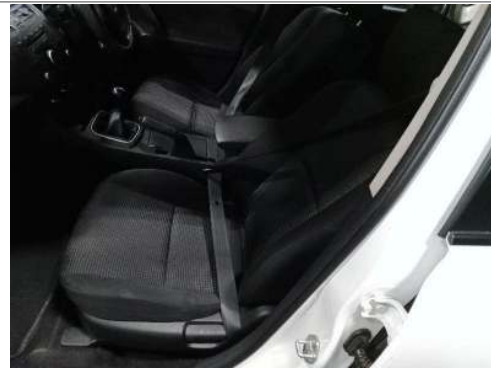
| Damage | Repair Way |
|---|---|
| Seat Front Left Dirty | Repair |

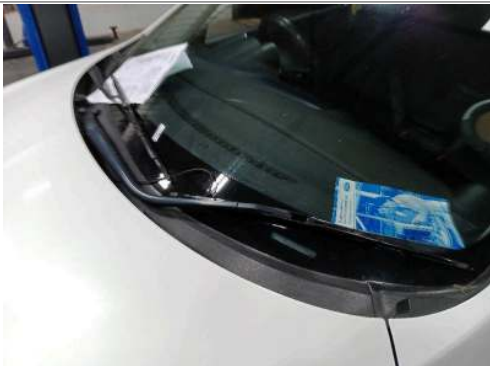
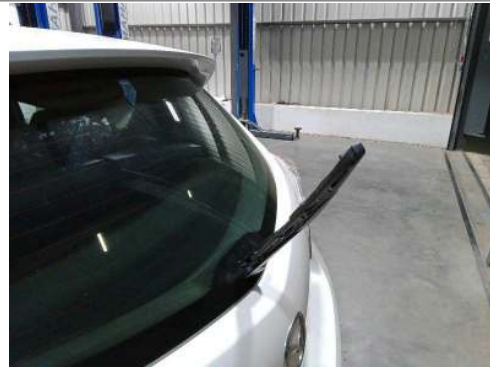
| Damage | Repair Way |
|---|---|
| Windscreen Wiper Damaged | Replace |

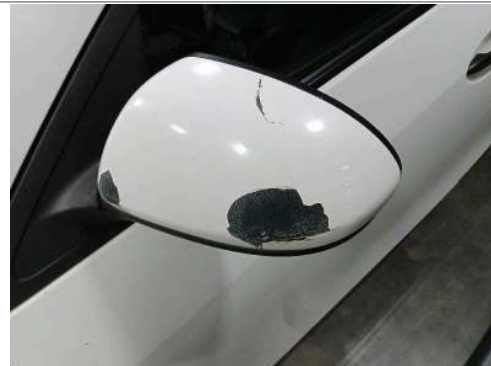
| Damage | Repair Way |
|---|---|
| Side Mirror Left Damaged | Repair |

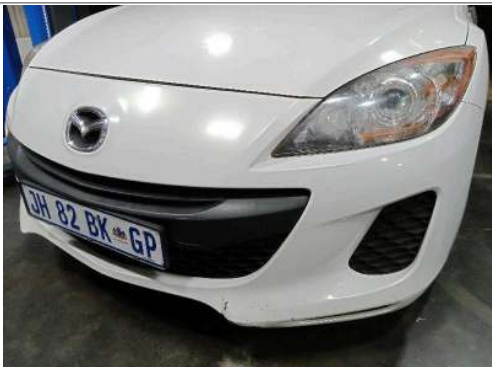
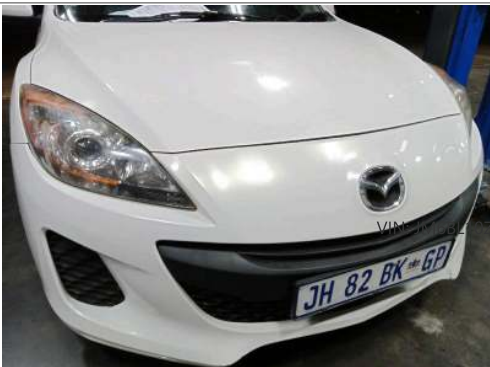
| Damage | Repair Way |
|---|---|
| Front Bumper Damaged | Repair |

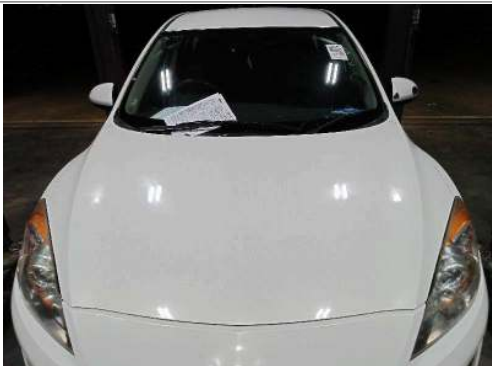
| Damage | Repair Way |
|---|---|
| Bonnet Residual Traces of Repair | Repair |

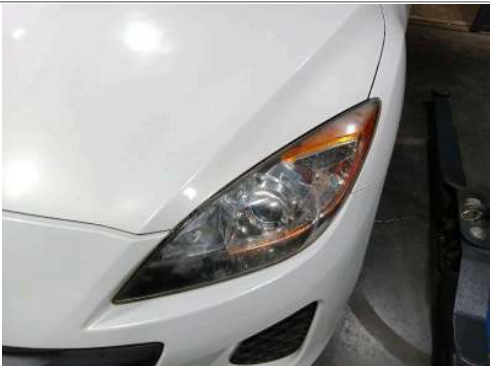
| Damage | Repair Way |
|---|---|
| Headlight Left Defective | Repair |

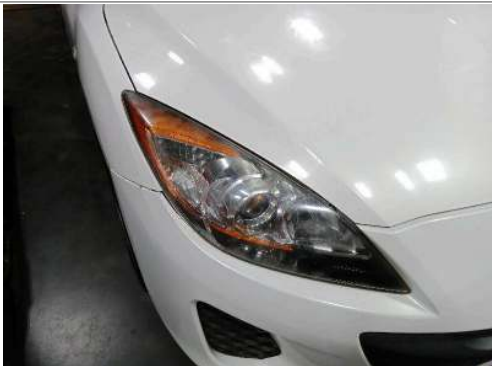
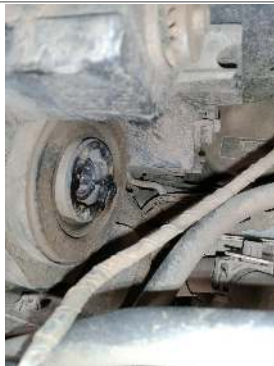
| Damage | Repair Way |
|---|---|
| Headlight Right Damaged | Repair |

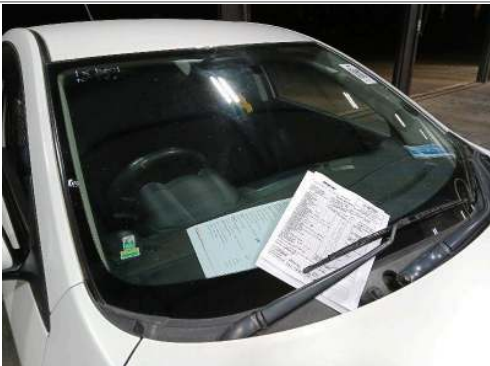
| Damage | Repair Way |
|---|---|
| Windscreen Chipped | Replace |

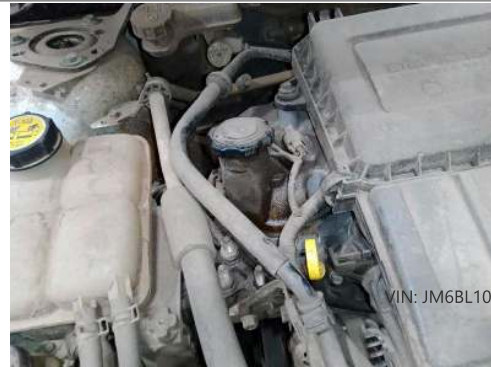
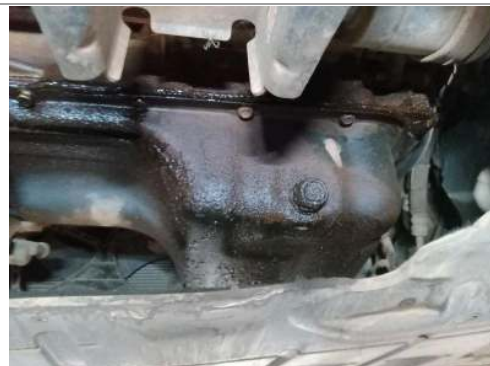
| Damage | Repair Way |
|---|---|
| Engine Oil Leak | Repair |

| Damage | Repair Way |
|---|---|
| Engine Noise Excessive | Repair |

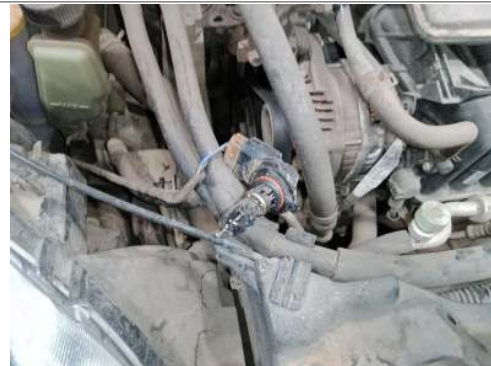
| Damage | Repair Way |
|---|---|
| Bright Light Right Damaged | Replace |

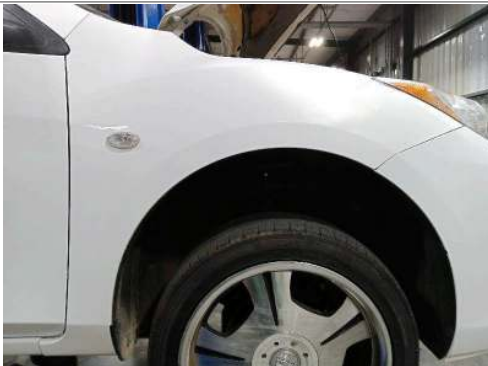
| Damage | Repair Way |
|---|---|
| Front Fender Right Dented | Repair |

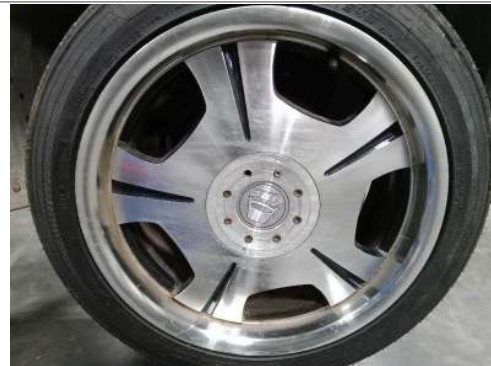
| Damage | Repair Way |
|---|---|
| Rim Front Right Scratched | Repair |

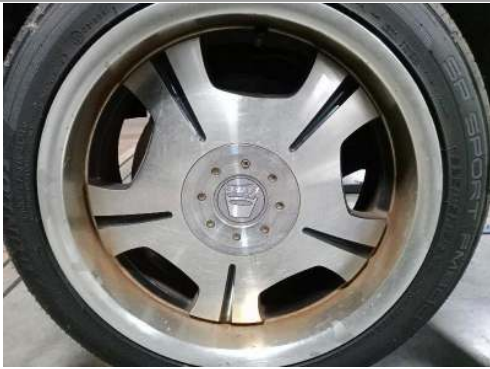
| Damage | Repair Way |
|---|---|
| Rim Rear Right Defective | Repair |

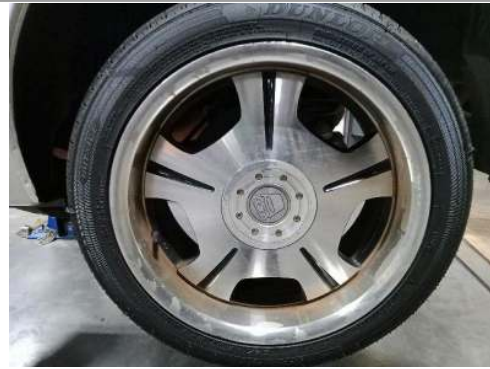
| Damage | Repair Way |
|---|---|
| Rim Rear Left Defective | Repair |

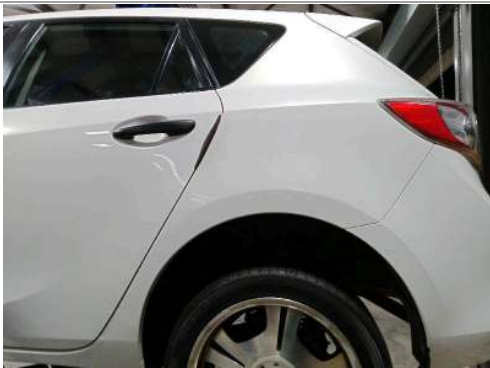
| Damage | Repair Way |
|---|---|
| Rear Fender Left Residual Traces of Repair | Repair |

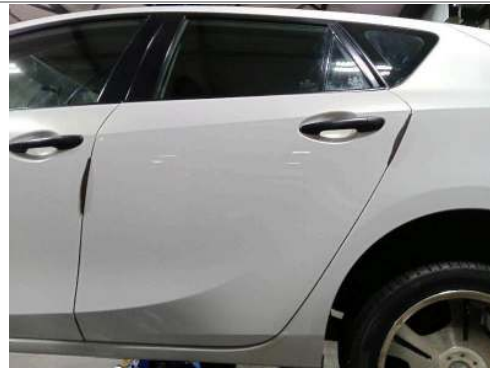
| Damage | Repair Way |
|---|---|
| Door Rear Left Residual Traces of Repair | Repair |

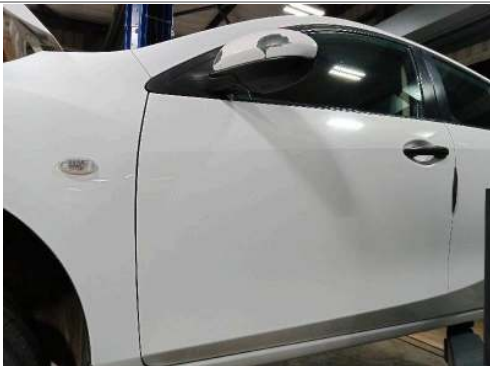
| Damage | Repair Way |
|---|---|
| Door Front Left Residual Traces of Repair | Repair |

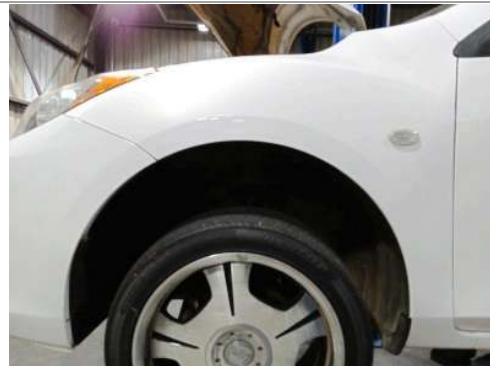
| Damage | Repair Way |
|---|---|
| Front Fender Left Paintwork • Scratched | Repair |

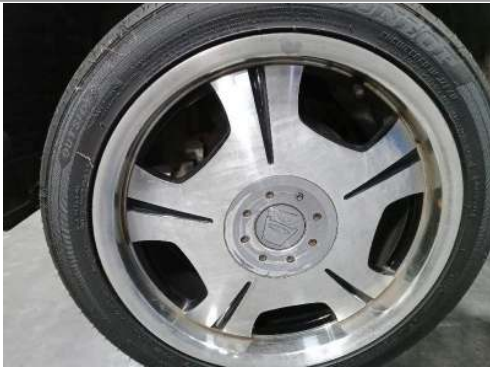
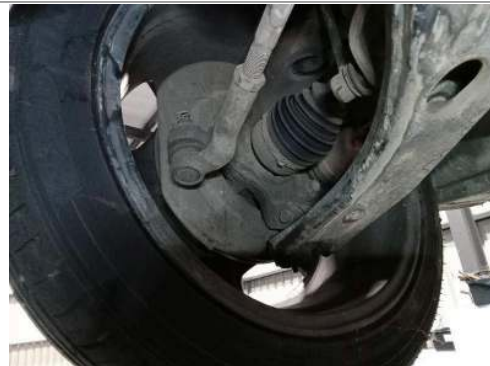
| Damage | Repair Way |
|---|---|
| Rim Front Left Dented | Repair |

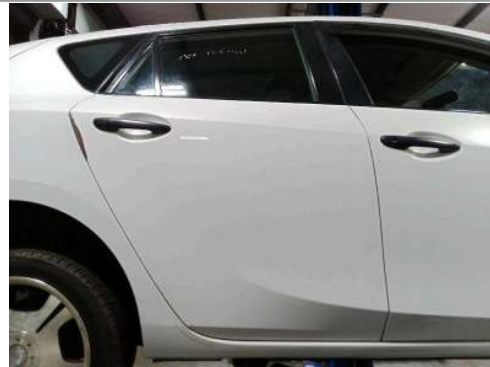
| Damage | Repair Way |
|---|---|
| Door Rear Right Paintwork • Scratched | Repair |

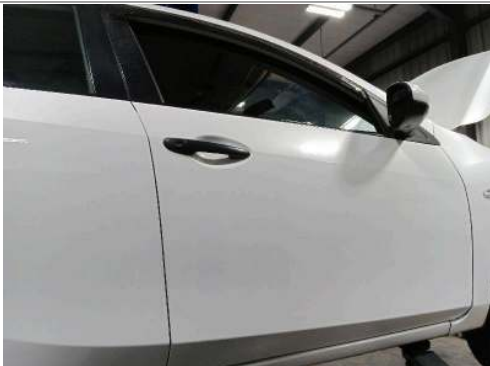
| Damage | Repair Way |
|---|---|
| Door Front Right Dented | Repair |

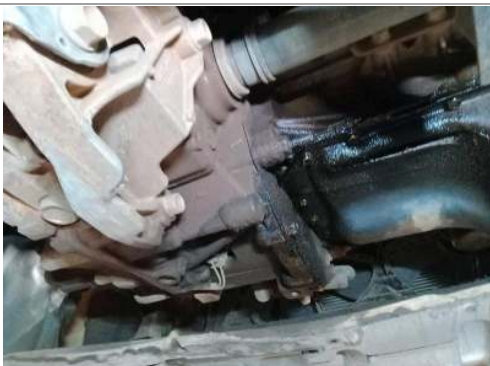
| Damage | Repair Way |
|---|---|
| Gearbox Oil Leak | Repair |

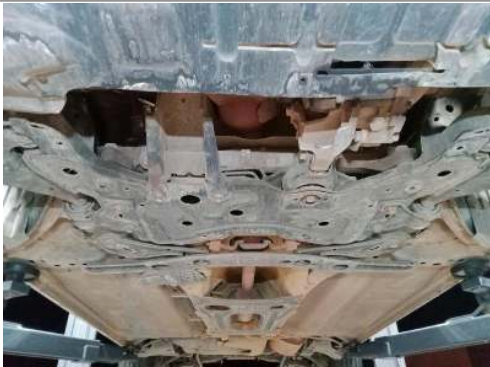
| Damage | Repair Way |
|---|---|
| Sub Frame Scratched | Repair |

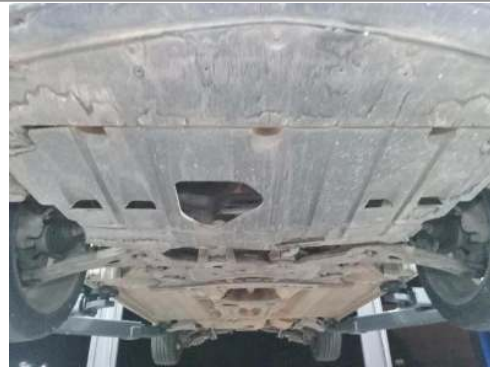
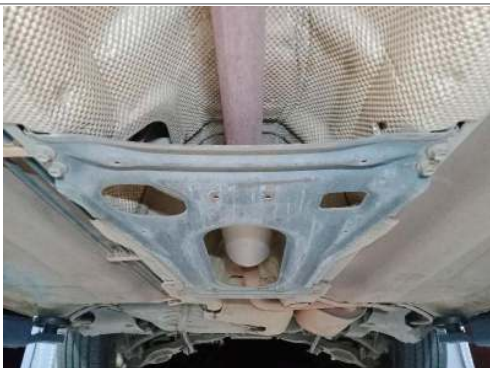
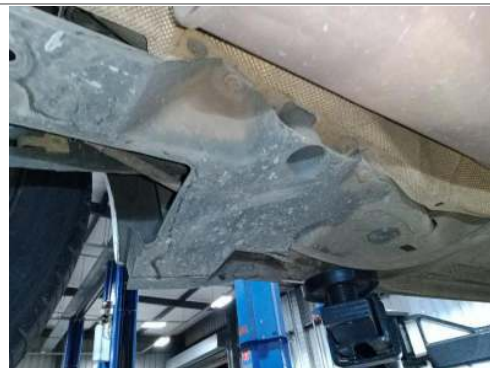
| Damage | Repair Way |
|---|---|
| Belly plates Defective | Repair |

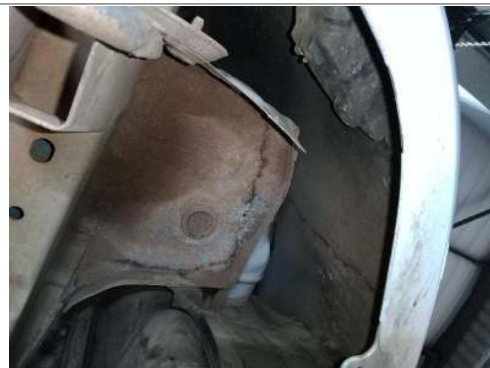
| Damage | Repair Way |
|---|---|
| Rear Fender Right / Inner Tray Dented | Repair |

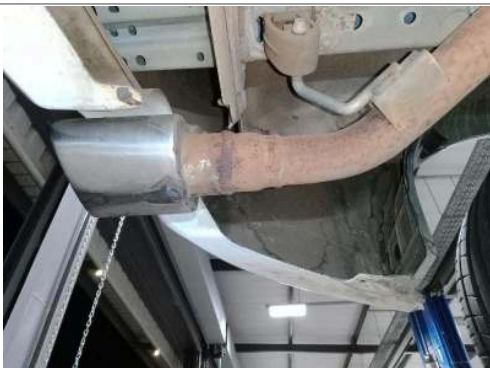
| Damage | Repair Way |
|---|---|
| Engine to silencer pipe Welded | Replace |

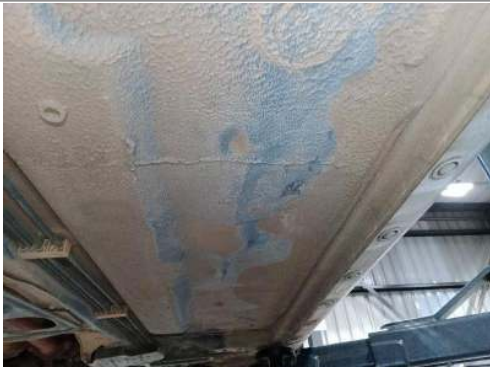
| Damage | Repair Way |
|---|---|
| Chassis Dented | Repair |

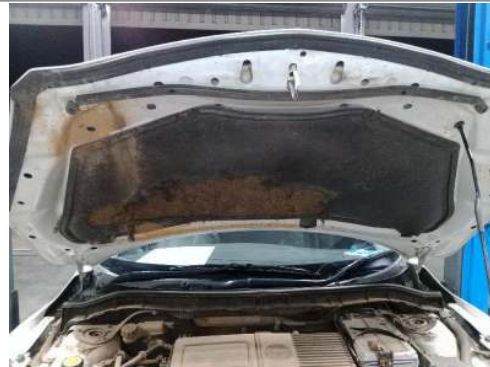
| Damage | Repair Way |
|---|---|
| Under bonnet insulation cover Damaged | Repair |

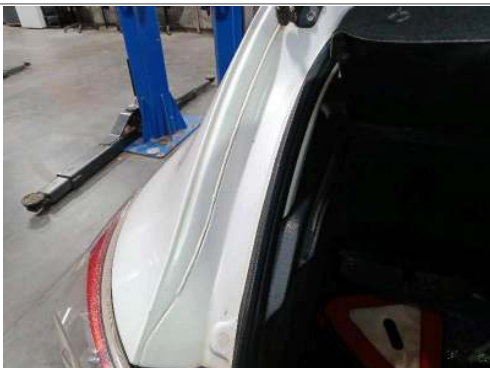
| Damage | Repair Way |
|---|---|
| C • Pillar Left Residual Traces of Repair | Repair |

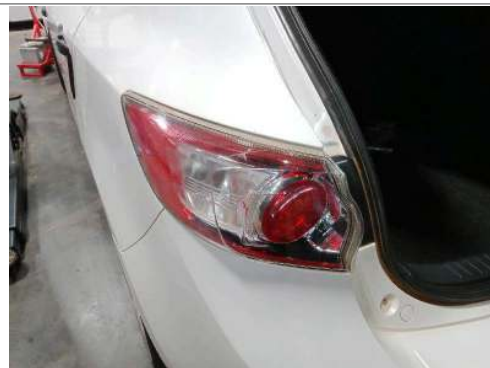
| Damage | Repair Way |
|---|---|
| Tail Light Left Cracked | Replace |

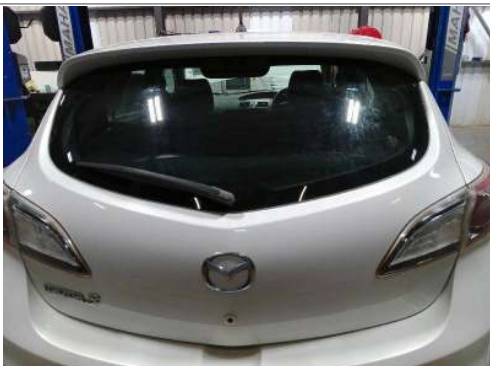
| Damage | Repair Way |
|---|---|
| Boot Lid / Hatch door Paintwork • Chipmarks | Repair |

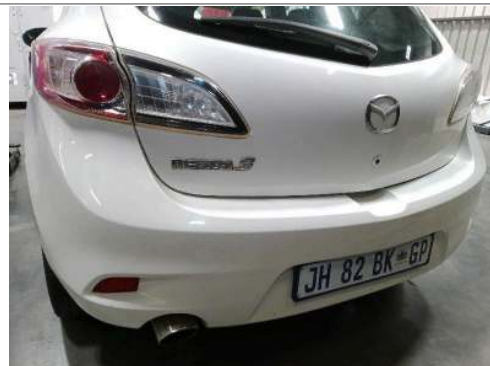
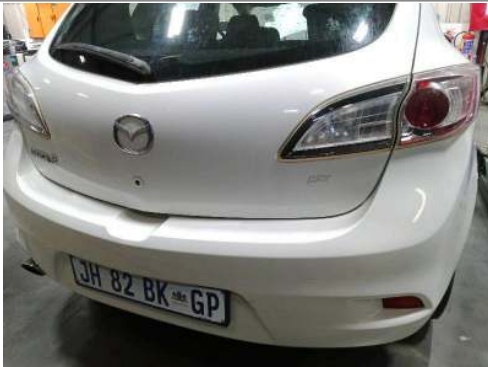
| Damage | Repair Way |
|---|---|
| Rear bumper Paintwork • Scratched | Repair |

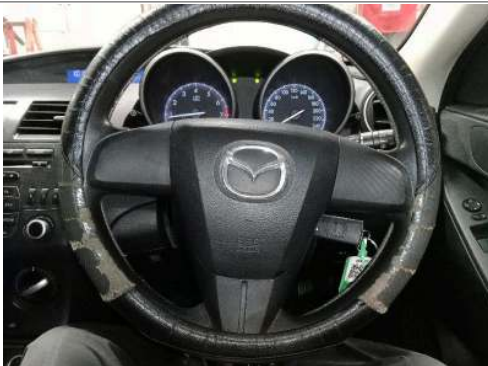
| Damage | Repair Way |
|---|---|
| Steering Wheel Trim Defective | Repair |

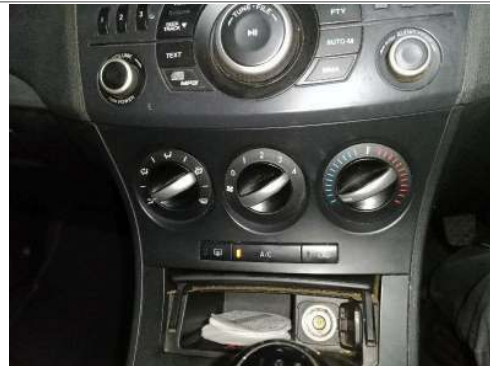
| Damage | Repair Way |
|---|---|
| Air Conditioner Insufficient | Replace |
