CONDITION REPORT

Report No:
2016899701
DATE
02/06/2025

Vehicle Type	PASSENGER VEHICLE	Registered Owner	
Manufacturer	MITSUBISHI	Registration Number	HZD020MP
Model	ASX 2.0 GLS ROCKFORD CVT [2014-2018]	Register Number	
VIN	JMYXTGA2WFZC00865	Date Of First Licensing	
Engine Number		Last COR	
Doors	5	License Expiry Date	31/01/2026
Color	WHITE	Power / Displacement	
Year Model	2016	Paint Finish	M - METALLIC
Km Reading	83,242 KM	Fuel	PETROL
Cab / Body Type	STATION WAGON	Transmission	AUTOMATIC

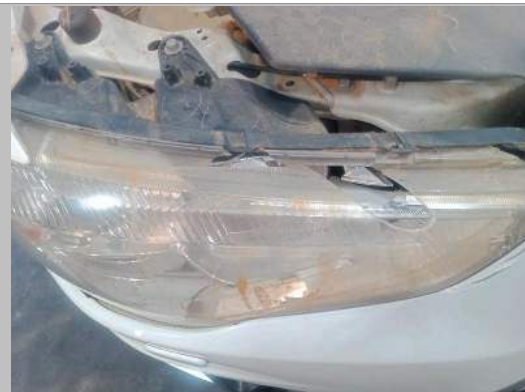
Damage	Repair Way
Headlight Right Damaged	Replace
Front Bumper Paintwork • Scratched	Repair
Bonnet Dented	Repair
Front Fender Left Paintwork • Chipmarks	Repair
Front Fender Right Paintwork • Chipmarks	Repair
Rear Fender Right Paintwork • Chipmarks	Repair
Door Front Right Paintwork • Chipmarks	Repair
Door Rear Right Paintwork • Scratched	Repair
Windscreen Cracked	Replace
Parking Brake Performance Left / Right Difference out of legal range	Repair
Tie Rod End right Damaged	Replace
