MFC Auction House
M57 Pretoria Rd, Glenmarais, KEMPTON PARK
Gauteng

Vehicle Type	PASSENGER VEHICLE	Registered Owner	MFC AUCTION HOUSE
Manufacturer	TOYOTA	Registration Number	LL31HMGP
Model	RUMION	Register Number	
VIN	JTDDND22S00614480	Date Of First Licensing	
Engine Number		Last COR	
Doors	5	License Expiry Date	31/10/2024
Color	WHITE	Power / Displacement	
Year Model		Paint Finish	M - METALLIC
Km Reading	23,932 KM	Fuel	PETROL
Cab / Body Type	STATION WAGON	Transmission	MANUAL

CONDITION REPORT

Report No: 2016312281

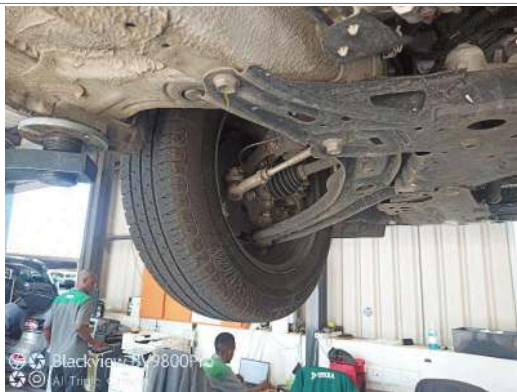
LF TYRE TREAD

Size	Load/Speed Index	Manufacture	Model	Type*	Production Date	Tread Depth (mm)
Front Left	185/65R15	88H	Bridgestone	Ecopia	V	1023	4 mm
Front Right	185/65R15	88H	Bridgestone	Ecopia	V	0923	4 mm
Rear Left	185/65R15	88H	Bridgestone	Ecopia	V	1023	4 mm
Rear Right	185/65R15	88H	Bridgestone	Ecopia	V	0923	4 mm
Spare	185/65R15	88H	Bridgestone	Ecopia	V	0000	5 mm

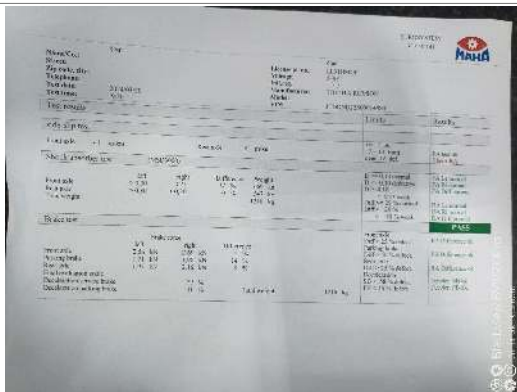
SHOCK & BRAKE REPORT

Left	Right	Axle Weight [KG]	Deceleration [m/s ²]
	Braking Force [KN]	Braking Force [KN]		
Front	2.5	2.6	-	
Rear	1.9	2.1	-	
Emergency / Parking	1.7	1.9	-

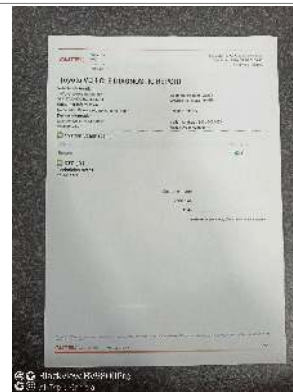
DIAGNOSTIC REPORT

During the diagnostic no active error messages were detected. (See also attached Diagnostic Report. For more information regarding the Fault Codes (DTC) and the recommended rectifications please contact the workshops of the vehicle manufacture).

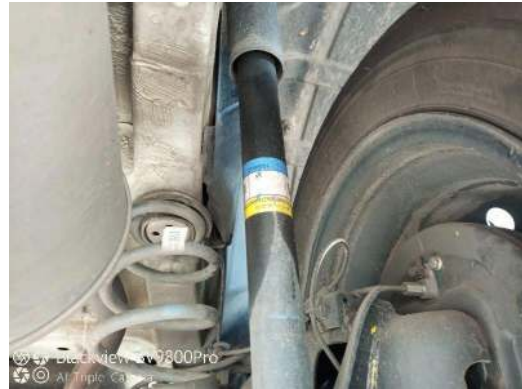
Damage	Repair Way
Shock Absorber Rear Right Leak	Replace
