CONDITION REPORT

Report No: 2016256558

DATE
06/02/2024

| Manufacturer | CHEVROLET | Registration Number | JXB681MP |

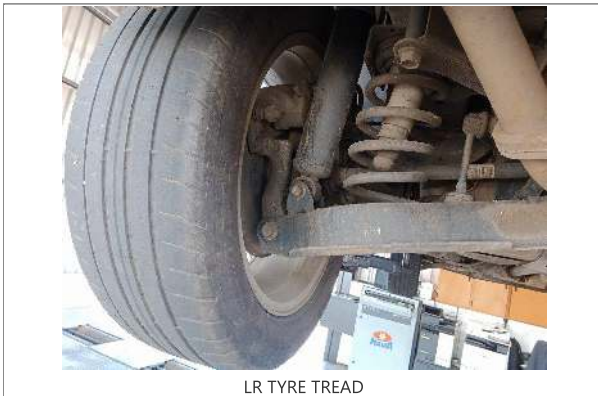
LR TYRE TREAD

| | Size | Load/Speed Index | Manufacture | Model | Type* | Production Date | Tread Depth (mm) |
|---|---|---|---|---|---|---|---|
| Rear Left | 235/50R19 | 99V | Goodyear | Eagle | V | 0421 | 1 mm |

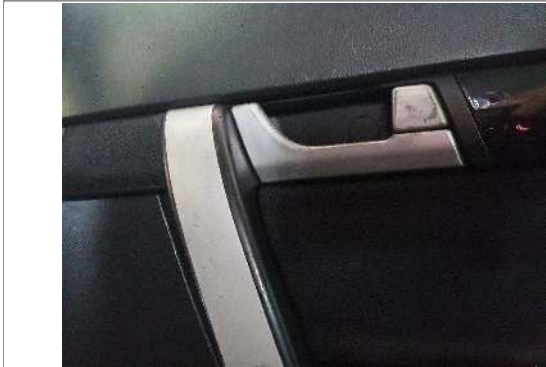
| Damage | Repair Way |
|--|---|
| Door Handle Rear Right Damaged | Replace |

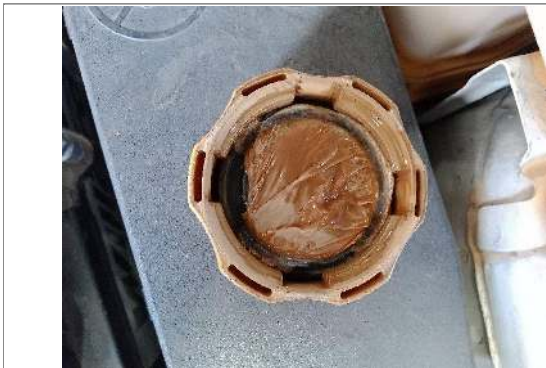
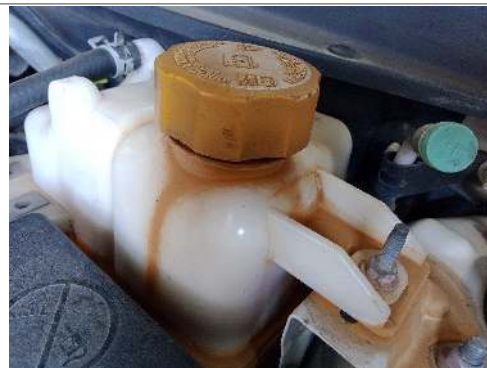
| Damage | Repair Way |
|--|---|
| Caps Defective | Replace |

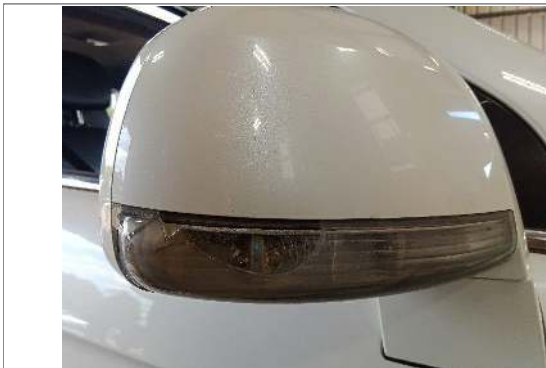
| Damage | Repair Way |
|--|---|
| Indicator Light Front Right Broken | Replace |

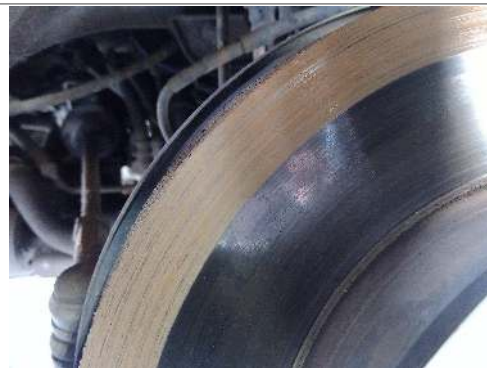
| Damage | Repair Way |
|--|---|
| Brake disc 1. Axle right Excessive Wear & Tear | Replace |

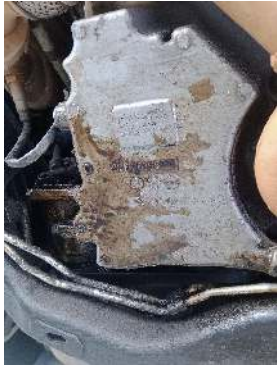
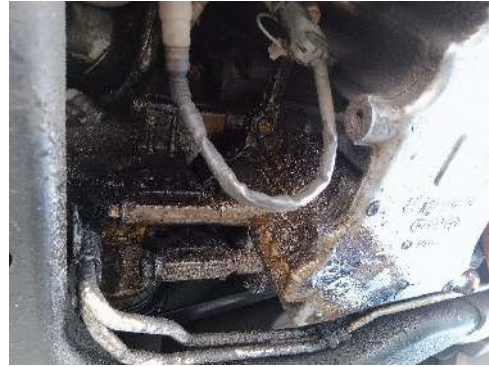
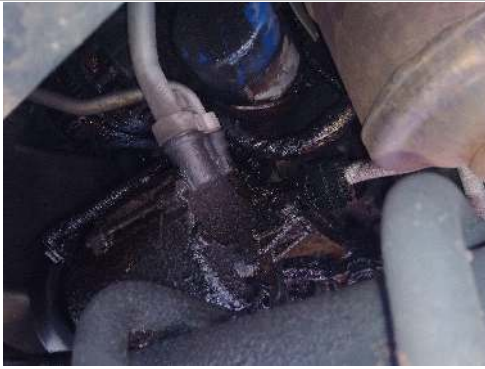
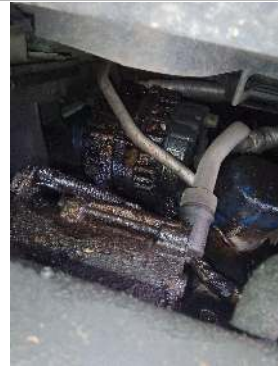
| Damage | Repair Way |
|--|---|
| Engine Oil Leak | Repair |

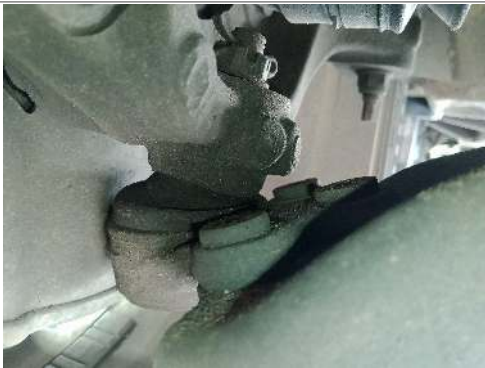
| Damage | Repair Way |
|--|---|
| Ball Joint(s) Front Axle Right Cracked | Replace |

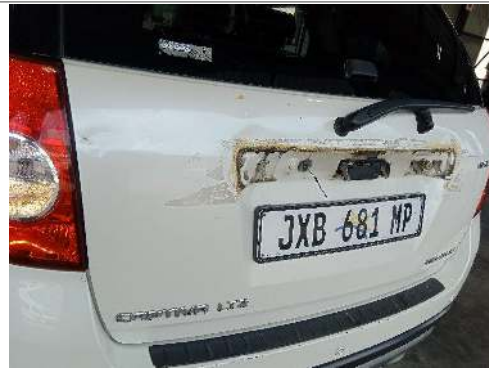
| Damage | Repair Way |
|--|---|
| Boot Lid / Hatch door Dented | Repair |
