MFC Auction House  
M57 Pretoria Rd, Glenmarais, KEMPTON PARK  
Gauteng

DEKRA MFC  
M57 Pretoria Rd - 1619  
KEMPTON PARK - GT  
08610 33572

| Manufacturer | HYUNDAI | Registration Number | CP67KKGP |
| Model | H-100 BAKKIE 2.6 DECK DSL PU [2011-2020] | Register Number | |

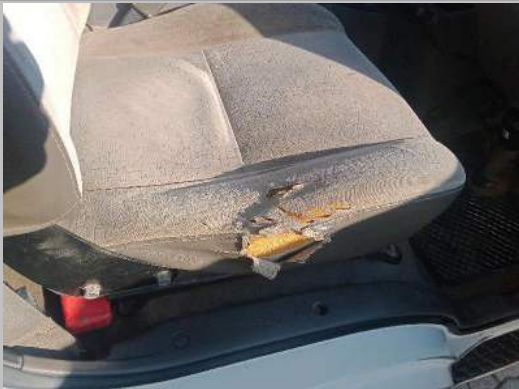
| Damage | Repair Way |
|---|---|
| Seat Front Right Torn / Cut | Repair |

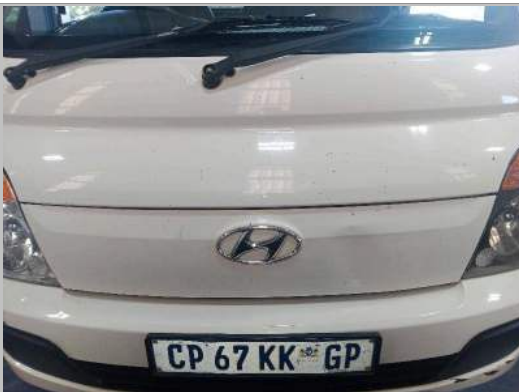
| Damage | Repair Way |
|---|---|
| Bonnet Dented | Repair |

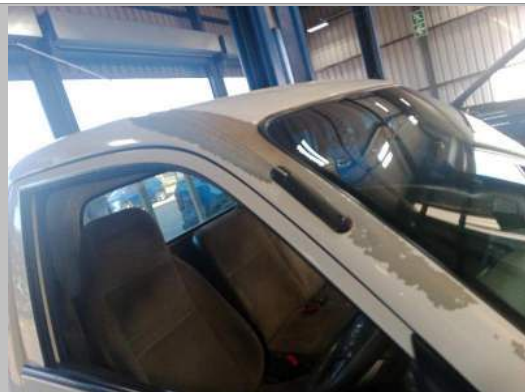
| Damage | Repair Way |
|---|---|
| A • Pillar Right Paintwork • Flaking | Repair |

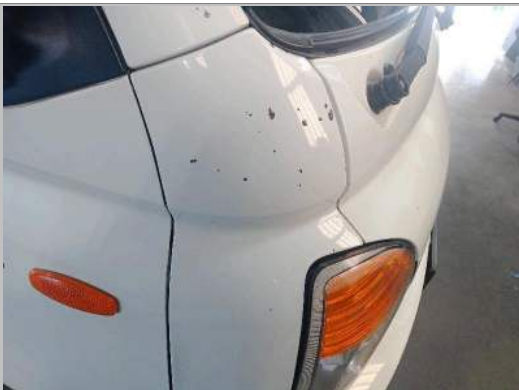
| Damage | Repair Way |
|---|---|
| Front Fender Right Paintwork • Chipmarks | Repair |

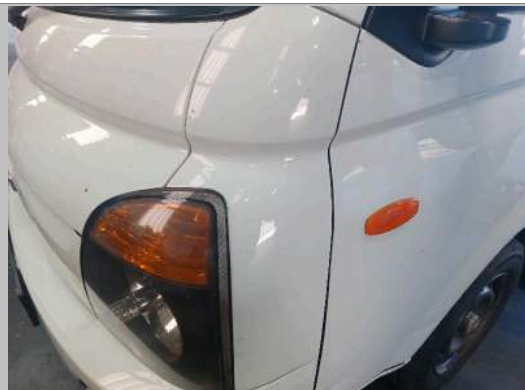
| Damage | Repair Way |
|---|---|
| Front Fender Left Paintwork • Scratched | Repair |

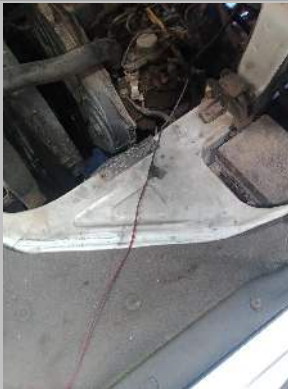
| Damage | Repair Way |
|---|---|
| Engine Wiring Defective | Repair |

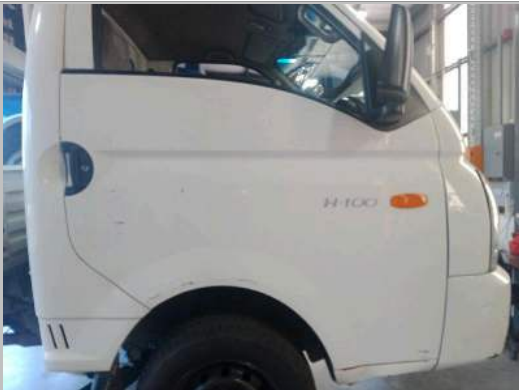
| Damage | Repair Way |
|---|---|
| Door Front Right Paintwork • Scratched | Repair |

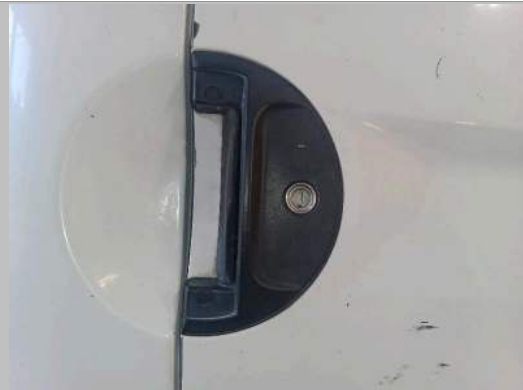
| Damage | Repair Way |
|---|---|
| Door Handle Front Right Damaged | Replace |

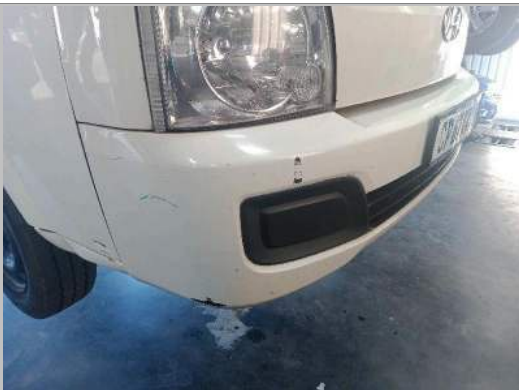
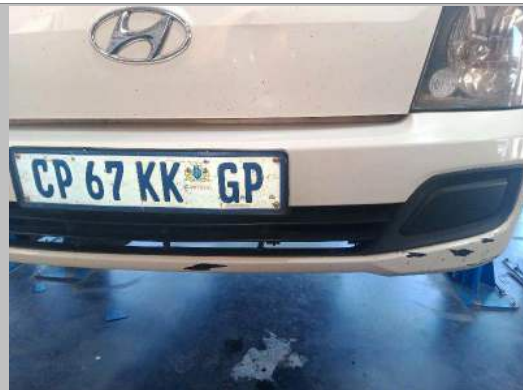
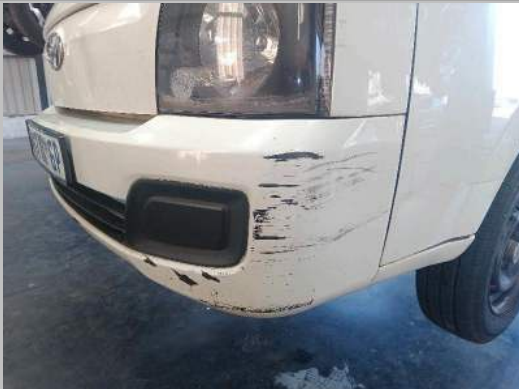
| Damage | Repair Way |
|---|---|
| Front Bumper Paintwork • Scratched | Repair |

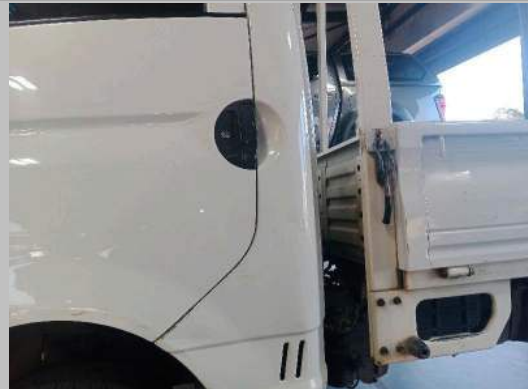
| Damage | Repair Way |
|---|---|
| B • Pillar Left Dented | Repair |

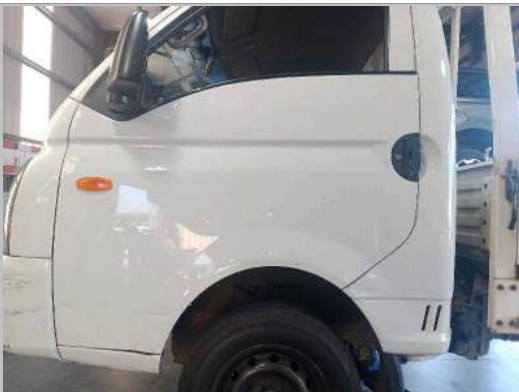
| Damage | Repair Way |
|---|---|
| Door Front Left Paintwork • Scratched | Repair |

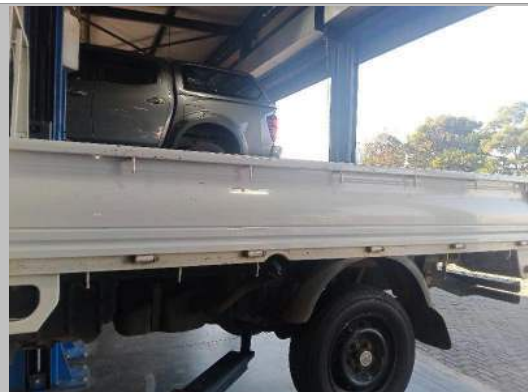
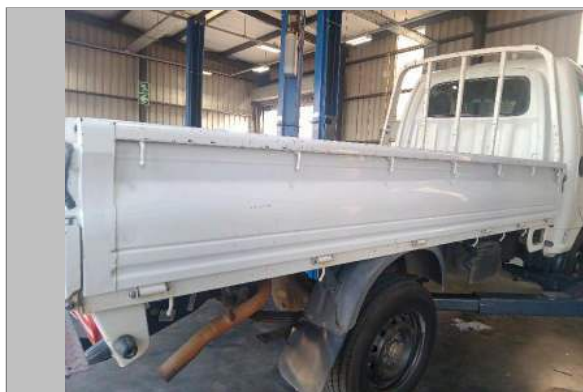
| Damage | Repair Way |
|---|---|
| Load Body Paintwork • Scratched | Repair |

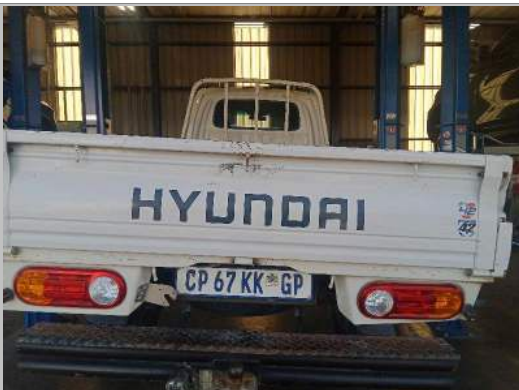
| Damage | Repair Way |
|---|---|
| Tailgate Paintwork • Scratched | Repair |

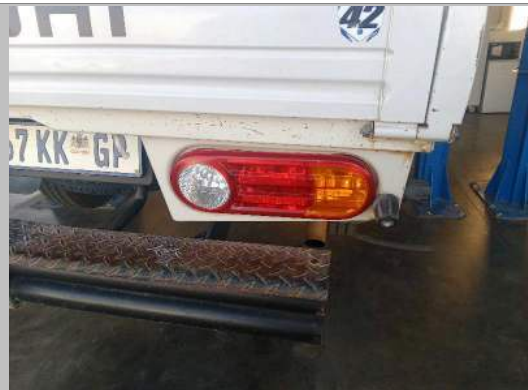
| Damage | Repair Way |
|---|---|
| Rear Lower Valance Dented | Repair |
