MFC Auction House  
M57 Pretoria Rd, Glenmarais, KEMPTON PARK  
Gauteng

| Manufacturer | HYUNDAI | Registration Number | HK72YPGP |

## CONDITION REPORT

Report No: 2016660424

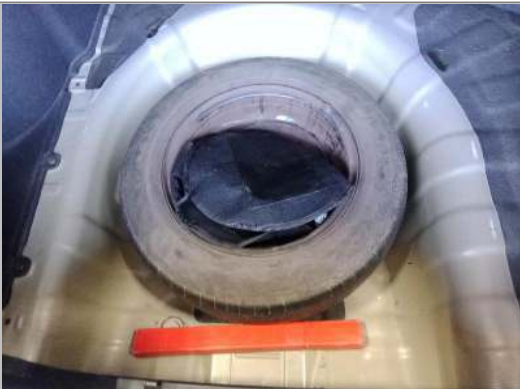
Sparewheel

| | Size | Load/Speed Index | Manufacture | Model | Type* | Production Date | Tread Depth (mm) |
|---|---|---|---|---|---|---|---|
| Spare | 175/70R14 | 84T | Kumho | Solus | V | 0000 | 1 mm |

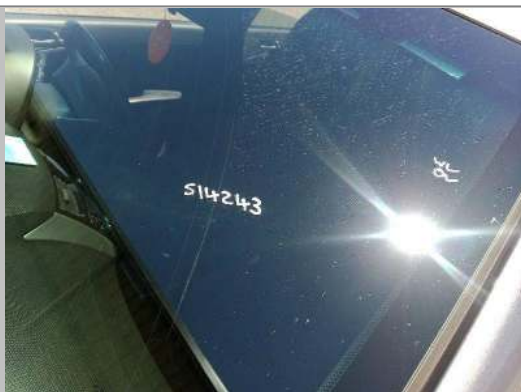
LICENSE DISC MISSING

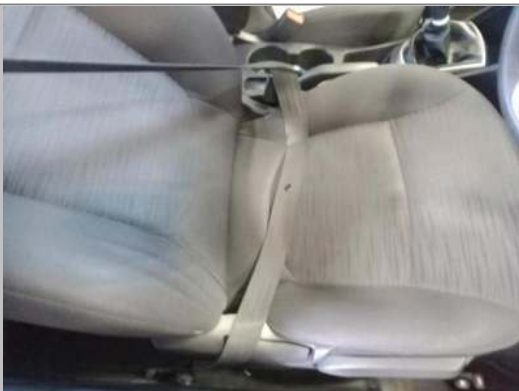
| Damage | Repair Way |
|---|---|
| Seat Front Left Torn / Cut | Repair |

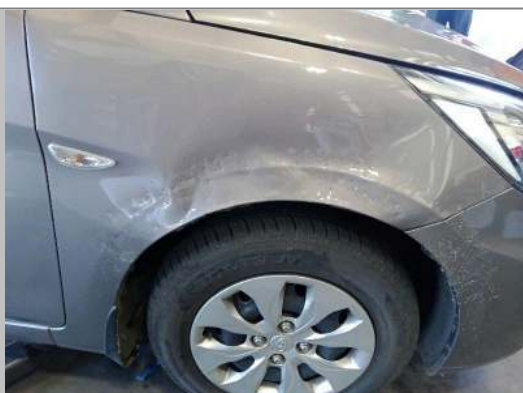
| Damage | Repair Way |
|---|---|
| Front Fender Left Paintwork • Scratched | Repair |

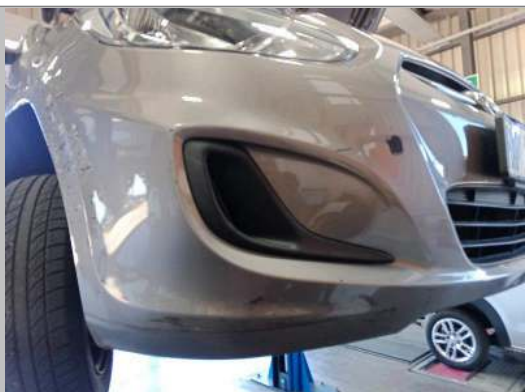
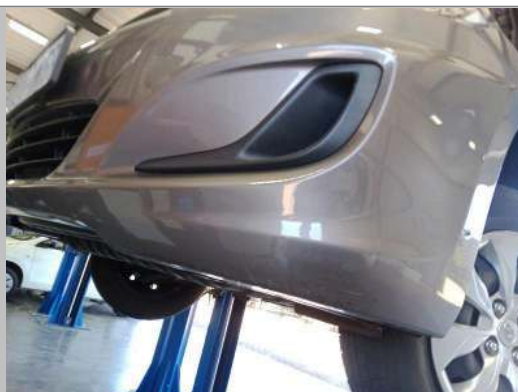
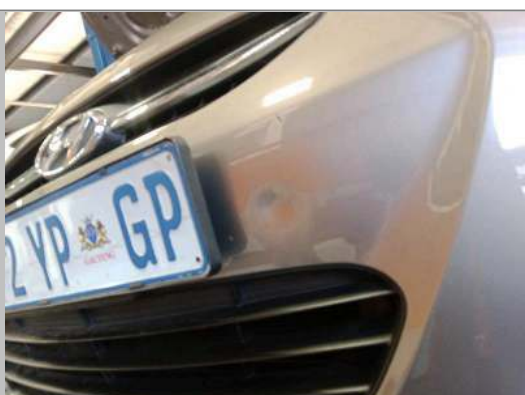
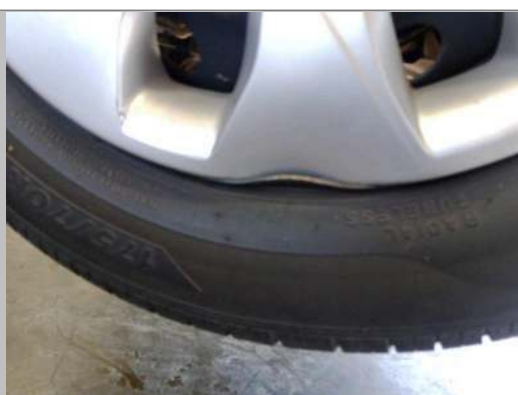
| Damage | Repair Way |
|---|---|
| Front Bumper Paintwork • Scratched | Repair |
