## CONDITION REPORT

Report No: 2016204863

MFC Auction House  
M57 Pretoria Rd, Glenmarais, KEMPTON PARK  
Gauteng

| Manufacturer | HYUNDAI | Registration Number | JB43GXGP |

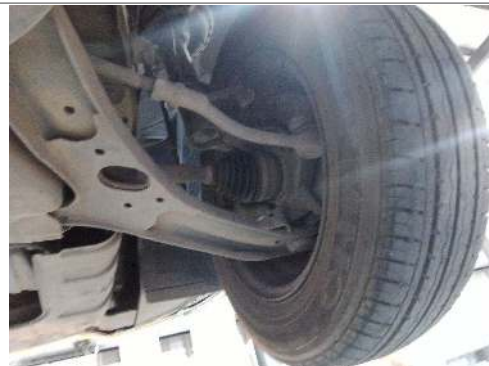
RF TYRE TREAD

| | Size | Load/Speed Index | Manufacture | Model | Type* | Production Date | Tread Depth (mm) |
|---|---|---|---|---|---|---|---|
| Front Right | 175/70R14 | 84T | Kumho | Solus | V | 2418 | 3 mm |

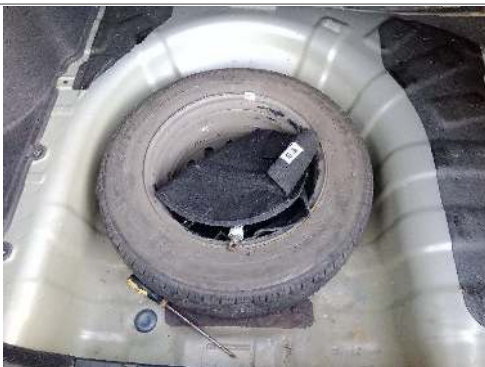
Sparewheel

| | Size | Load/Speed Index | Manufacture | Model | Type* | Production Date | Tread Depth (mm) |
|---|---|---|---|---|---|---|---|
| Spare | 175/70R14 | 84T | Kumho | Solus | V | /////// | 1 mm |

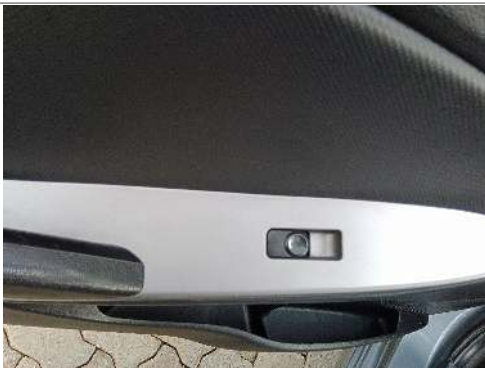
| Damage | Repair Way |
|---|---|
| Switch Electrical Window Winder front left Defective | Repair |

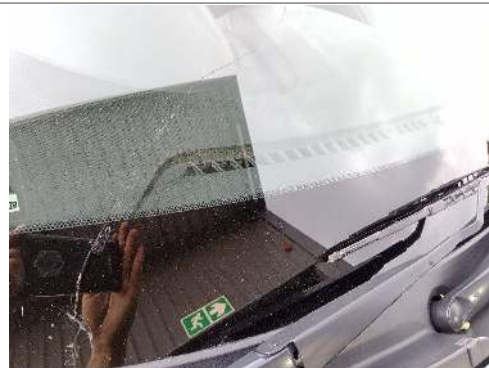
| Damage | Repair Way |
|---|---|
| Windscreen Cracked | Replace |

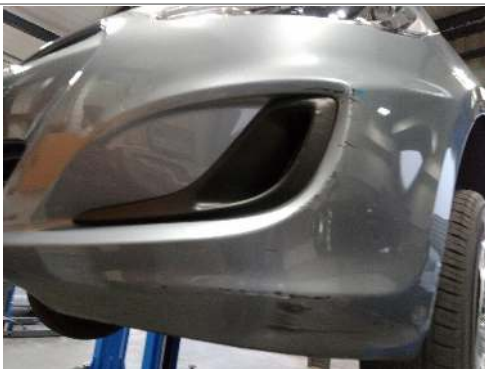
| Damage | Repair Way |
|---|---|
| Front Bumper Paintwork • Scratched | Repair |

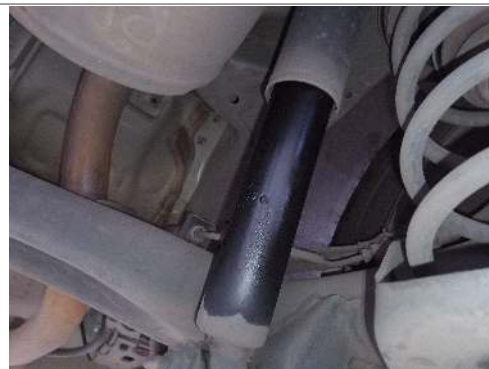
| Damage | Repair Way |
|---|---|
| Shock Absorber Rear Right Sweat | Replace |
