MFC Auction House  
M57 Pretoria Rd, Glenmarais, KEMPTON PARK  
Gauteng

| Manufacturer | HYUNDAI | Registration Number | JJ95HFGP |

## CONDITION REPORT

Report No: 2016295247

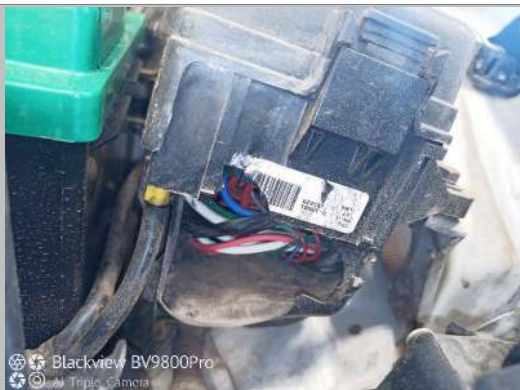
| Damage | Repair Way |
|---|---|
| Fuse box damage | Replace |

Fuse box damage

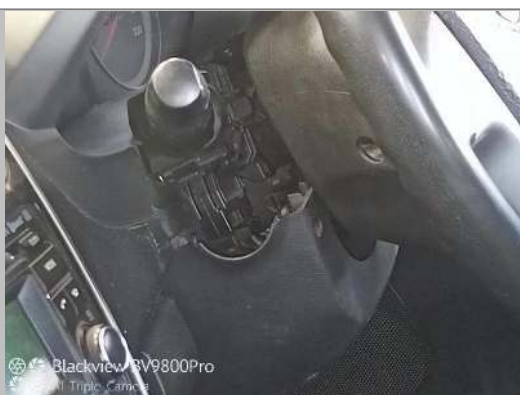
| Damage | Repair Way |
|---|---|
| Steering column cover damage | Repair |

Steering column cover damage

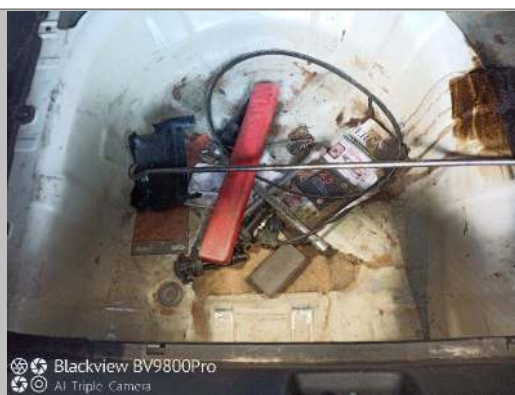
No spare wheel

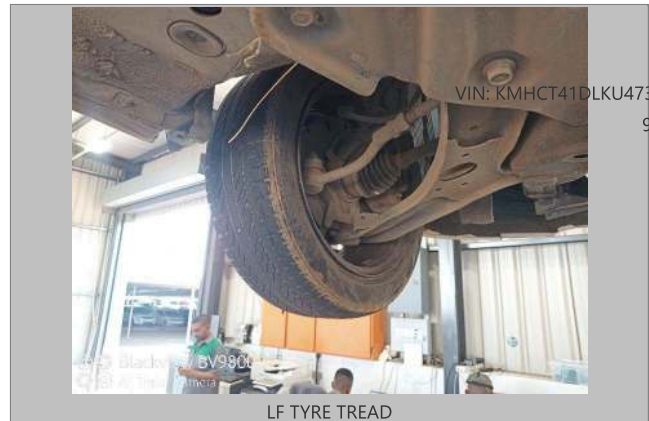
LF TYRE TREAD

| | Size | Load/Speed Index | Manufacture | Model | Type* | Production Date | Tread Depth (mm) |
|---|---|---|---|---|---|---|---|
| Front Left | 165/60R14 | 75H | Dunlop | Sp sport | V | 2915 | 2 mm |

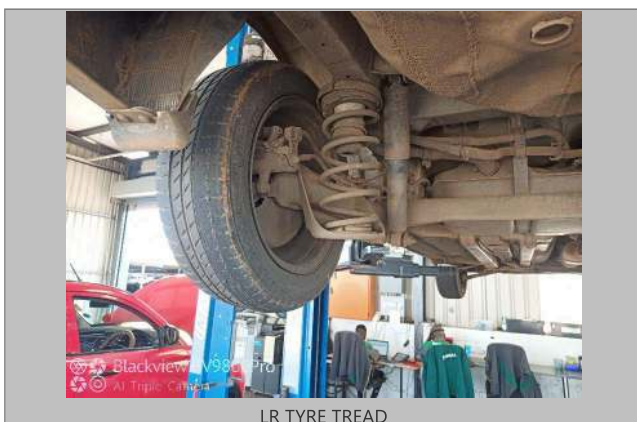
LR TYRE TREAD

| | Size | Load/Speed Index | Manufacture | Model | Type* | Production Date | Tread Depth (mm) |
|---|---|---|---|---|---|---|---|
| Rear Left | 165/60R14 | 75H | Continental | Contact | V | 1407 | 0 mm |

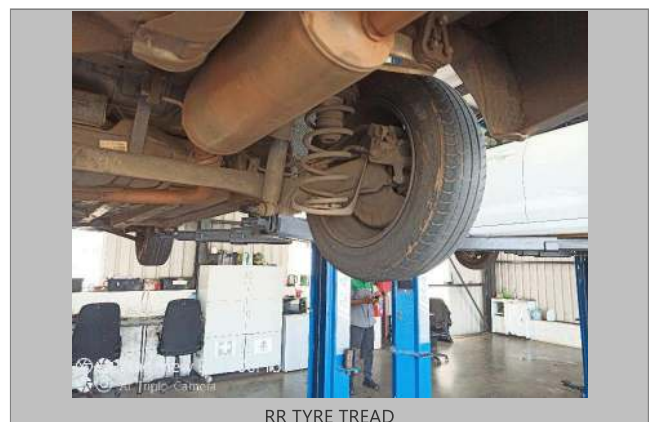
RR TYRE TREAD

| | Size | Load/Speed Index | Manufacture | Model | Type* | Production Date | Tread Depth (mm) |
|---|---|---|---|---|---|---|---|
| Rear Right | 165/65R14 | 79H | Nexen | Cp661 | V | 4414 | 2 mm |

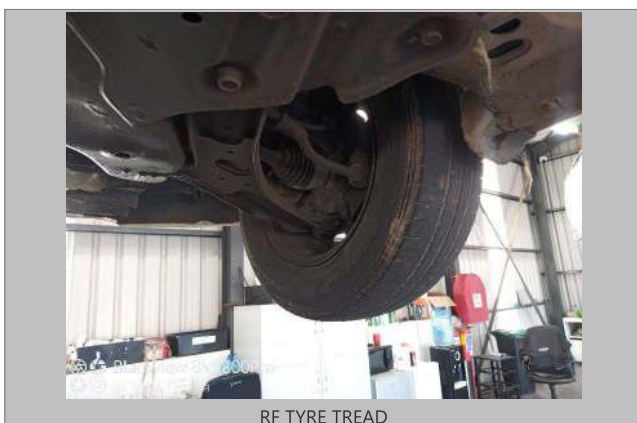
RF TYRE TREAD

| | Size | Load/Speed Index | Manufacture | Model | Type* | Production Date | Tread Depth (mm) |
|---|---|---|---|---|---|---|---|
| Front Right | 185/70R14 | 88T | Goodyear | Assurance | V | 1018 | 2 mm |

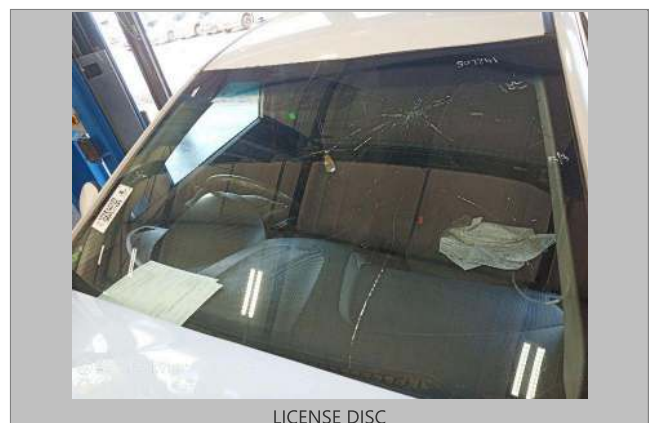
LICENSE DISC

| Damage | Repair Way |
|---|---|
| No license dice | Replace |

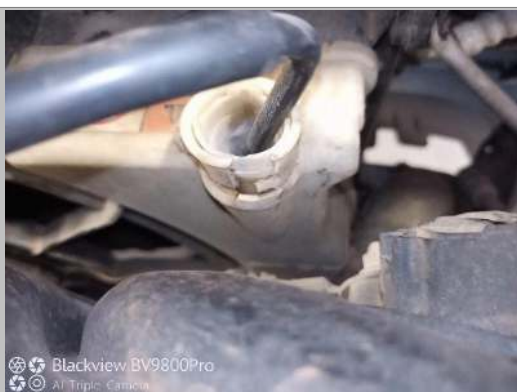
| | Damage | Repair Way |
|---|---|---|
| | Expansion Bottle Damaged | Replace |

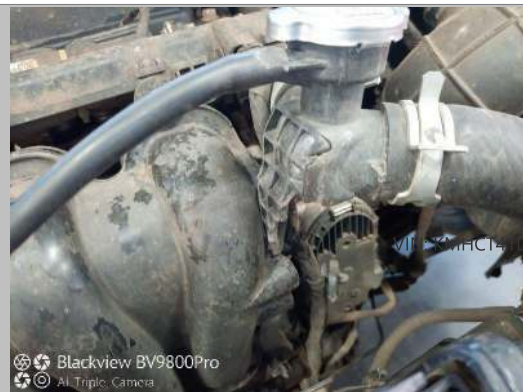
| | Damage | Repair Way |
|---|---|---|
| | Hoses Damaged | Repair |

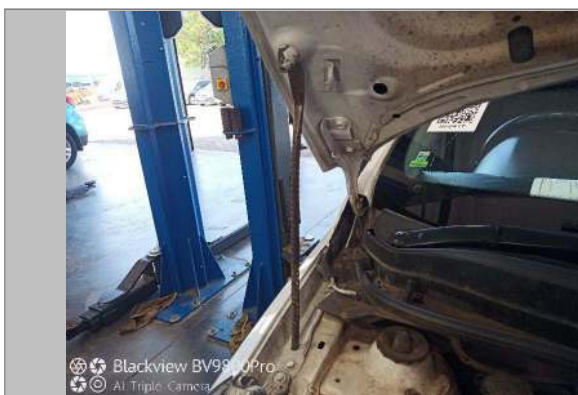
| | Damage | Repair Way |
|---|---|---|
| | Bonnet safety caps Missing | Replace |

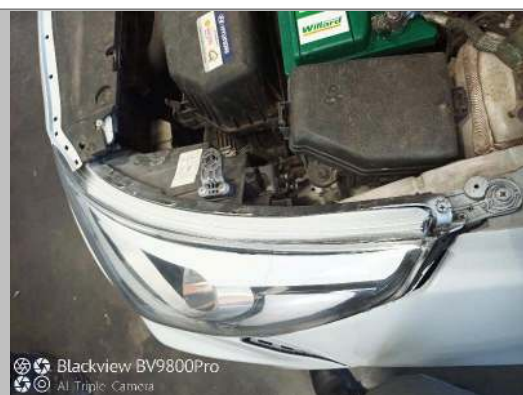
| | Damage | Repair Way |
|---|---|---|
| | Headlight Left Damaged | Replace |

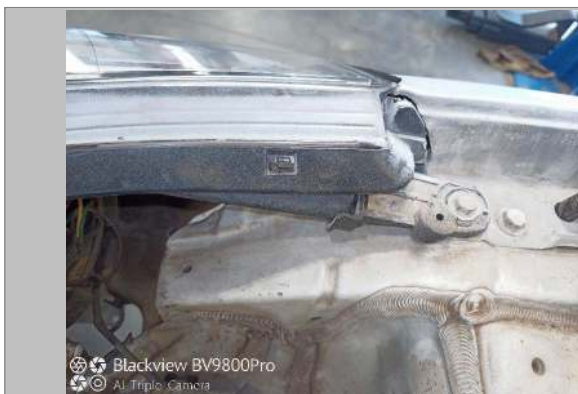
| | Damage | Repair Way |
|---|---|---|
| | Headlight Right Damaged | Replace |

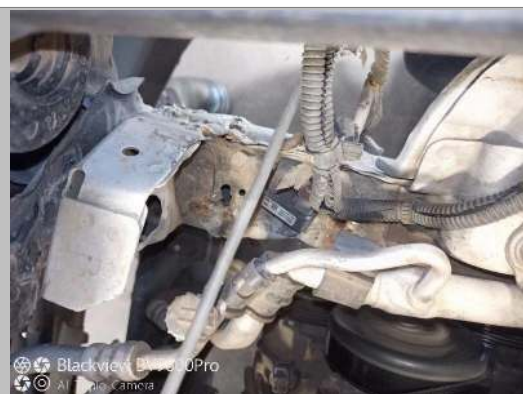
| Damage | Repair Way |
|---|---|
| Main Beam Right Welded | Repair |

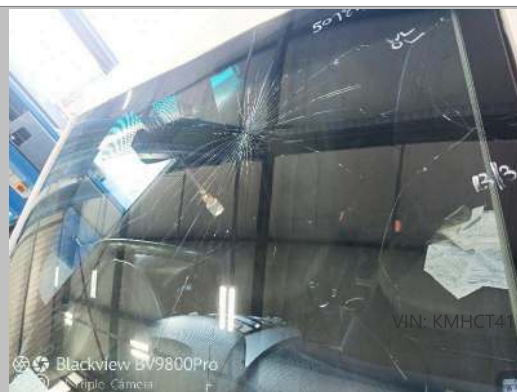
| Damage | Repair Way |
|---|---|
| Windscreen Cracked | Replace |

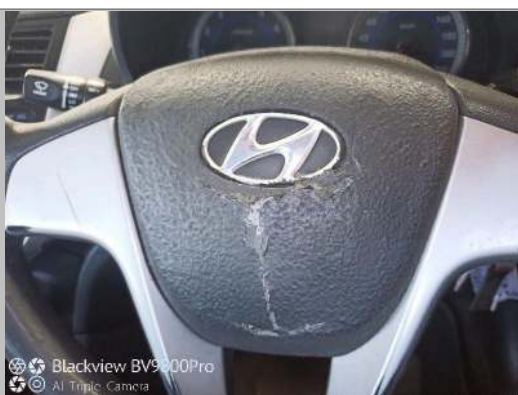
| | Damage | Repair Way |
|---|---|---|
| | Steering Wheel Trim Damaged | Replace |

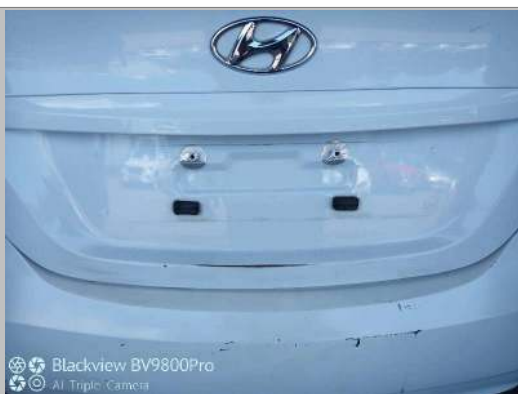
| | Damage | Repair Way |
|---|---|---|
| | Number Plate Rear Missing | Replace |

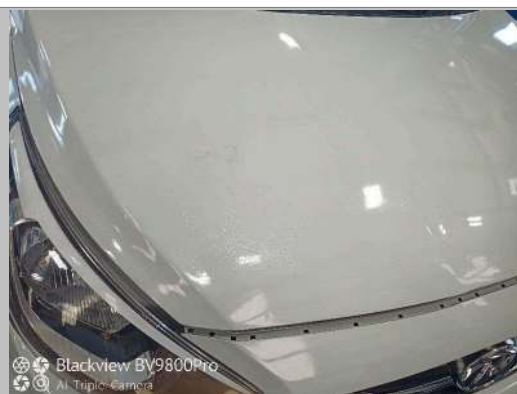
| | Damage | Repair Way |
|---|---|---|
| | Bonnet Paintwork • Blisters | Repair |

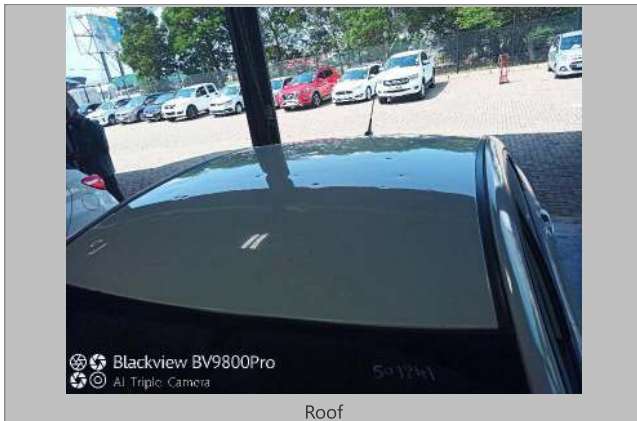
| Damage | Repair Way |
|---|---|
| Roof Dented | Repair |

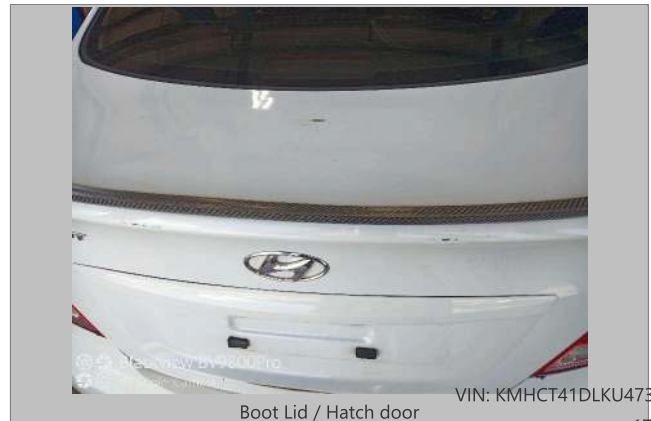
| | Damage | Repair Way |
|---|---|---|
| | Boot Lid / Hatch door Paintwork • Scratched | Repair |

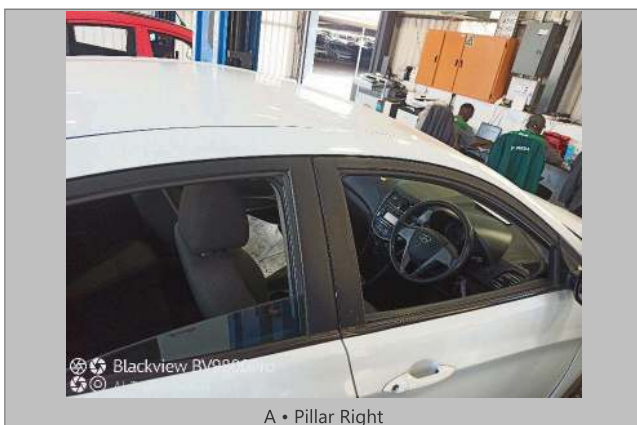
| | Damage | Repair Way |
|---|---|---|
| | A • Pillar Right Dented | Repair |

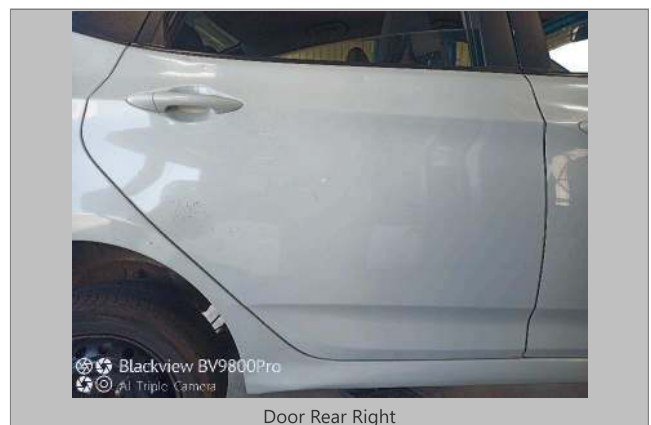
| | Damage | Repair Way |
|---|---|---|
| | Door Rear Right Paintwork • Scratched | Repair |

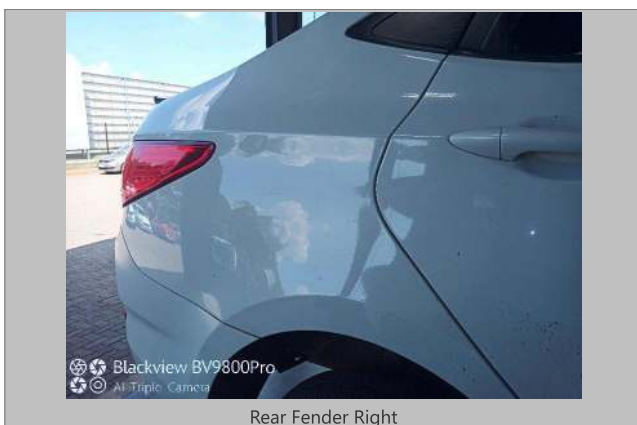
| | Damage | Repair Way |
|---|---|---|
| | Rear Fender Right Dented | Repair |

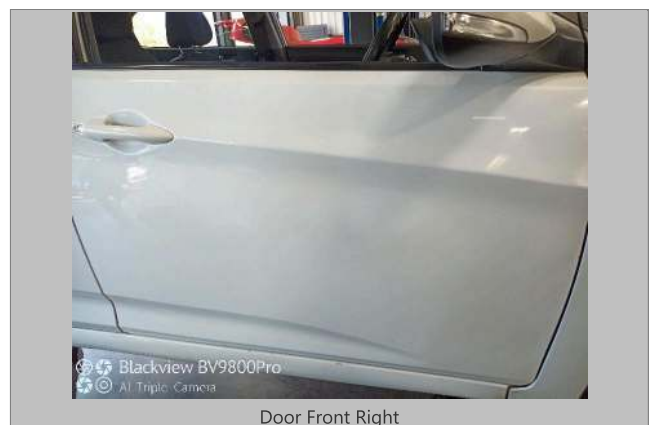
| | Damage | Repair Way |
|---|---|---|
| | Door Front Right Dented | Repair |

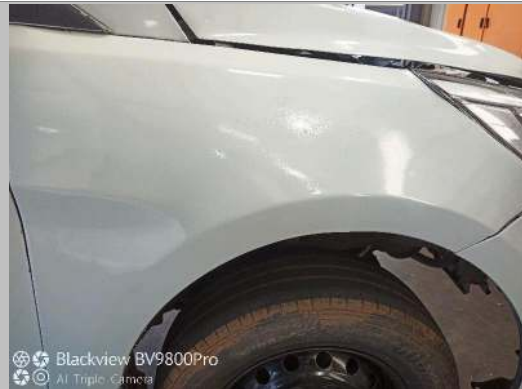
| | Damage | Repair Way |
|---|---|---|
| | Front Fender Right Paintwork • Blisters | Repair |

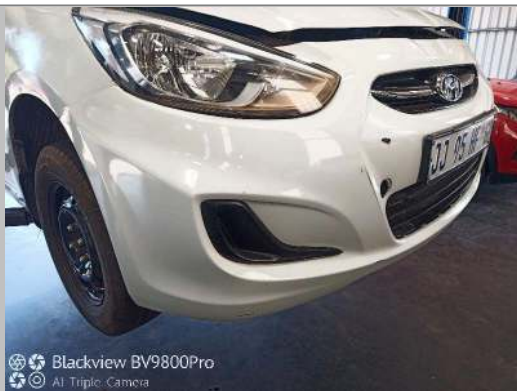
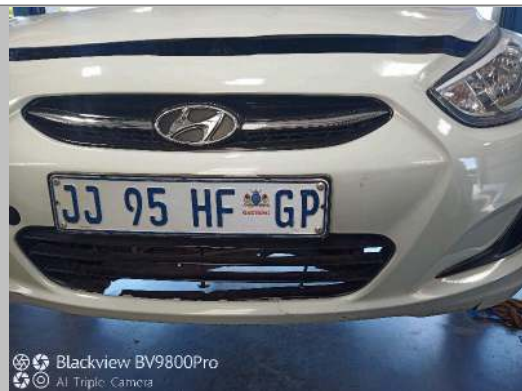
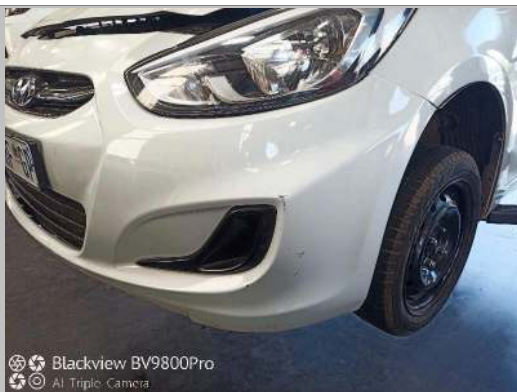
| | Damage | Repair Way |
|---|---|---|
| | Front Bumper Paintwork • Scratched | Repair |

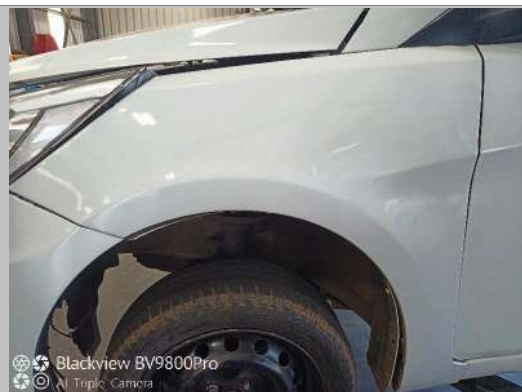
| | Damage | Repair Way |
|---|---|---|
| | Front Fender Left Paintwork • Pitmarks | Repair |

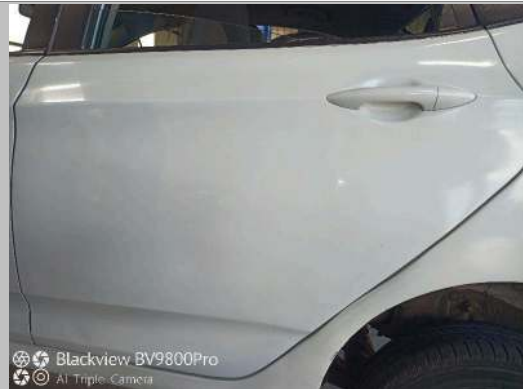
| | Damage | Repair Way |
|---|---|---|
| | Door Rear Left Paintwork • Scratched | Repair |

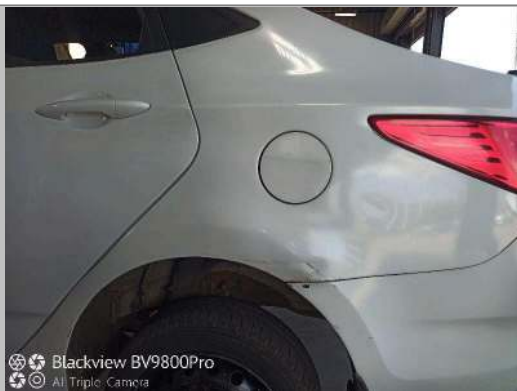
| | Damage | Repair Way |
|---|---|---|
| | Rear Fender Left Dented | Repair |

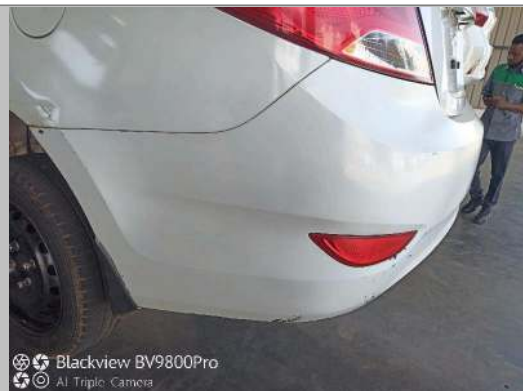
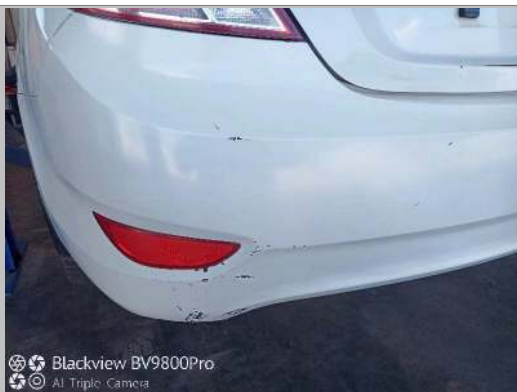
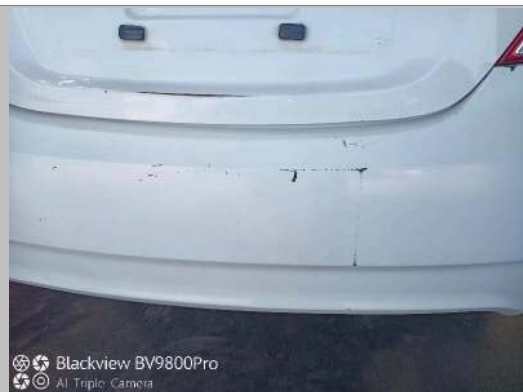
| Damage | Repair Way |
|---|---|
| Rear bumper Paintwork • Scratched | Repair |

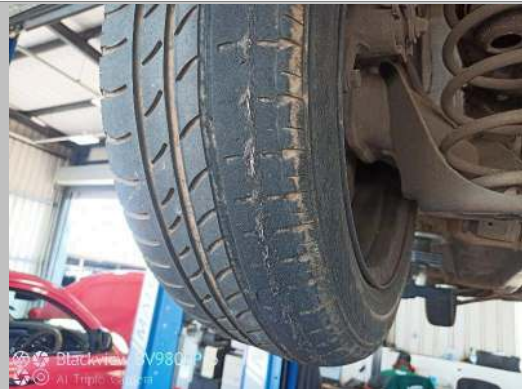
| Damage | Repair Way |
|---|---|
| Tyre Rear Left Damaged | Replace |

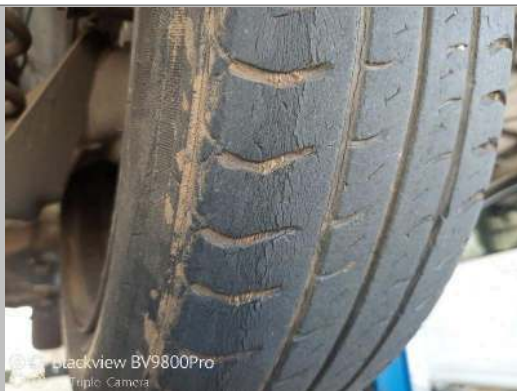
| Damage | Repair Way |
|---|---|
| Tyre Rear Right Defective | Replace |

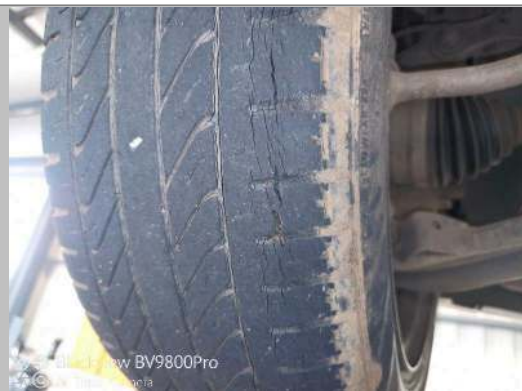
| Damage | Repair Way |
|---|---|
| Tyre Front Left Torn / Cut | Replace |

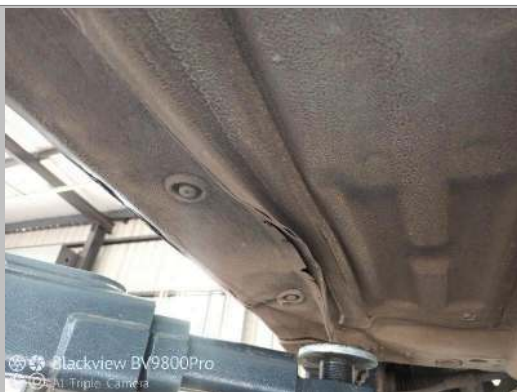
| Damage | Repair Way |
|---|---|
| Chassis Dented | Repair |

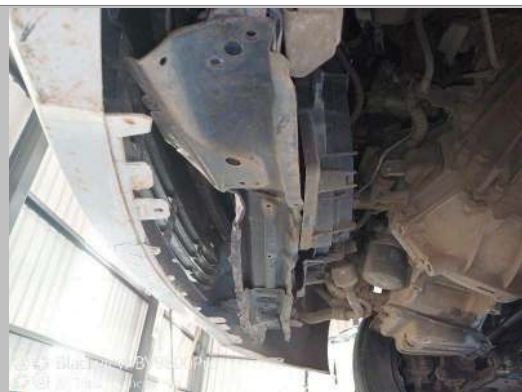
| Damage | Repair Way |
|---|---|
| Radiator Cradle Dented | Replace |

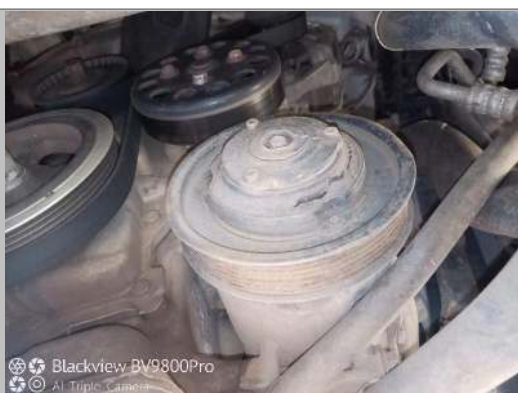
| | Damage | Repair Way |
|---|---|---|
| | Air conditioner pump Damaged | Repair |

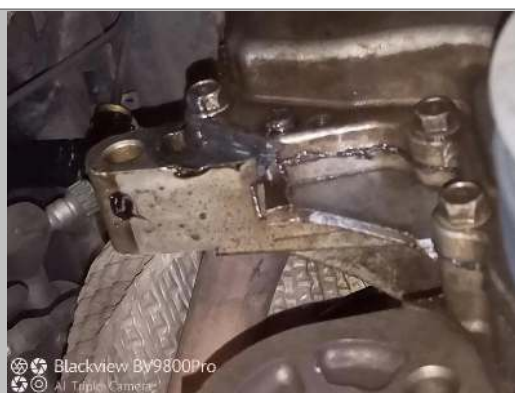
| | Damage | Repair Way |
|---|---|---|
| | Engine Oil Leak | Repair |

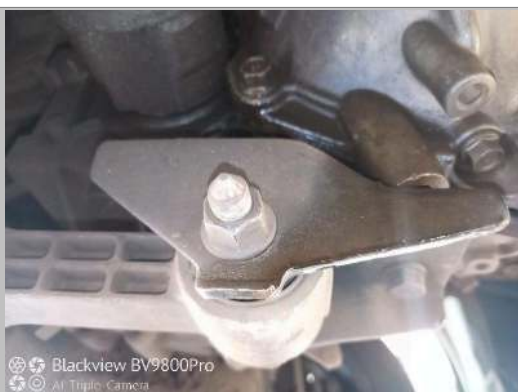
| Damage | Repair Way |
|---|---|
| Gearbox Oil Leak | Repair |

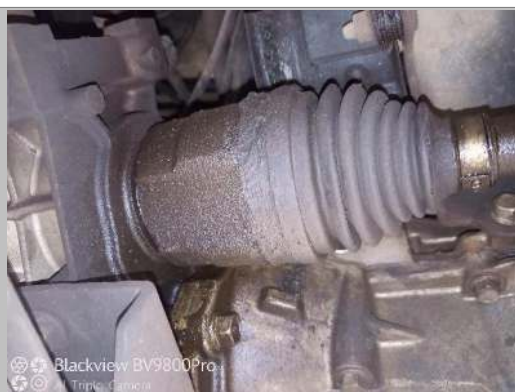
| Damage | Repair Way |
|---|---|
| CV Joint(s) Boot(s) Front Right (inner/outer) Defective | Replace |

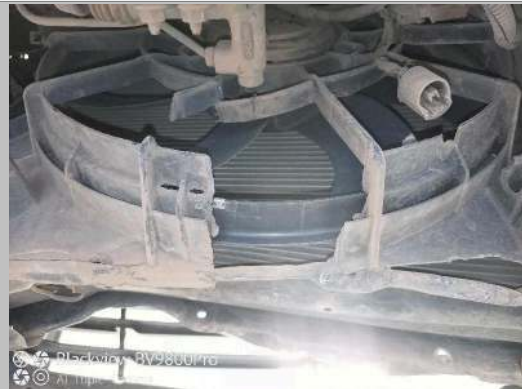
| | Damage | Repair Way |
|---|---|---|
| | Fan Damaged | Replace |

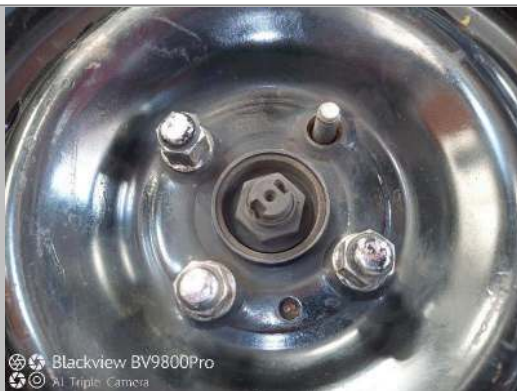
| Damage | Repair Way |
|---|---|
| Bolt(s) / Nut(s) Front Wheel Left Missing | Replace |

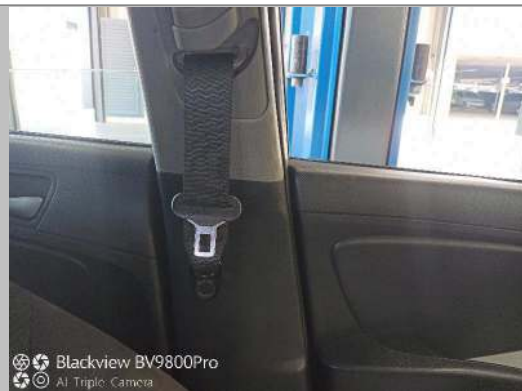
| | Damage | Repair Way |
|---|---|---|
| | Seat Belt Front Left Defective | Repair |

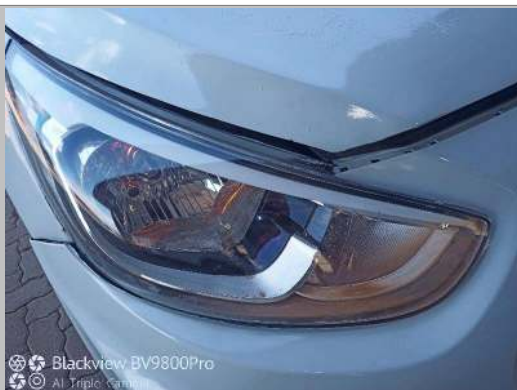
| | Damage | Repair Way |
|---|---|---|
| | Dim and Bright Indicator Light Malfunction | Repair |
