MFC Auction House
M57 Pretoria Rd, Glenmarais, KEMPTON PARK
Gauteng

Vehicle Type	PASSENGER VEHICLE	Registered Owner	
Manufacturer	HYUNDAI	Registration Number	JYK223MP
Model	ELANTRA	Register Number	
VIN	KMHD041BVJU748685	Date Of First Licensing	
Engine Number		Last COR	
Doors	4	License Expiry Date	
Color	WHITE	Power / Displacement	
Year Model		Paint Finish	TWO COAT UNI
Km Reading	160,570 KM	Fuel	PETROL
Cab / Body Type	SEDAN	Transmission	AUTOMATIC

VEHICLE INSPECTION

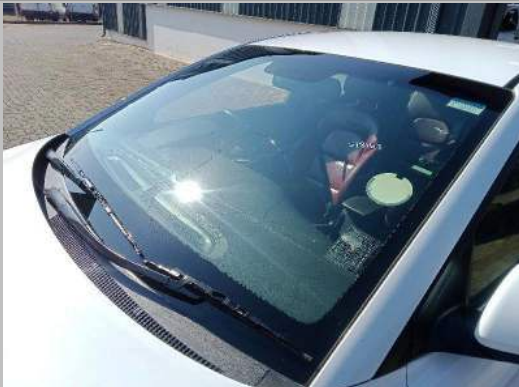
LICENSE DISC

Sub Frame Scratched	Repair
Belly plates Damaged	Repair
Gearbox Oil Leak	Repair
Fuel Tank Dented	Repair
Body and Exterior	Vehicle license disk missing
Undercarriage	Bottom of engine and gearbox fully covered
Body and Exterior	Stone chips and spray work on some body panels
Body and Exterior	Dents and scratches on some body panels
Body and Exterior	Poor residual traces of repair on some body panels
Body and Exterior	Some body panels misaligned

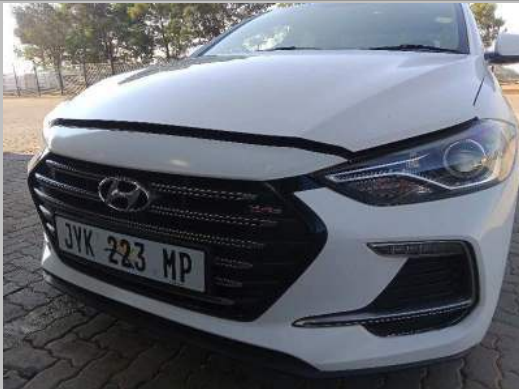
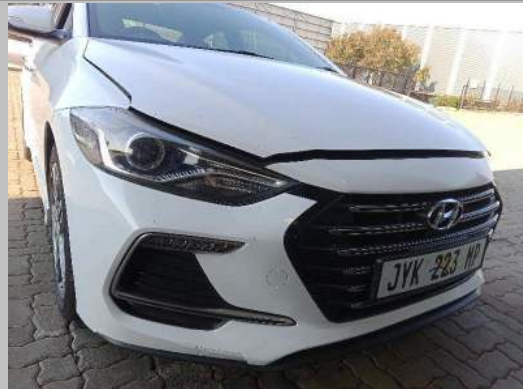
Damage	Repair Way
Engine Oil Leak	Repair
Seat Front Right Torn / Cut	Repair
Door Panel Front Right Defective	Repair
Steering Wheel Trim Defective	Repair
Front Bumper Residual Traces of Repair	Repair
Bonnet Paintwork • Chipmarks	Repair
Front Fender Left Dented	Repair
Rear Fender Left Dented	Repair
Rear Fender Right Paintwork • Scratched	Repair
Front Fender Left / Inner Tray Defective	Repair
Rear Fender Right / Inner Tray Damaged	Repair
Door Front Left Paintwork • Scratched	Repair
Door Front Right Paintwork • Scratched	Repair
Door Rear Left Dented	Repair
Door Rear Right Paintwork • Scratched	Repair
Boot Lid / Hatch door Residual Traces of Repair	Repair
Rear bumper Paintwork • Scratched	Repair
Inner Boot Floor Pan and Spare Wheel Well Paintwork • Scratched	Repair
Sill Panel Left Damaged	Repair
Sill Panel Right Residual Traces of Repair	Repair
Windscreen Cracked	Replace
Tyre Rear Left Damaged	Replace
Rim Front Left Dented	Repair

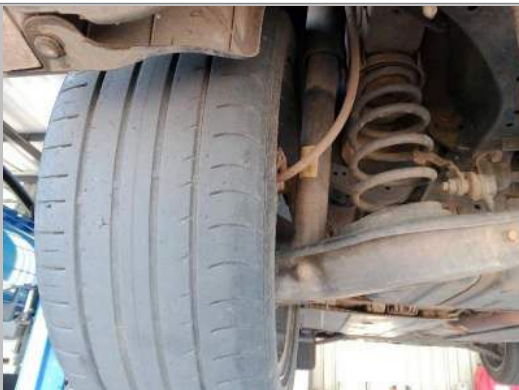
Tyre Rear Left

Size	Load/Speed Index	Manufacture	Model	Type*	Production Date	Tread Depth (mm)
Front Left	225/45Z R17	94W	Hilo	Vantage	V	0125	6 mm
Front Right	225/45Z R17	94W	Hilo	Vantage	V	0125	6 mm
Rear Left	225/45 R17	91W	Hankook	Ventus	V	0221	0 mm
Rear Right	225/45 R17	91W	Dunlop	Sp-Sport	V	0617	1 mm
Spare	T125/80 R16	97M	Hankook	Temporary		2518	1 mm
