CONDITION REPORT

Report No: 2016466181

MFC Auction House
M57 Pretoria Rd, Glenmarais, KEMPTON PARK
Gauteng

| Manufacturer | HYUNDAI | Registration Number | JX44SGGP |

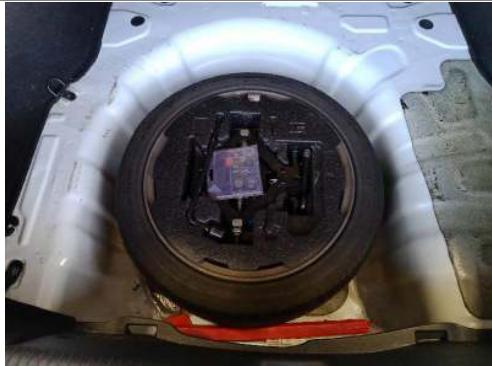
Spare wheel and Accessories

| Damage | Repair Way |
|--|--|
| Spare Tyre Worn | Replace |

| | Size | Load/Speed Index | Manufacture | Model | Type* | Production Date | Tread Depth (mm) |
|---|---|---|---|---|---|---|---|
| Spare | 215/45 R17 | 91W | Sailwin | Sportway | V | 3821 | 0 mm |

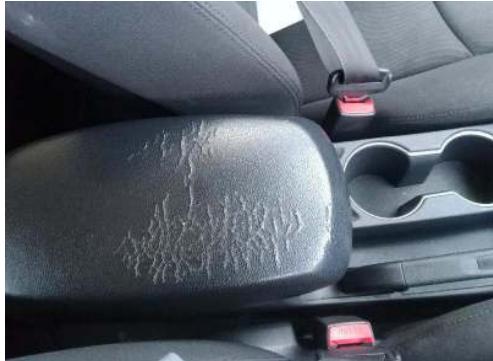
| Damage | Repair Way |
|---|---|
| Center Console / Cubbyhole + Lid Defective | Repair |

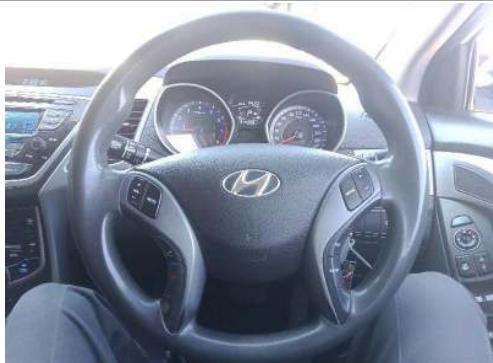
| Damage | Repair Way |
|---|---|
| Steering Wheel Trim Defective | Repair |

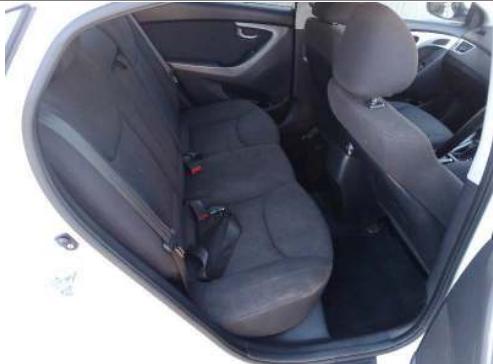
| Damage | Repair Way |
|---|---|
| Seat Rear Dirty | Repair |

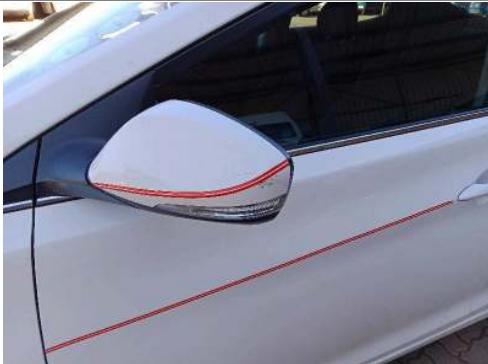
| Damage | Repair Way |
|---|---|
| Side Mirror Left Paintwork • Scratched | Repair |

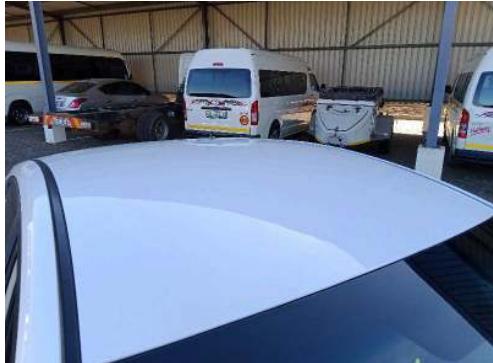
| Damage | Repair Way |
|--|--|
| Roof Dented | Repair |

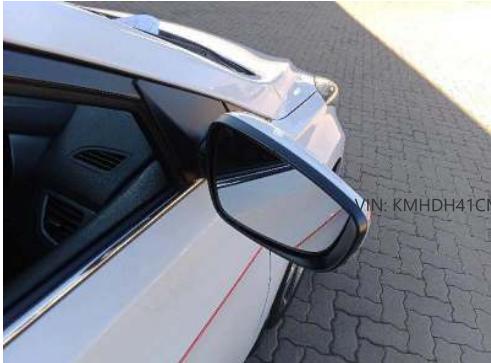
| Damage | Repair Way |
|---|---|
| Side Mirror Right Paintwork • Scratched | Repair |

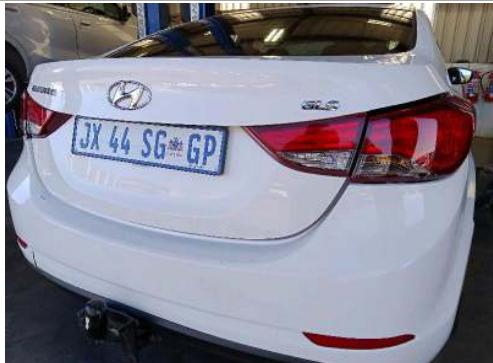
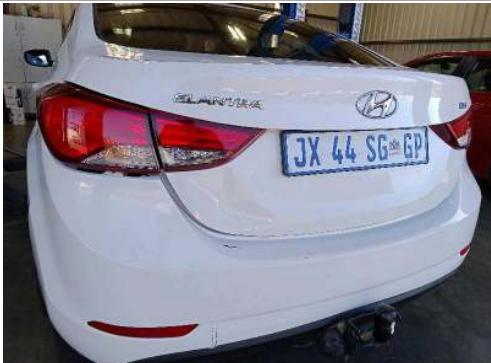
| Damage | Repair Way |
|---|---|
| Rear bumper Damaged | Repair |

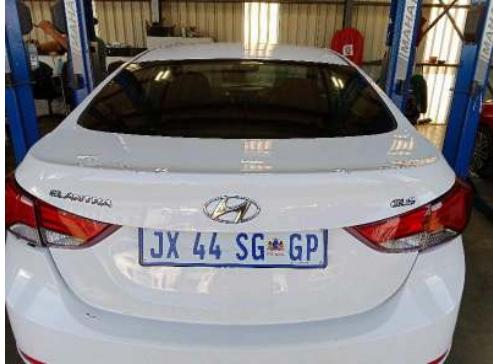
| Damage | Repair Way |
|---|---|
| Boot Lid / Hatch door Damaged | Repair |

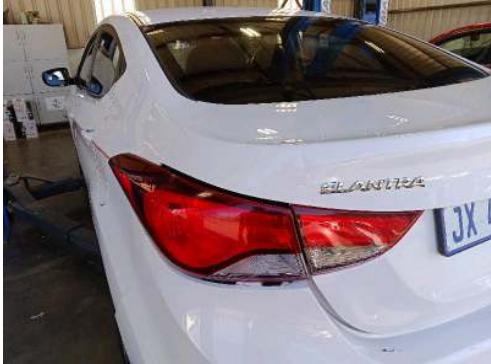
| Damage | Repair Way |
|---|---|
| Tail Light Left Defective | Repair |

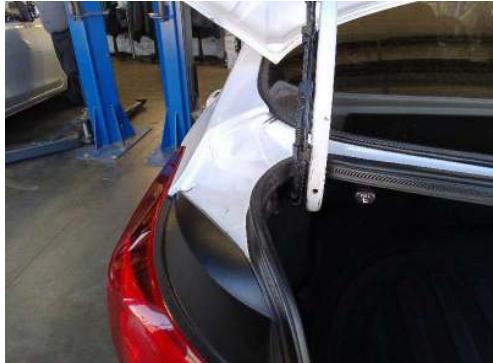
| Damage | Repair Way |
|---|---|
| C • Pillar Left Dented | Repair |

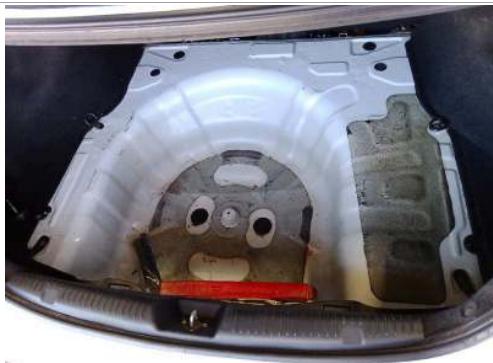
| Damage | Repair Way |
|---|---|
| Inner Boot Floor Pan and Spare Wheel Well Residual Traces of Repair | Repair |

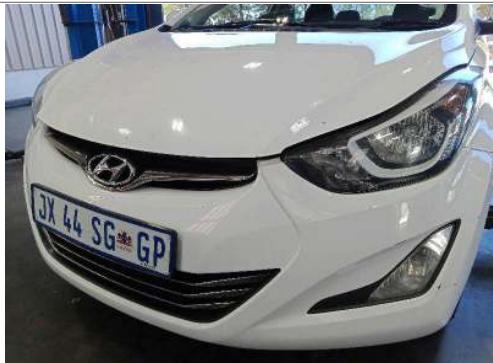
| Damage | Repair Way |
|---|---|
| Front Bumper Damaged | Repair |

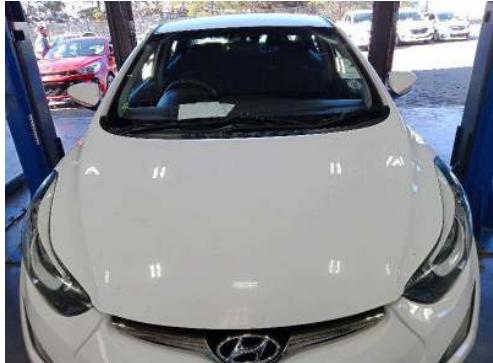
| Damage | Repair Way |
|---|---|
| Bonnet Paintwork • Chipmarks | Repair |

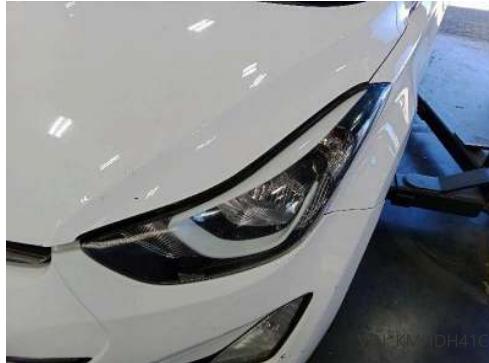
| Damage | Repair Way |
|---|---|
| Headlight Left Scratched | Repair |

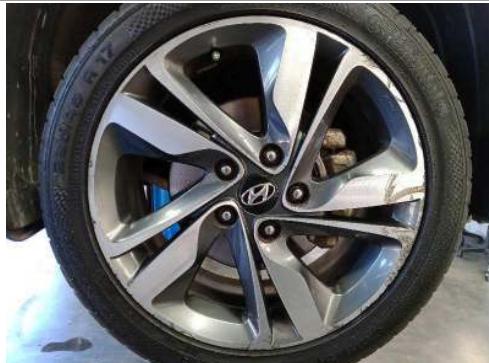
| Damage | Repair Way |
|--|--|
| Rim Front Right Scratched | Repair |

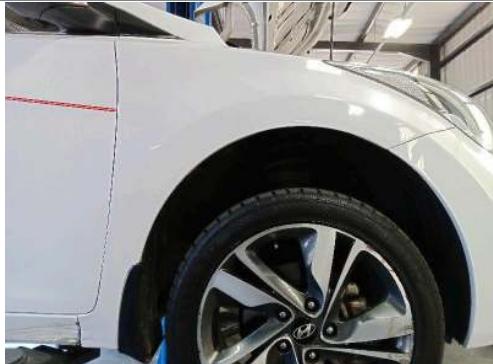
| Damage | Repair Way |
|---|---|
| Front Fender Right Residual Traces of Repair | Repair |

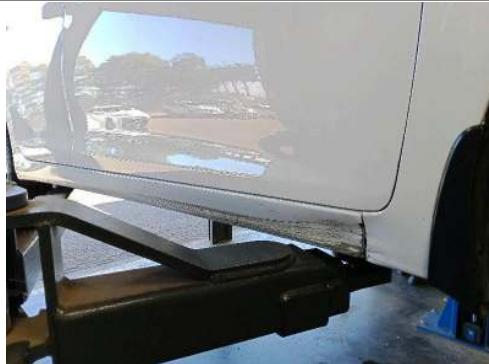
| Damage | Repair Way |
|---|---|
| Rocker Panel Right Damaged | Repair |

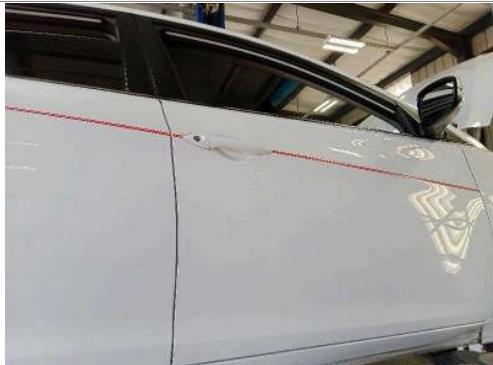
| Damage | Repair Way |
|---|---|
| Door Front Right Dented | Repair |

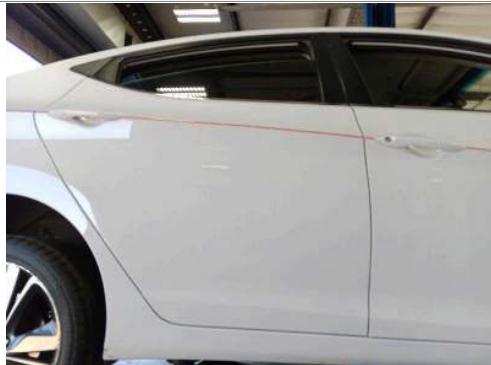
| Damage | Repair Way |
|---|---|
| Door Rear Right Residual Traces of Repair | Repair |

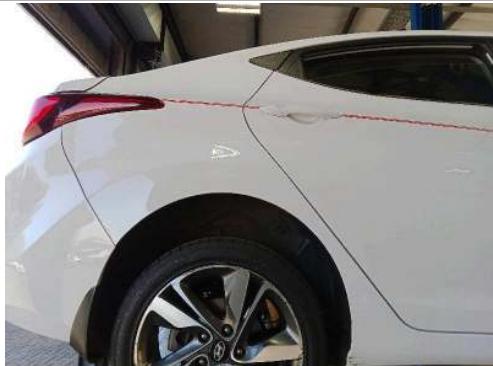
| Damage | Repair Way |
|---|---|
| Rear Fender Right Paintwork • Scratched | Repair |

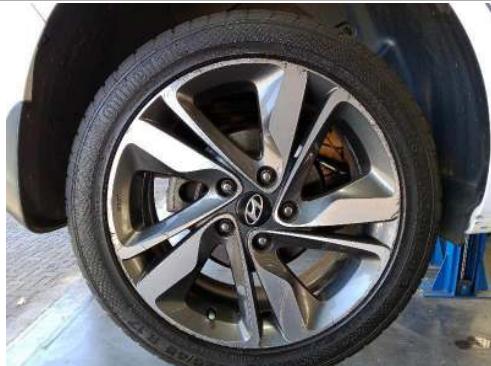
| Damage | Repair Way |
|--|--|
| Rim Rear Right Scratched | Repair |

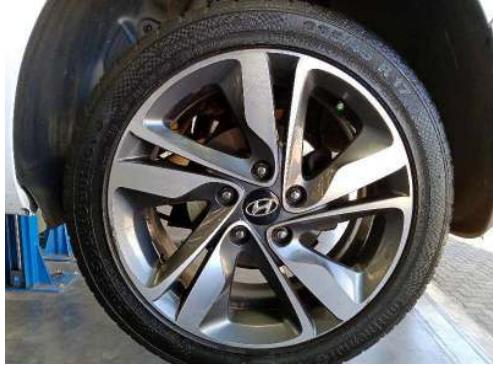
| Damage | Repair Way |
|--|--|
| Rim Rear Left Scratched | Repair |

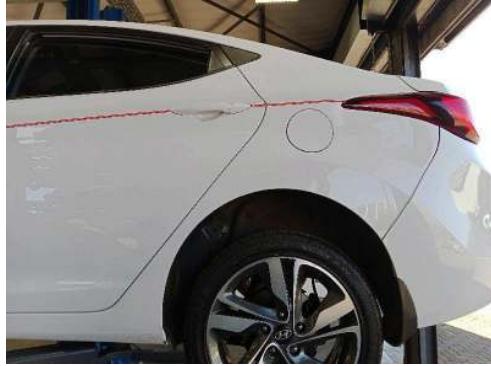
| Damage | Repair Way |
|---|---|
| Rear Fender Left Dented | Repair |

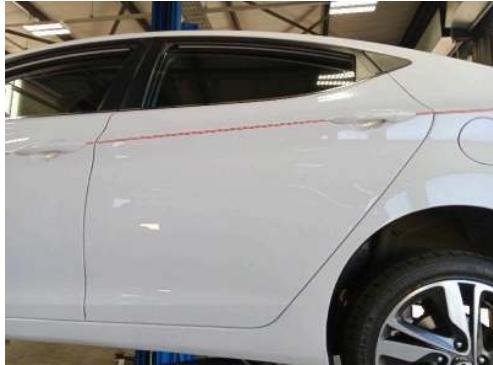
| Damage | Repair Way |
|---|---|
| Door Rear Left Dented | Repair |

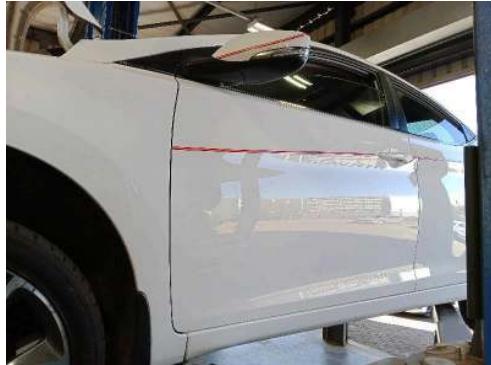
| Damage | Repair Way |
|---|---|
| Door Front Left Dented | Repair |

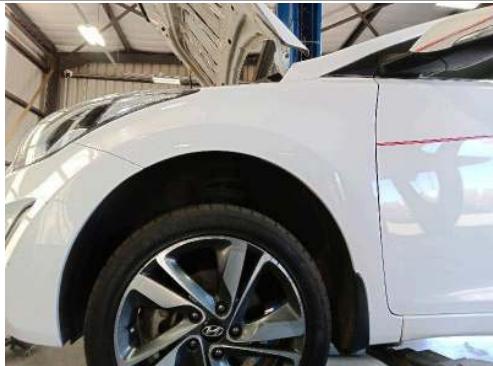
| Damage | Repair Way |
|---|---|
| Front Fender Left Residual Traces of Repair | Repair |

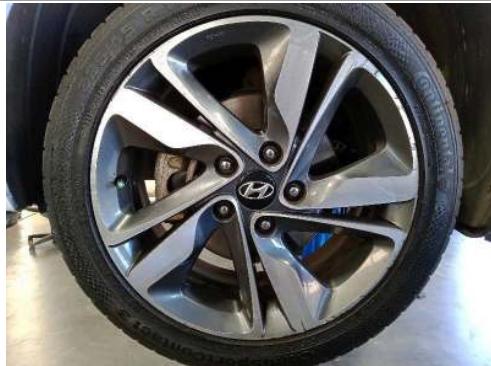
| Damage | Repair Way |
|--|--|
| Rim Front Left Scratched | Repair |

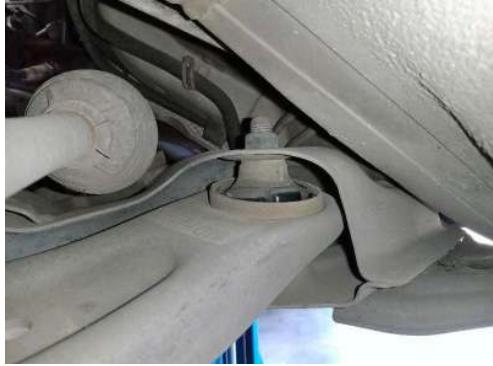
| Damage | Repair Way |
|--|--|
| Control Arm Bush(es) Front Axle Left Cracked | Replace |

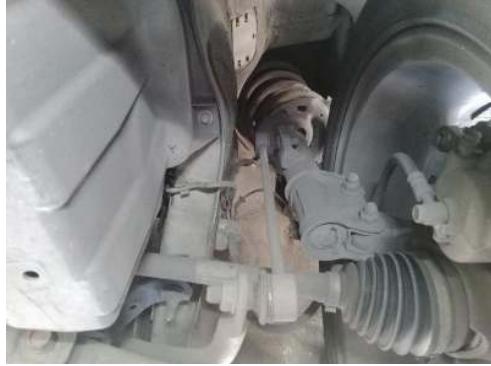
| Damage | Repair Way |
|--|--|
| Stabilizer Mounting Front Left Defective | Replace |

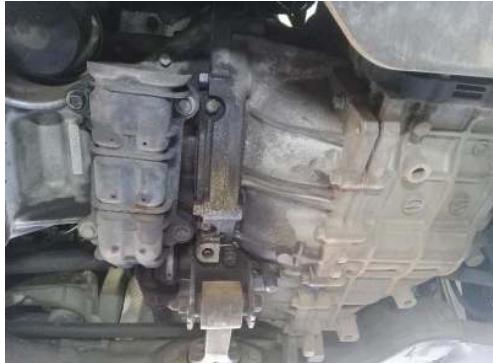
| Damage | Repair Way |
|--|--|
| Gearbox Oil Leak | Repair |

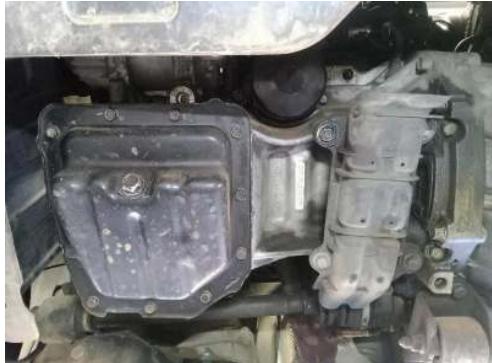
| Damage | Repair Way |
|---|---|
| Engine Oil Leak | Repair |

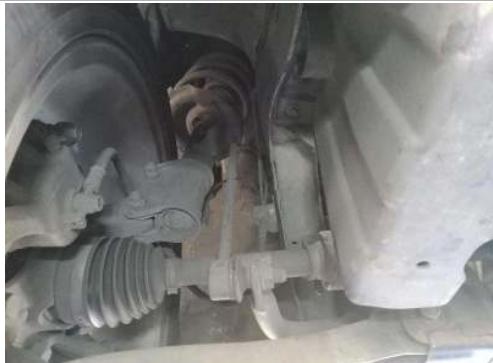
| Damage | Repair Way |
|--|--|
| Stabilizer Mounting Front Right Defective | Replace |

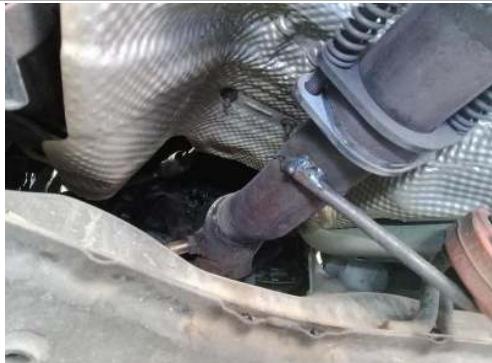
| Damage | Repair Way |
|--|--|
| Engine to silencer pipe Welded | Replace |

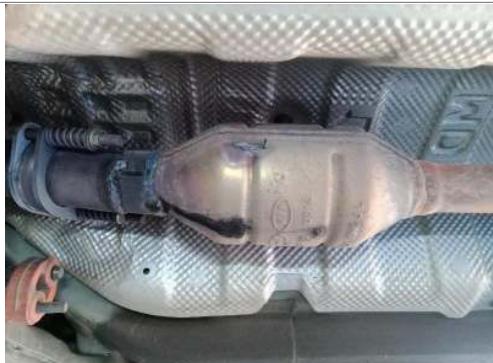
| Damage | Repair Way |
|--|--|
| Catalytic converter Welded | Repair |

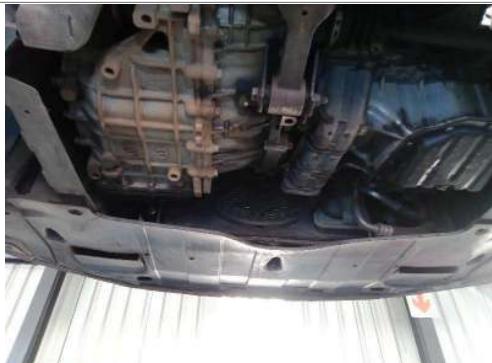
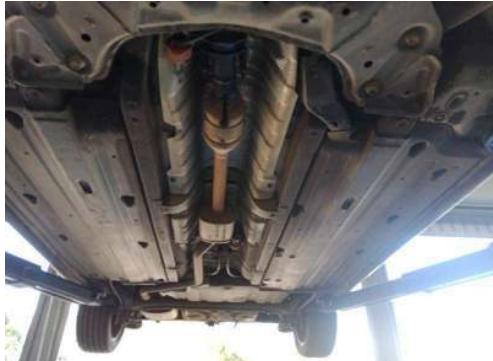
| Damage | Repair Way |
|--|--|
| Belly plates Defective | Repair |

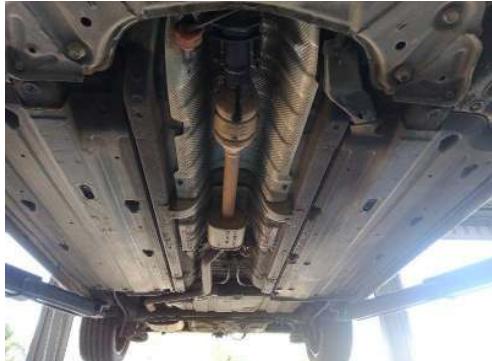
| Damage | Repair Way |
|--|--|
| Chassis Scratched | Repair |

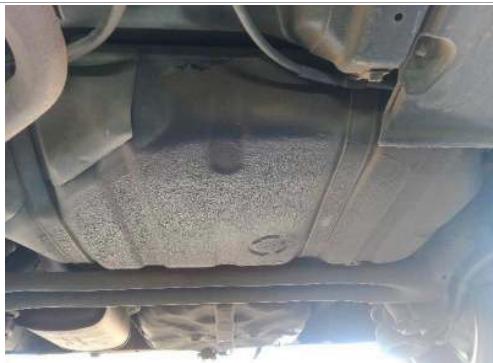
| Damage | Repair Way |
|--|--|
| Fuel Tank Dented | Repair |

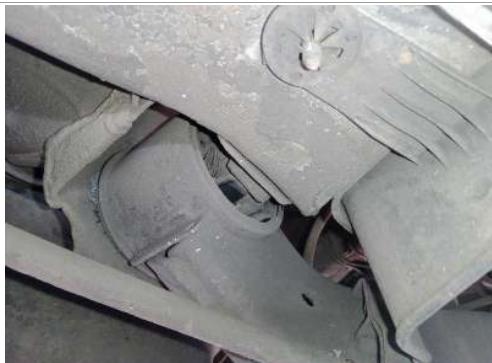
| Damage | Repair Way |
|--|--|
| Mounting Rubber(s) Rear Axle Left Cracked | Replace |

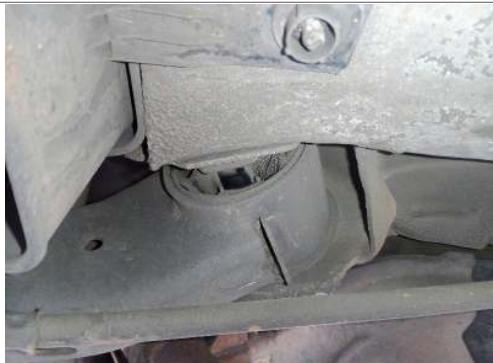
| Damage | Repair Way |
|--|--|
| Mounting Rubber(s) Rear Axle Right Cracked | Replace |

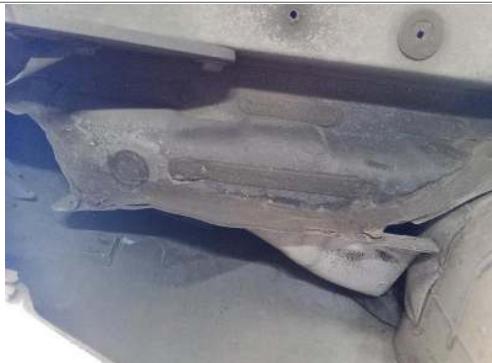
| Damage | Repair Way |
|---|---|
| Rear Fender Left / Inner Tray Damaged | Repair |

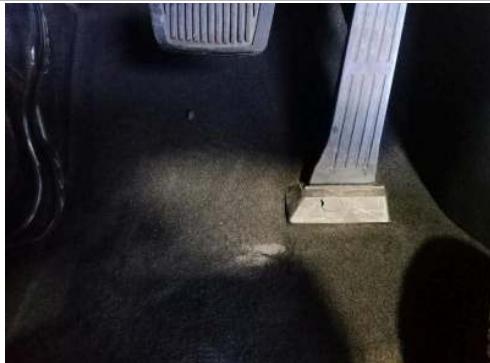
| Damage | Repair Way |
|---|---|
| Carpet Front Damaged | Replace |
