## CONDITION REPORT

Report No:  
2016903489  
DATE  
05/06/2025

| Manufacturer | HYUNDAI | Registration Number | FWX543MP |
| Model | IX35 2.0 EXECUTIVE [2010-2013] | Register Number | |

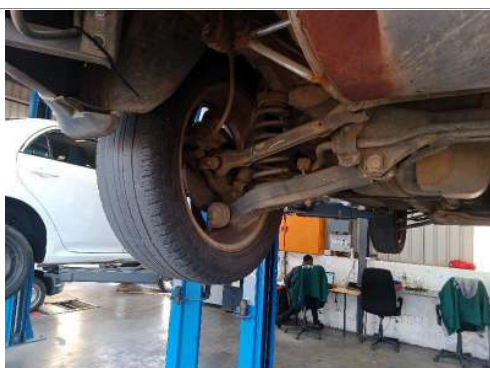
LR TYRE TREAD

| | Size | Load/Speed Index | Manufacture | Model | Type* | Production Date | Tread Depth (mm) |
|---|---|---|---|---|---|---|---|
| Rear Left | 225/55R18 | 98V | Goodyear | Efficient gr | V | 4319 | 1 mm |

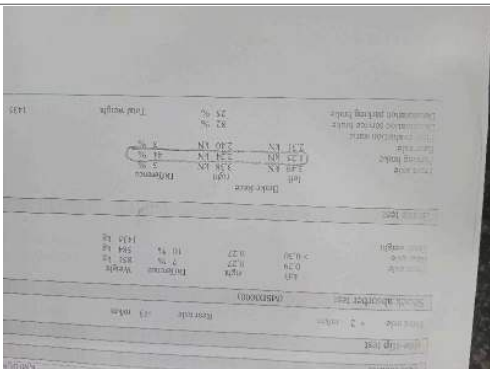
| Damage | Repair Way |
|---|---|
| Parking Brake Performance Left / Right Difference out of legal range | Repair |

| | Left | Right | | |
|---|---|---|---|---|
| Emergency / Parking | 1.2 | 2.2 | - | |

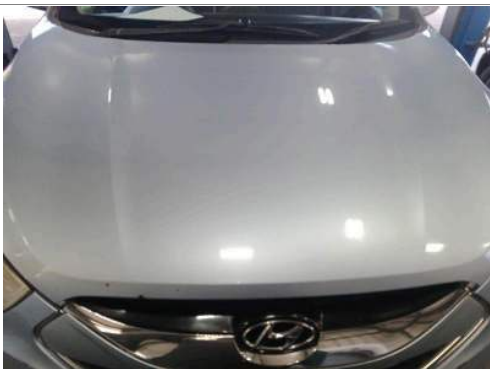
| Damage | Repair Way |
|---|---|
| Bonnet Paintwork • Chipmarks | Repair |

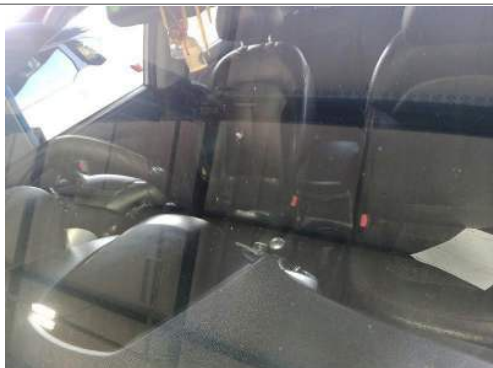
| Damage | Repair Way |
|---|---|
| Windscreen Chipped | Repair |

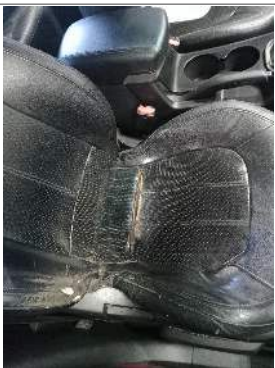
| Damage | Repair Way |
|---|---|
| Seat Front Right Damaged | Repair |

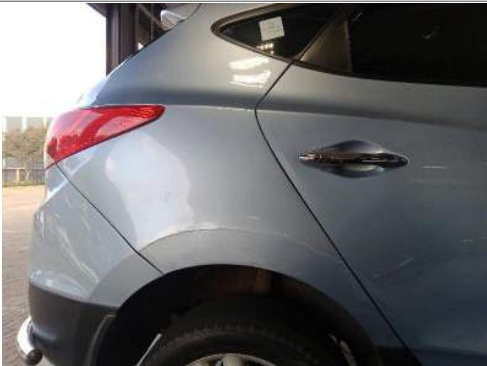
| Damage | Repair Way |
|---|---|
| Rear Fender Right Paintwork • Scratched | Repair |

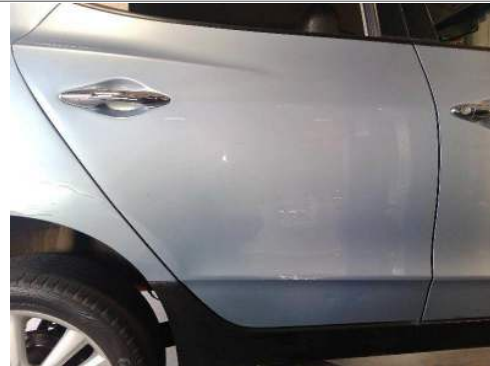
| Damage | Repair Way |
|---|---|
| Door Rear Right Paintwork • Scratched | Repair |

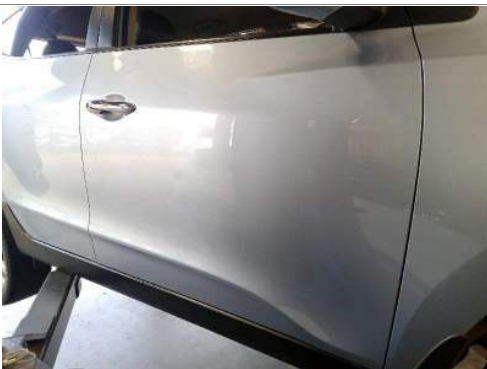
| Damage | Repair Way |
|---|---|
| Door Front Right Paintwork • Scratched | Repair |

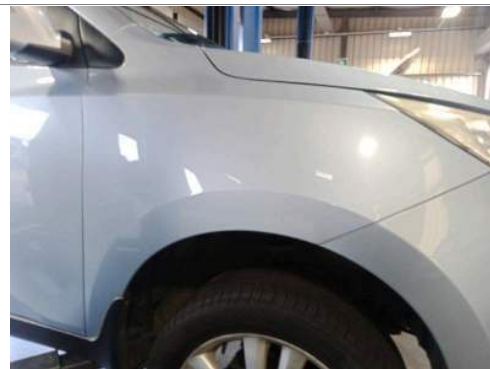
| Damage | Repair Way |
|---|---|
| Front Fender Right Paintwork • Scratched | Repair |

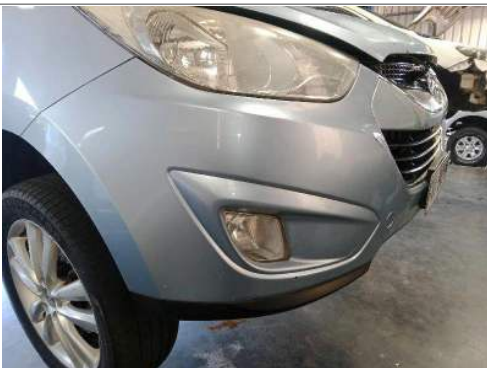
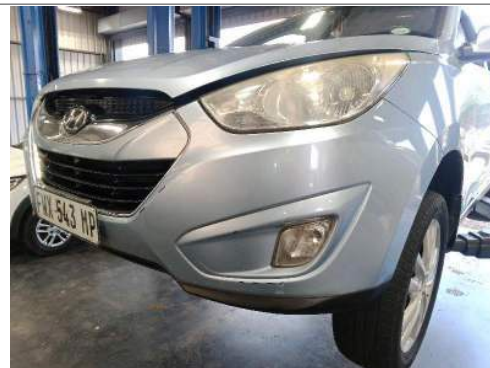
| Damage | Repair Way |
|---|---|
| Front Bumper Paintwork • Scratched | Repair |

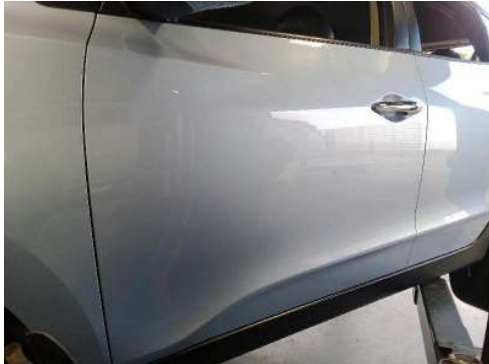
| Damage | Repair Way |
|---|---|
| Door Front Left Paintwork • Scratched | Repair |

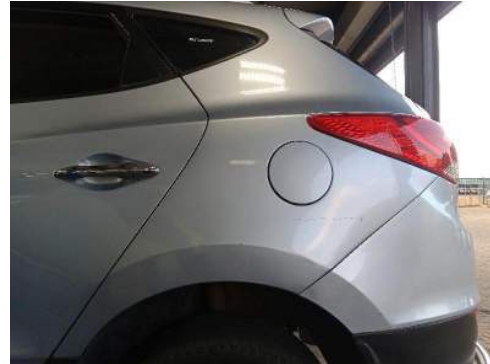
| Damage | Repair Way |
|---|---|
| Rear Fender Left Dented | Repair |

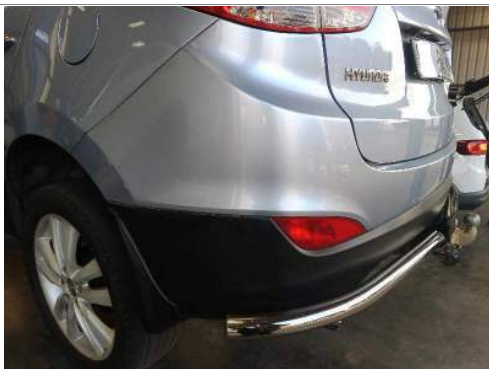
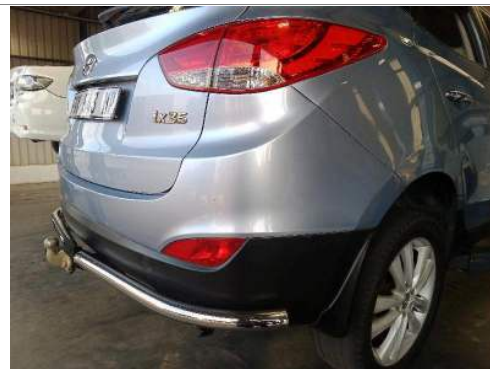
| Damage | Repair Way |
|---|---|
| Rear bumper Paintwork • Scratched | Repair |

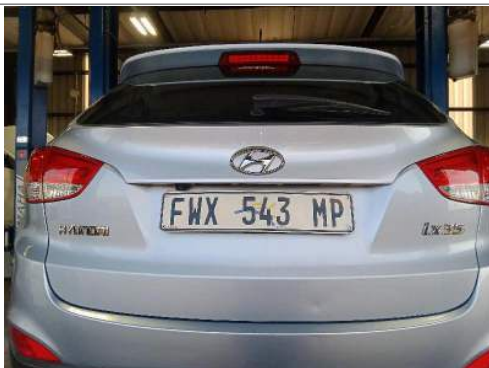
| Damage | Repair Way |
|---|---|
| Boot Lid / Hatch door Dented | Repair |

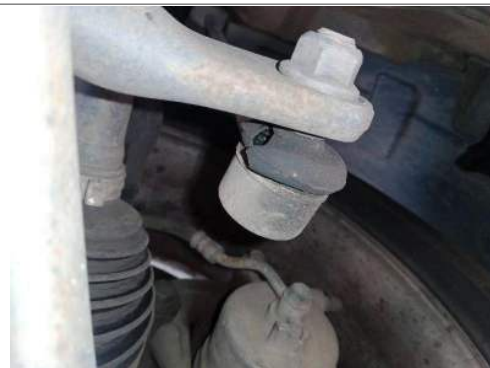
| Damage | Repair Way |
|---|---|
| Stabilizer Mounting Front Left Damaged | Replace |

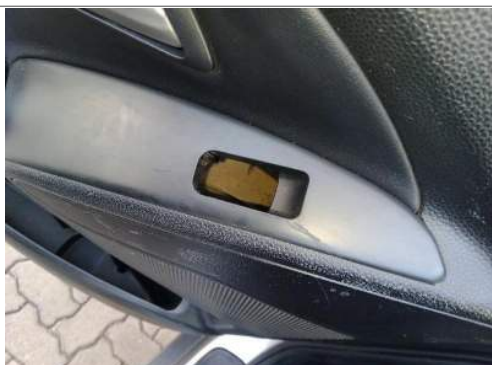
| Damage | Repair Way |
|---|---|
| Switch Electrical Window Winder rear left Damaged | Repair |

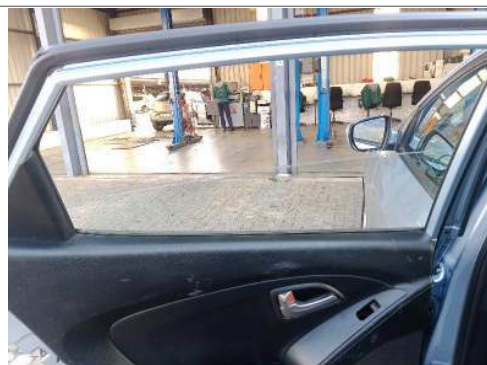
| Damage | Repair Way |
|---|---|
| Window Rear Door Left Defective | Repair |
