## CONDITION REPORT

Report No: 2016395143

MFC Auction House  
M57 Pretoria Rd, Glenmarais, KEMPTON PARK  
Gauteng

Vehicle Type	PASSENGER VEHICLE	Registered Owner	MFC AUCTION HOUSE
Manufacturer	HYUNDAI	Registration Number	FGT291L
Model	H-1	Register Number	
VIN	KMHWH81KMGU801461	Date Of First Licensing	
Engine Number		Last COR	
Doors	5	License Expiry Date	31/12/2024
Color	WHITE	Power / Displacement	
Year Model		Paint Finish	C - COMMON
Km Reading	264,302 KM	Fuel	DIESEL
Cab / Body Type	OTHERS	Transmission	AUTOMATIC

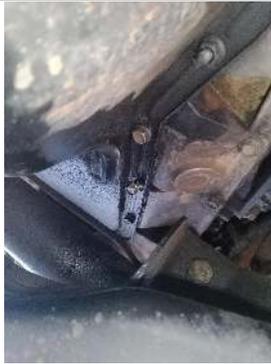
Oil sump bolt loose

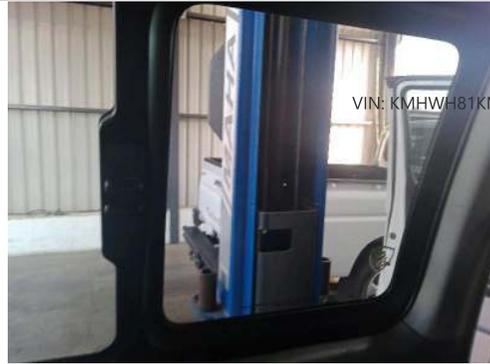
Left side sliding window damag

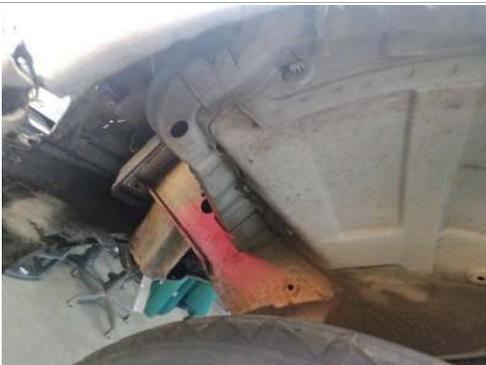
L/F fender liner missing

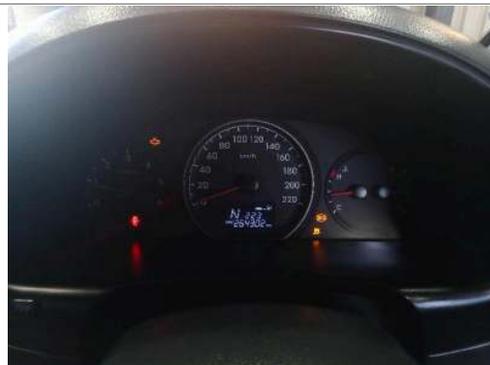
Body exterior	Signs of spray work done on some body panels
Body exterior	Minor dents scratches and stone chips on some body
Warning lights illuminated.	Repair.
Axle and suspension	Excessive noise front suspension

Warning lights illuminated

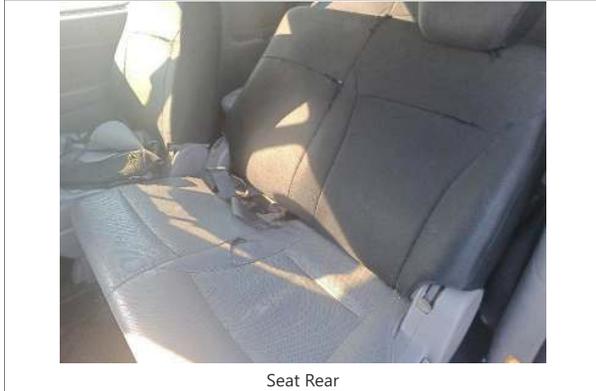
Damage	Repair Way
Engine Oil Leak	Repair
Engine Wiring Defective	Repair
Windscreen Wiper Malfunction	Replace
Park Light Rear Right Defective	Repair
Fog Light Front Left Missing	Replace
Fog Light Front Right Defective	Replace
Seat Front Right Excessive Wear & Tear	Repair
Seat Rear Torn / Cut	Repair
Door Handle Rear Right Damaged	Replace
Channel / Roof Gutter Left Damaged	Repair
Front Bumper Residual Traces of Repair	Repair
Grill Damaged	Replace
Bonnet Paintwork • Flaking	Repair
Front Fender Left Residual Traces of Repair	Repair
Rear Fender Right Residual Traces of Repair	Repair
Door Front Left Residual Traces of Repair	Repair
Sill Panel Right Damaged	Repair
Sliding Door Dented	Repair
Windscreen Cracked	Replace
Shock Absorber Rear Right Leak	Replace
Tyre Rear Left Smooth	Replace
Bolt(s) / Nut(s) Front Wheel Left Missing	Replace
Catalytic converter Welded	Replace
Axle and suspension.	Both front control arm bushes covered

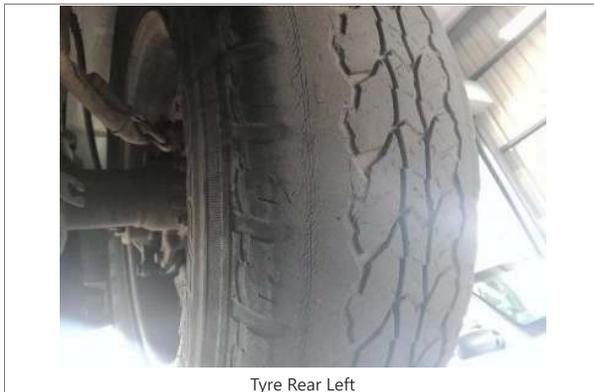
Tyre Rear Left

Size	Load/Speed Index	Manufacture	Model	Type*	Production Date	Tread Depth (mm)
Front Left	215/65R16	109/107R	Grenlander	L-max		0119	1 mm
Front Right	215/65R16	109/107R	Grenlander	L-max	V	0119	1 mm
Rear Left	215/70R16	99T	Lanvigator	Catchfors	V	1321	0 mm
Rear Right	215/65R16	98H	Continental	Contact	V	4018	1 mm
Spare	195/75R16	107/105	Michelin	Aglis	V	///////	1 mm
