| Manufacturer | KIA | Registration Number | FJ90WWGP |
| Model | PICANTO 1.0 LX 5-DR [2011-2018] | Register Number | |

## CONDITION REPORT

Report No: 2016674532

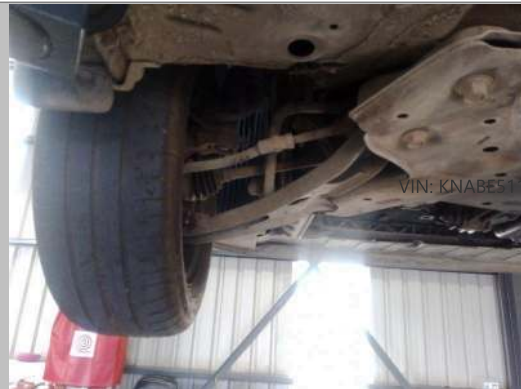
LF TYRE TREAD

| | Size | Load/Speed Index | Manufacture | Model | Type* | Production Date | Tread Depth (mm) |
|---|---|---|---|---|---|---|---|
| Front Left | 185/60R14 | 82H | Goodyear | Efficient | V | 0422 | 0 mm |

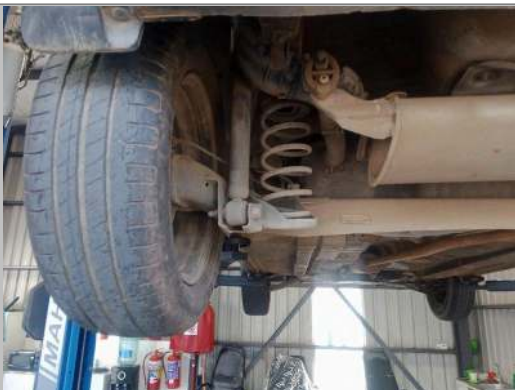
LR TYRE TREAD

| | Size | Load/Speed Index | Manufacture | Model | Type* | Production Date | Tread Depth (mm) |
|---|---|---|---|---|---|---|---|
| Rear Left | 185/60R14 | 82H | Goodyear | Efficient | V | 2419 | 1 mm |

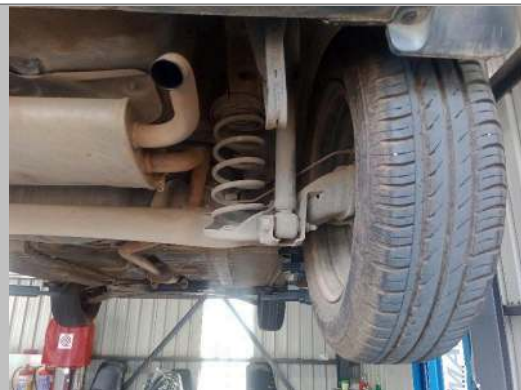
RR TYRE TREAD

| | Size | Load/Speed Index | Manufacture | Model | Type* | Production Date | Tread Depth (mm) |
|---|---|---|---|---|---|---|---|
| Rear Right | 175/65R14 | 82T | Continental | Contieco | V | 4617 | 4 mm |

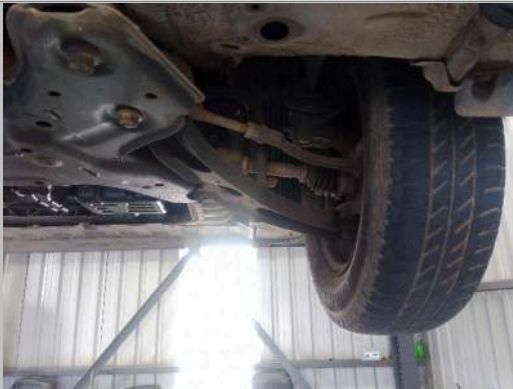
RF TYRE TREAD

| | Size | Load/Speed Index | Manufacture | Model | Type* | Production Date | Tread Depth (mm) |
|---|---|---|---|---|---|---|---|
| Front Right | 175/70R13 | 82T | Continental | Contieco | V | 3511 | 0 mm |

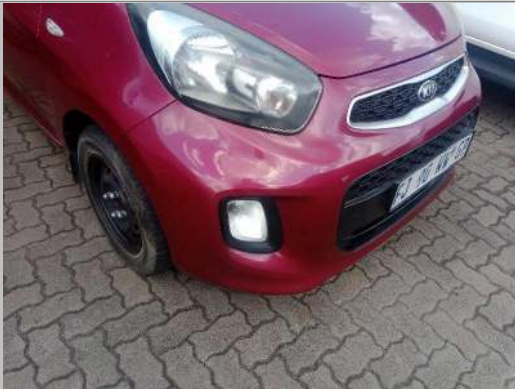
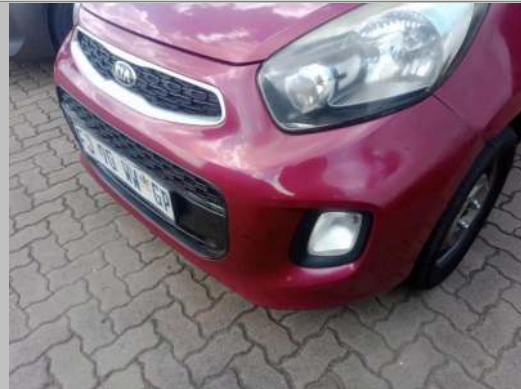
| Damage | Repair Way |
|---|---|
| Front Bumper Damaged | Repair |

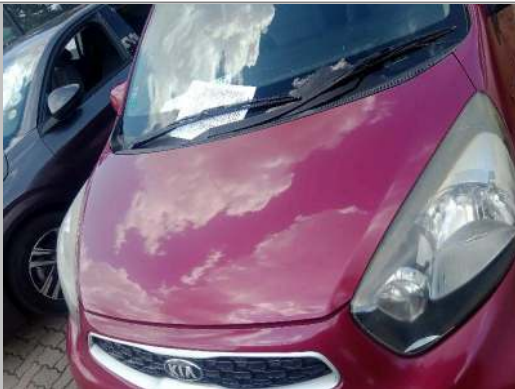
| Damage | Repair Way |
|---|---|
| Bonnet Damaged | Repair |

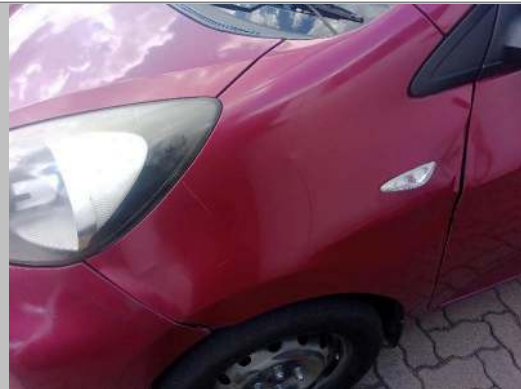
| Damage | Repair Way |
|---|---|
| Front Fender Left Damaged | Repair |

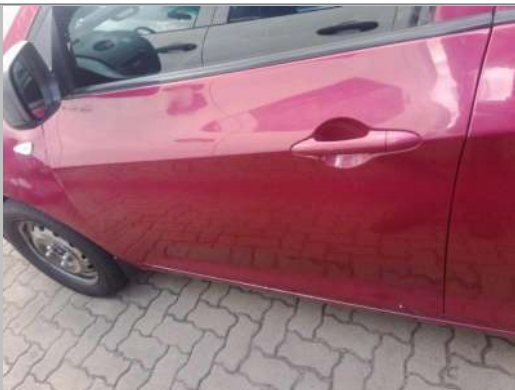
| Damage | Repair Way |
|---|---|
| Door Front Left Damaged | Repair |

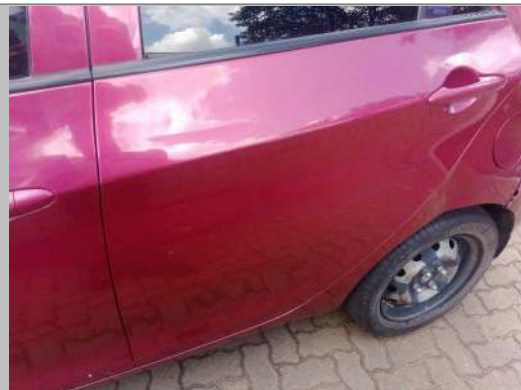
| Damage | Repair Way |
|---|---|
| Door Rear Left Damaged | Repair |

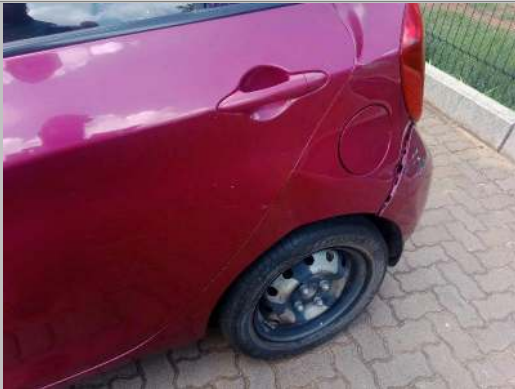
| Damage | Repair Way |
|---|---|
| Rear Fender Left Damaged | Repair |

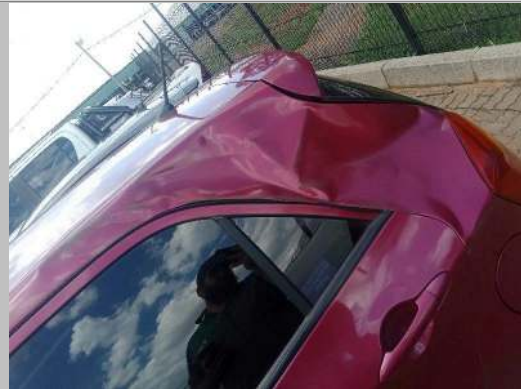
| Damage | Repair Way |
|---|---|
| C • Pillar Left Damaged | Repair |

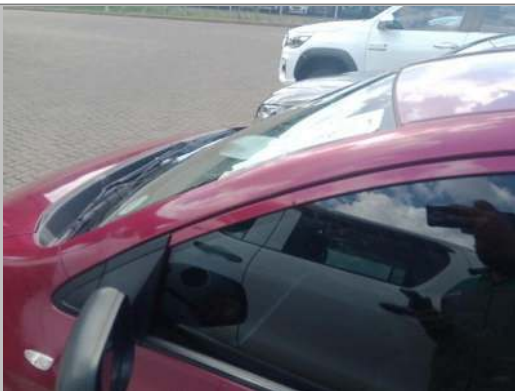
| Damage | Repair Way |
|---|---|
| A • Pillar Left Damaged | Repair |

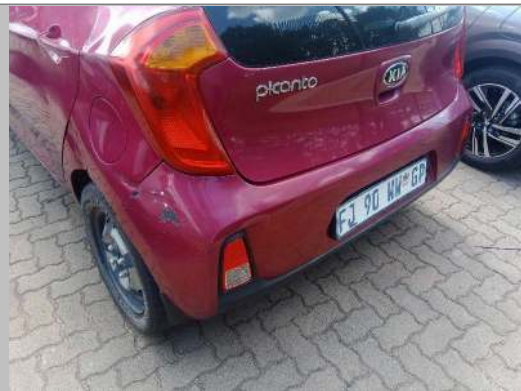
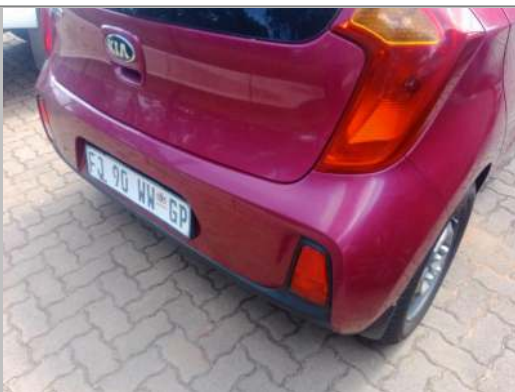
| Damage | Repair Way |
|---|---|
| Rear bumper Damaged | Repair |

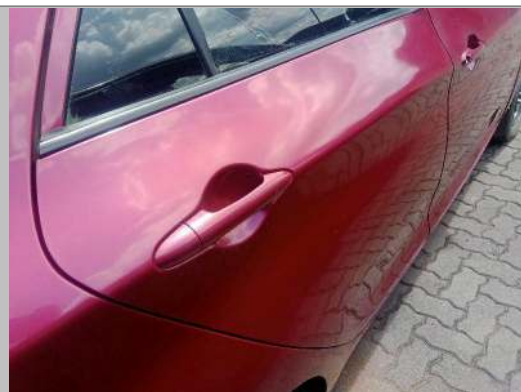
| Damage | Repair Way |
|---|---|
| Door Rear Right Damaged | Repair |

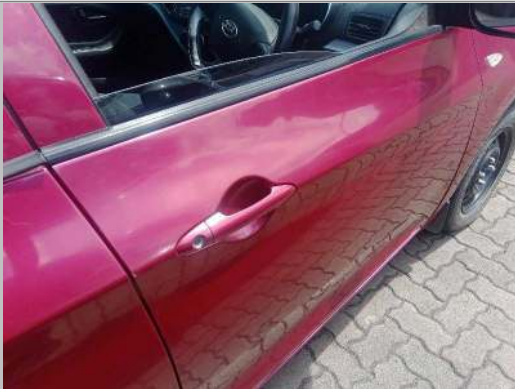
| Damage | Repair Way |
|---|---|
| Door Front Right Damaged | Repair |

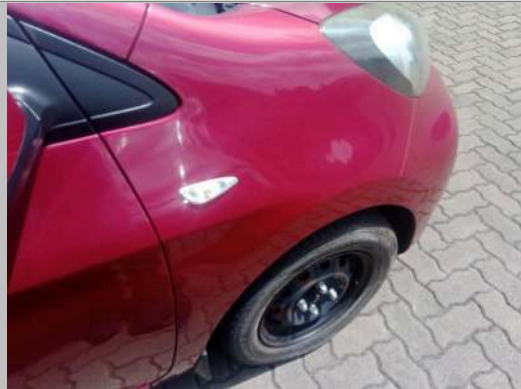
| Damage | Repair Way |
|---|---|
| Front Fender Right Damaged | Repair |

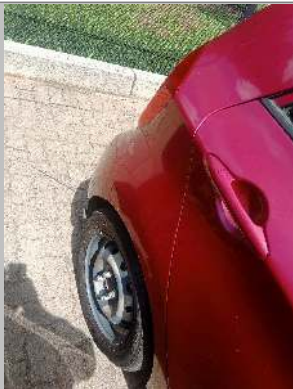
| Damage | Repair Way |
|---|---|
| Rear Fender Right Damaged | Repair |

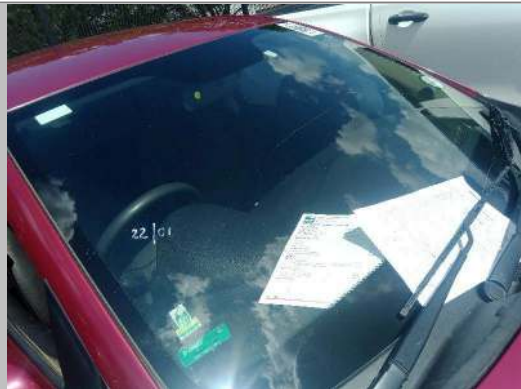
| Damage | Repair Way |
|---|---|
| Windscreen Damaged | Repair |

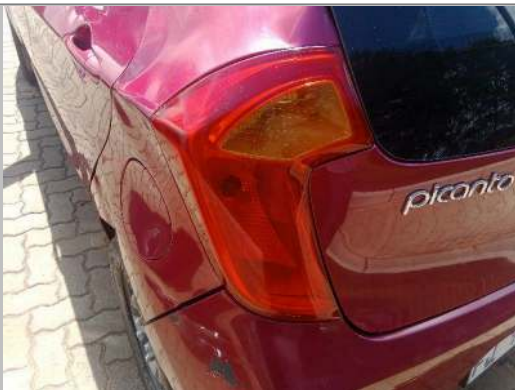
| Damage | Repair Way |
|---|---|
| Tail Light Left Damaged | Replace |

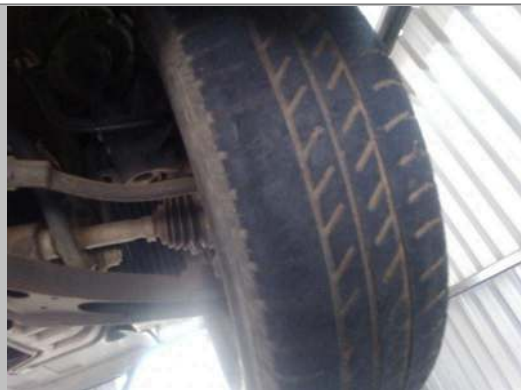
| Damage | Repair Way |
|---|---|
| Tyre Front Right Worn | Replace |

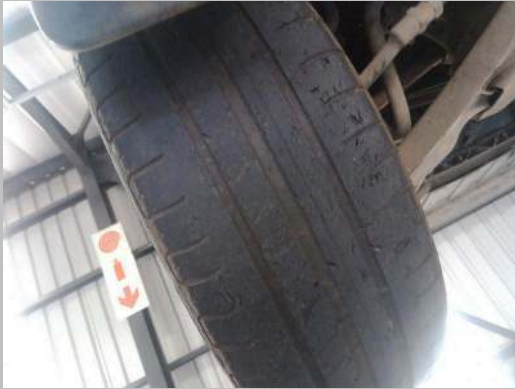
| Damage | Repair Way |
|---|---|
| Tyre Front Left Worn | Replace |

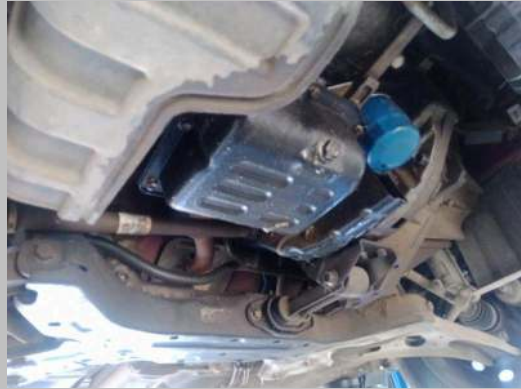
| Damage | Repair Way |
|---|---|
| Engine Oil Leak | Replace |

General Comments: ACCORDING TO AGE AND MILEAGE OF VEHICLE NORMAL WEAR AND TEAR ON INTERIOR, EXTERIOR, ELECTRICAL AND MECHANICAL PARTS.Engine Compartment: excessive oil leak.

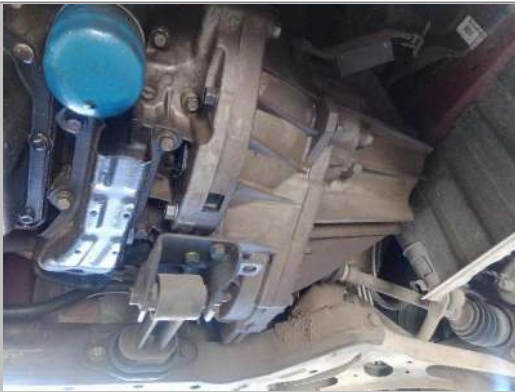
| Damage | Repair Way |
|---|---|
| Gearbox Oil Leak | Repair |

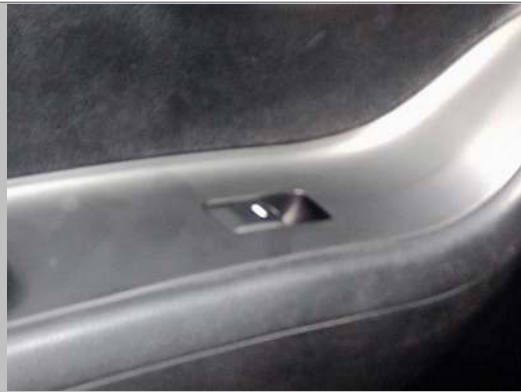
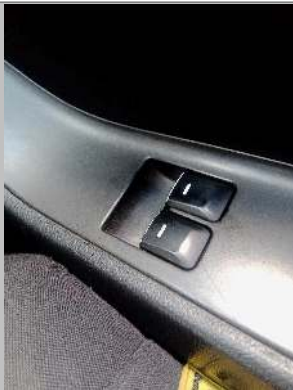
| Damage | Repair Way |
|---|---|
| Switch Electrical Window Winder front left Defective | Replace |
