MFC Auction House  
M57 Pretoria Rd, Glenmarais, KEMPTON PARK  
Gauteng

| Manufacturer | KIA | Registration Number | JV91HRGP |

## CONDITION REPORT

Report No: 2016439572

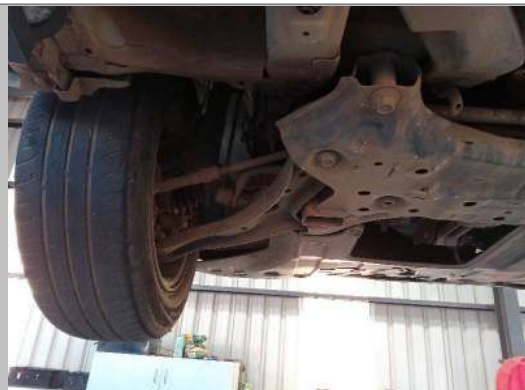
LF TYRE TREAD

| | Size | Load/Speed Index | Manufacture | Model | Type* | Production Date | Tread Depth (mm) |
|---|---|---|---|---|---|---|---|
| Front Left | 185/65 R15 | 88H | Nexen | Nblue | V | 1220 | 1 mm |

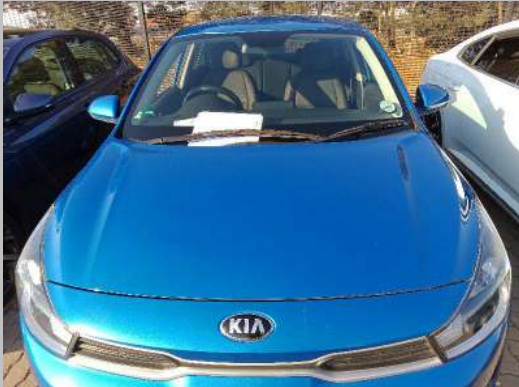
| Damage | Repair Way |
|---|---|
| Bonnet Dented | Repair |

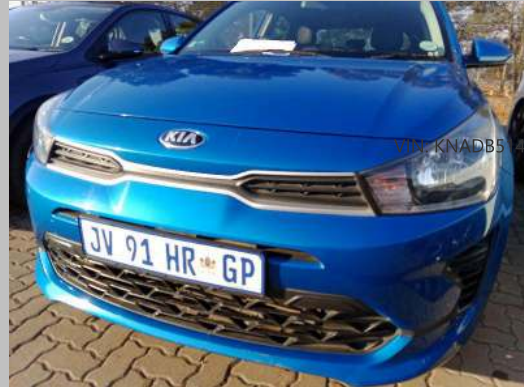
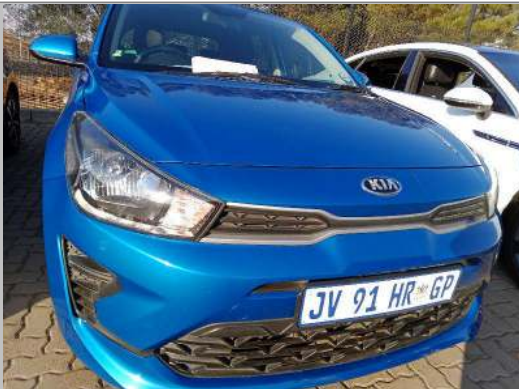
| Damage | Repair Way |
|---|---|
| Front Bumper Paintwork • Scratched | Repair |

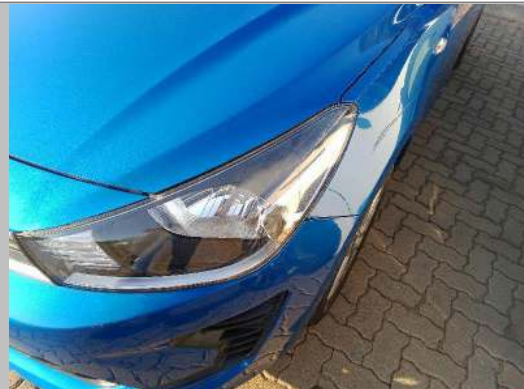
| Damage | Repair Way |
|---|---|
| Headlight Left Defective | Repair |

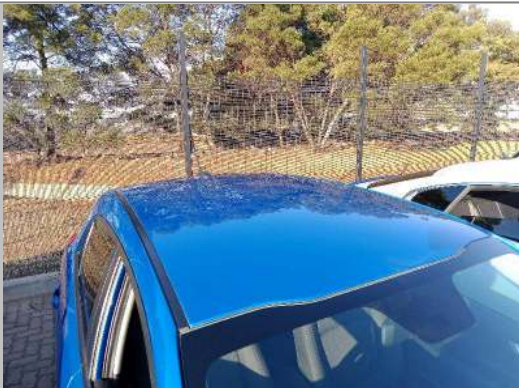
| Damage | Repair Way |
|---|---|
| Roof Dented | Repair |

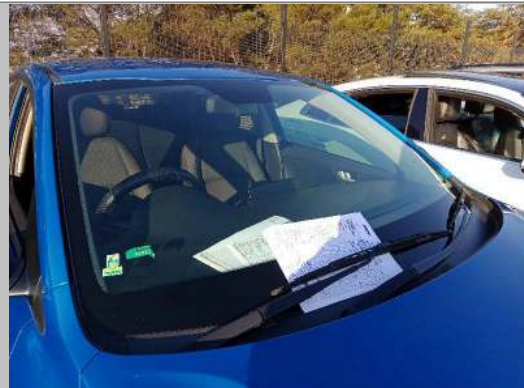
| Damage | Repair Way |
|---|---|
| Windscreen Chipped | Repair |

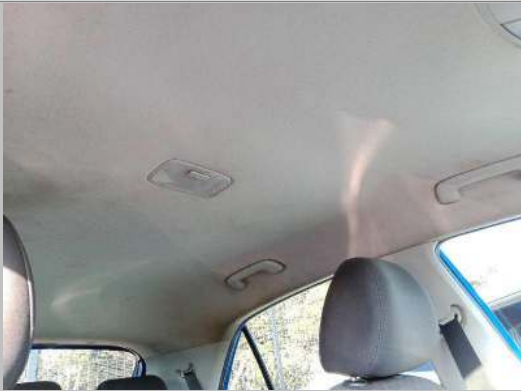
| Damage | Repair Way |
|---|---|
| Hood Lining Dirty | Repair |

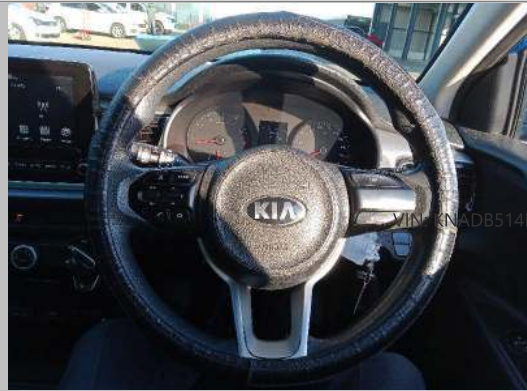
| Damage | Repair Way |
|---|---|
| Steering Wheel Trim Defective | Repair |

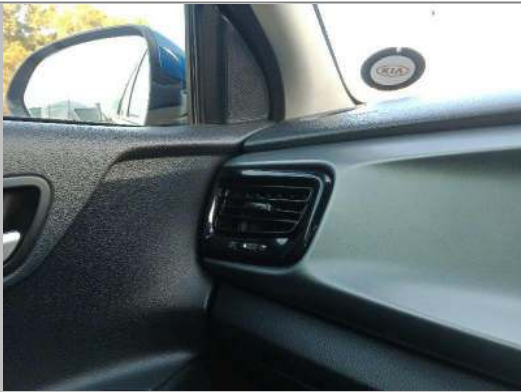
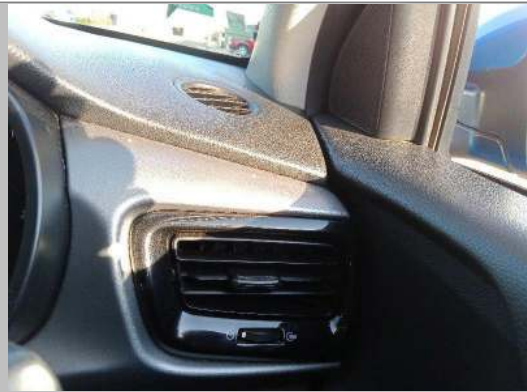
| Damage | Repair Way |
|---|---|
| Central Air Vent Defective | Repair |

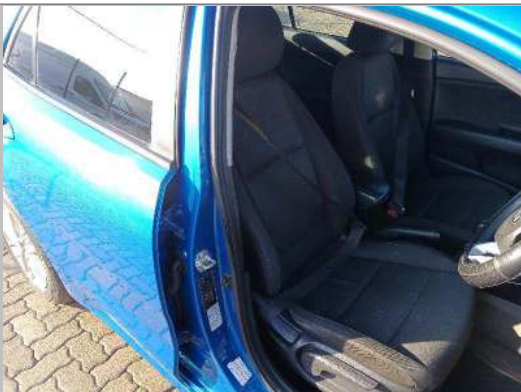
| Damage | Repair Way |
|---|---|
| Door Sealing Rubber Front Right Damaged | Replace |

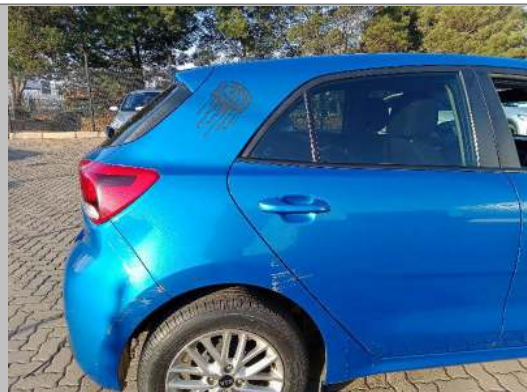
| Damage | Repair Way |
|---|---|
| Rear Fender Right Damaged | Repair |

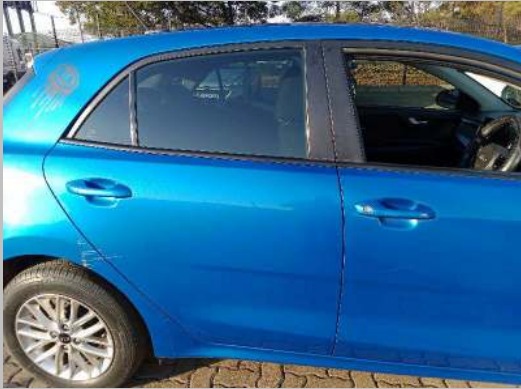
| Damage | Repair Way |
|---|---|
| Door Rear Right Paintwork • Scratched | Repair |

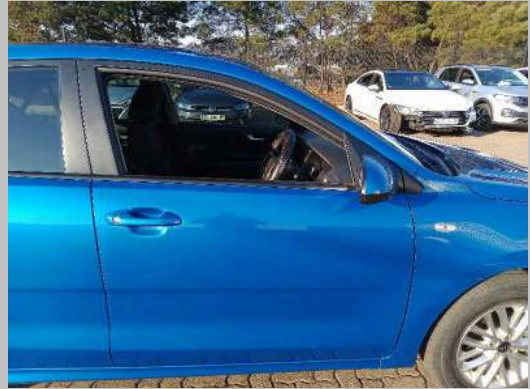
| Damage | Repair Way |
|---|---|
| Door Front Right Paintwork • Scratched | Repair |

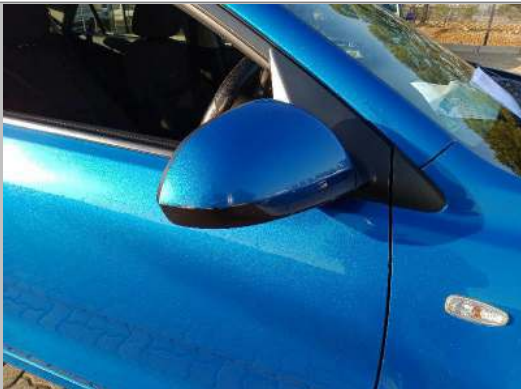
| Damage | Repair Way |
|---|---|
| Side Mirror Right Paintwork • Scratched | Repair |

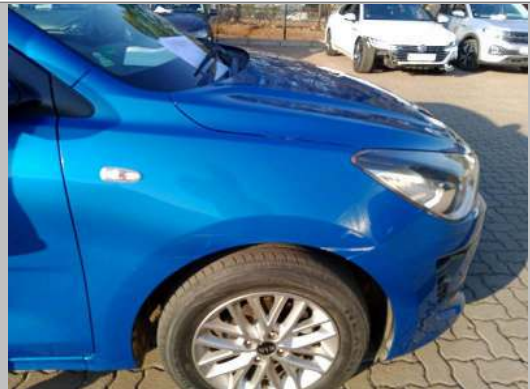
| Damage | Repair Way |
|---|---|
| Front Fender Right Damaged | Repair |

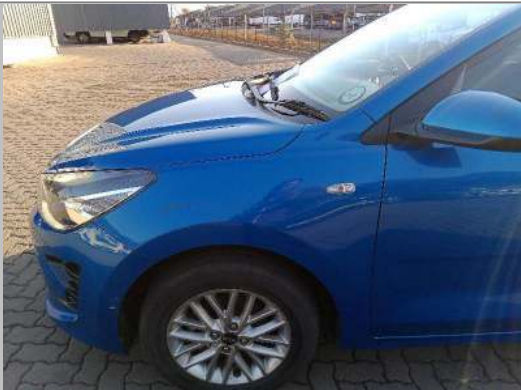
| Damage | Repair Way |
|---|---|
| Front Fender Left Paintwork • Scratched | Repair |

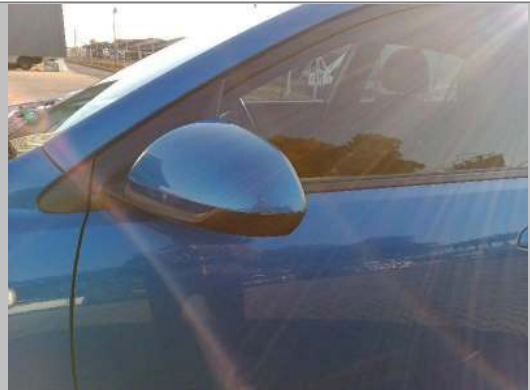
| Damage | Repair Way |
|---|---|
| Side Mirror Left Paintwork • Scratched | Repair |

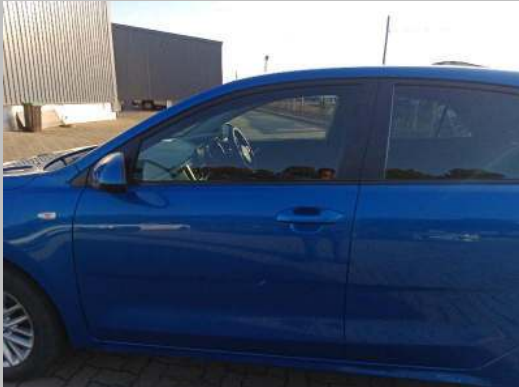
| Damage | Repair Way |
|---|---|
| Door Front Left Dented | Repair |

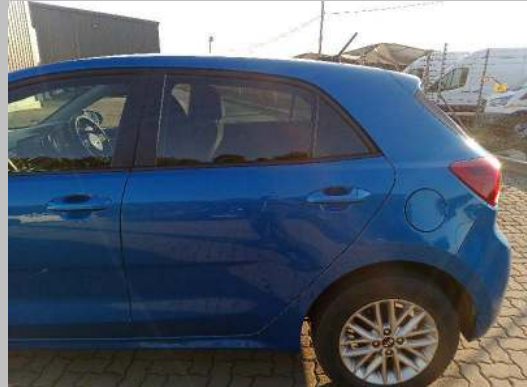
| Damage | Repair Way |
|---|---|
| Door Rear Left Paintwork • Scratched | Repair |

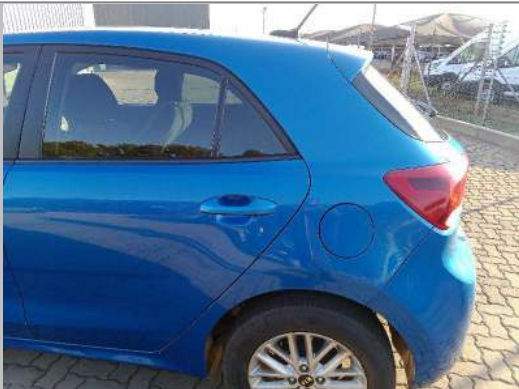
| Damage | Repair Way |
|---|---|
| Rear Fender Left Paintwork • Scratched | Repair |

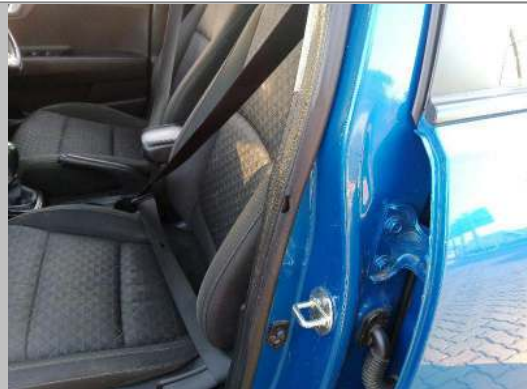
| Damage | Repair Way |
|---|---|
| Door Sealing Rubber Front Left Torn / Cut | Replace |

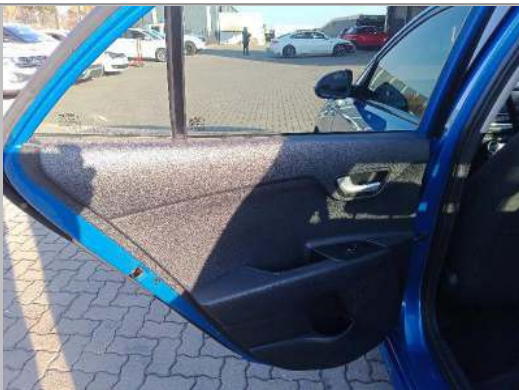
| Damage | Repair Way |
|---|---|
| Door Panel Rear Left Defective | Repair |

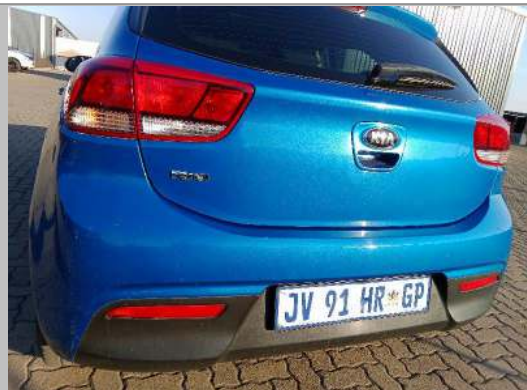
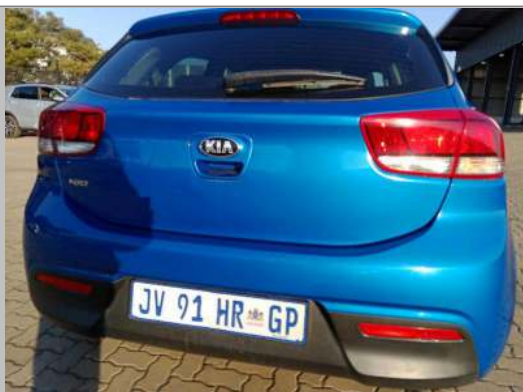
| Damage | Repair Way |
|---|---|
| Rear bumper Paintwork • Scratched | Repair |

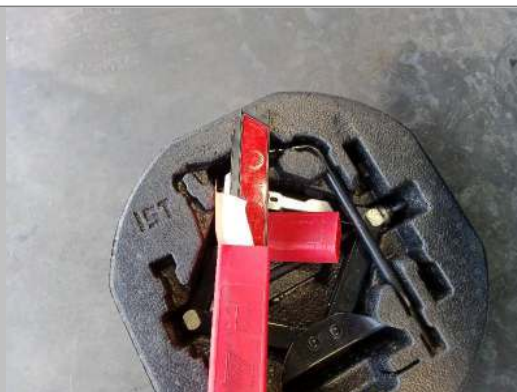
| Damage | Repair Way |
|---|---|
| Triangle Damaged | Replace |

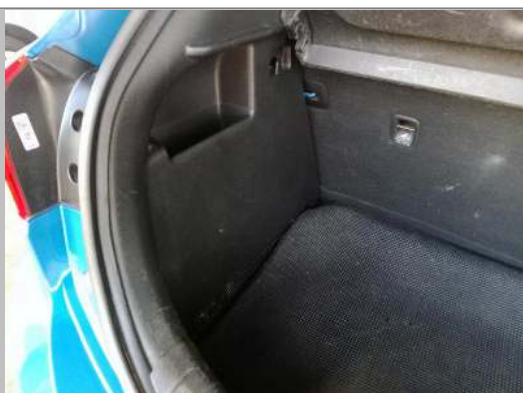
| Damage | Repair Way |
|---|---|
| Boot Panel Left Defective | Repair |

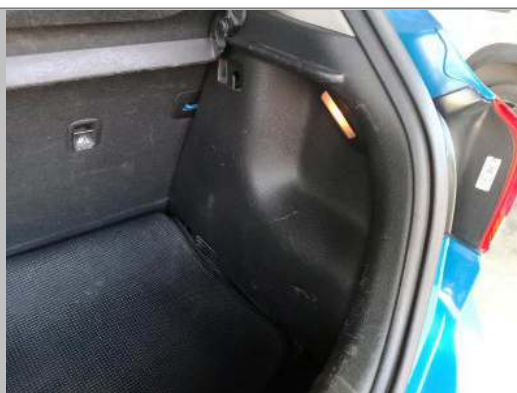
| Damage | Repair Way |
|---|---|
| Boot Panel Right Defective | Repair |

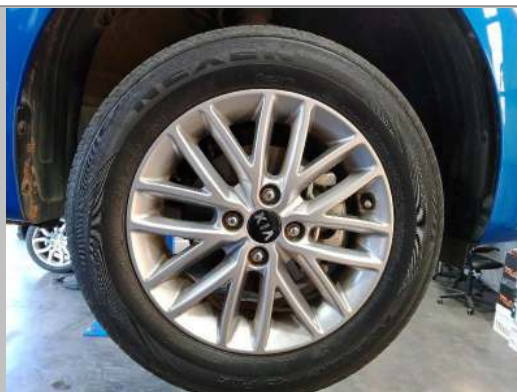
| Damage | Repair Way |
|---|---|
| Tyre Front Right Defective | Replace |

| | Size | Load/Speed Index | Manufacture | Model | Type* | Production Date | Tread Depth (mm) |
|---|---|---|---|---|---|---|---|
| Front Right | 185/65 R15 | 88H | Nexen | Nblue | V | 1420 | 3 mm |

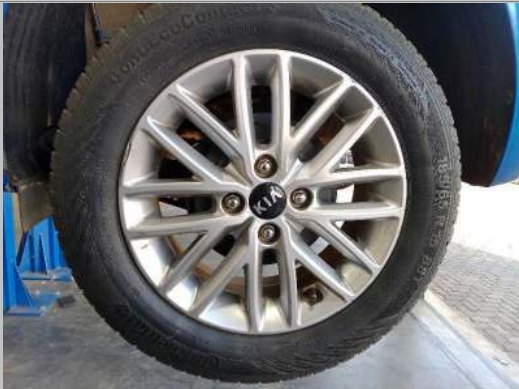
| Damage | Repair Way |
|---|---|
| Rim Rear Left Scratched | Repair |

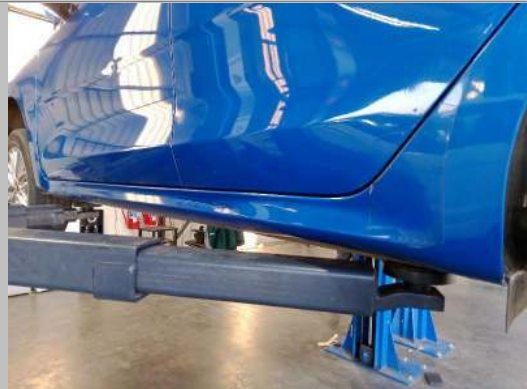
| Damage | Repair Way |
|---|---|
| Rocker Panel Left Defective | Repair |

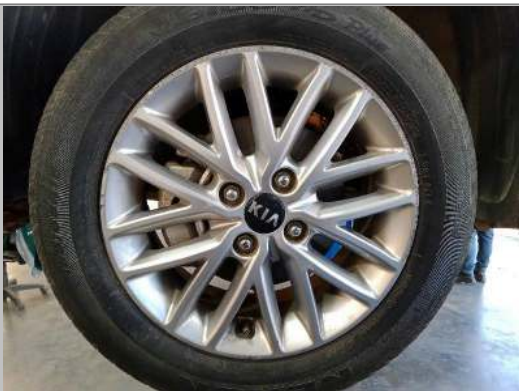
| Damage | Repair Way |
|---|---|
| Rim Front Left Scratched | Repair |

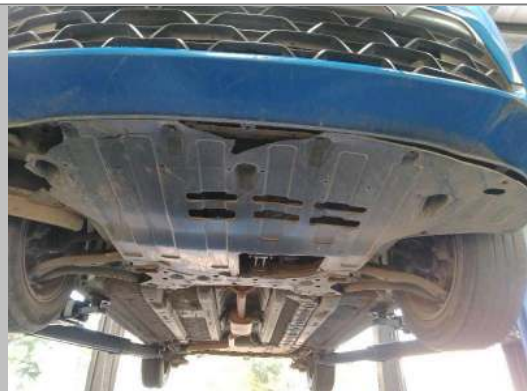
| Damage | Repair Way |
|---|---|
| Belly plates Damaged | Replace |

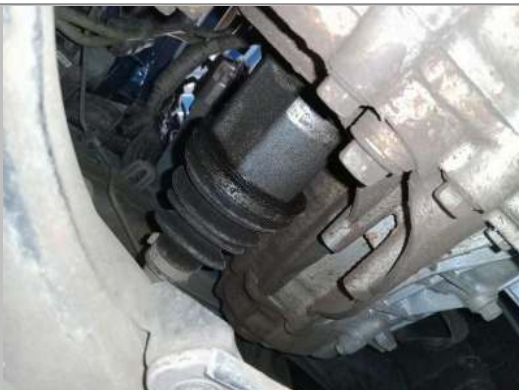
| Damage | Repair Way |
|---|---|
| CV Joint(s) Boot(s) Front Left (inner/outer) Defective | Replace |

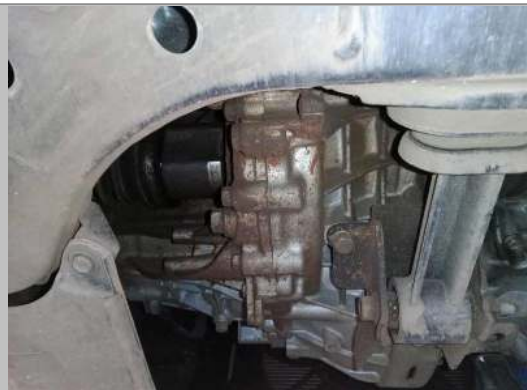
| Damage | Repair Way |
|---|---|
| Gearbox Oil Sweat | Repair |

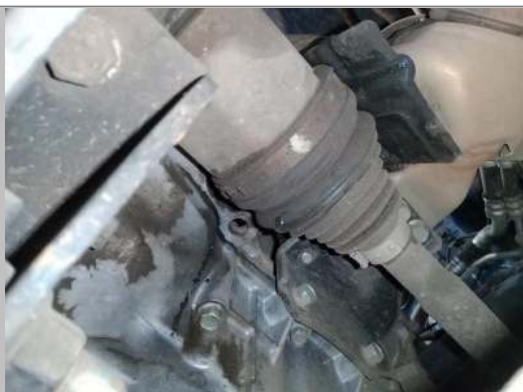
| Damage | Repair Way |
|---|---|
| CV Joint(s) Boot(s) Front Right (inner/outer) Damaged | Replace |

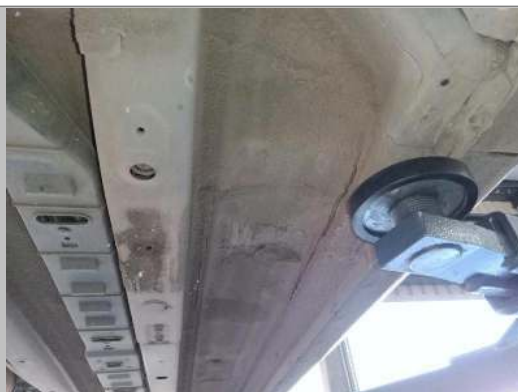
| Damage | Repair Way |
|---|---|
| Chassis Damaged | Repair |

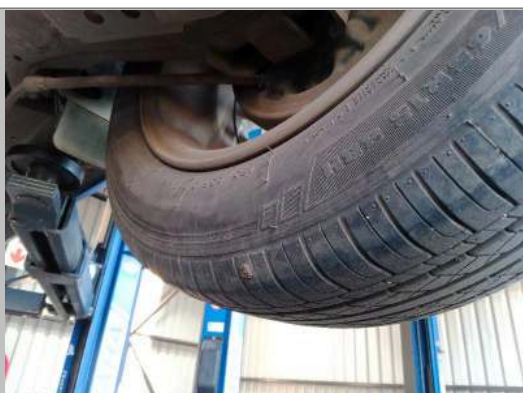
| Damage | Repair Way |
|---|---|
| Tyre Rear Right Defective | Replace |

| | Size | Load/Speed Index | Manufacture | Model | Type* | Production Date | Tread Depth (mm) |
|---|---|---|---|---|---|---|---|
| Rear Right | 185/65 R15 | 88H | Champro | GT Radial | V | 2521 | 5 mm |
