MFC Auction House
M57 Pretoria Rd, Glenmarais, KEMPTON PARK
Gauteng

Vehicle Type	PASSENGER VEHICLE	Registered Owner	MFC
Manufacturer	KIA	Registration Number	KP27VKGP
Model	RIO	Register Number	
VIN	KNADB518LN6634242	Date Of First Licensing	
Engine Number		Last COR	
Doors	5	License Expiry Date	31/10/2023
Color	SILVER	Power / Displacement	
Year Model		Paint Finish	TWO COAT METALLIC
Km Reading	51,173 KM	Fuel	PETROL
Cab / Body Type	HATCHBACK	Transmission	MANUAL

CONDITION REPORT

Report No: 2016213100

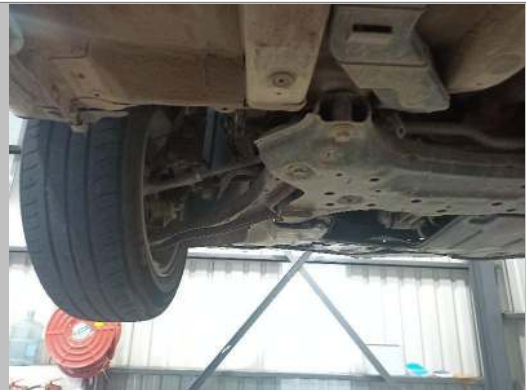
LF TYRE TREAD

Size	Load/Speed Index	Manufacture	Model	Type*	Production Date	Tread Depth (mm)
Front Left	185/65R15	88H	Nexen	Radial	V	4521	0 mm
Front Right	185/65R15	88H	Nexen	Radial	V	4521	1 mm
Rear Left	185/65R15	88H	Autogrip	Radial	V	1523	4 mm
Rear Right	185/65R15	88H	Autogrip	Radial	V	2122	2 mm

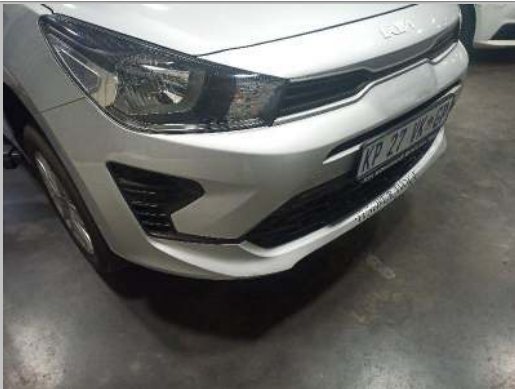
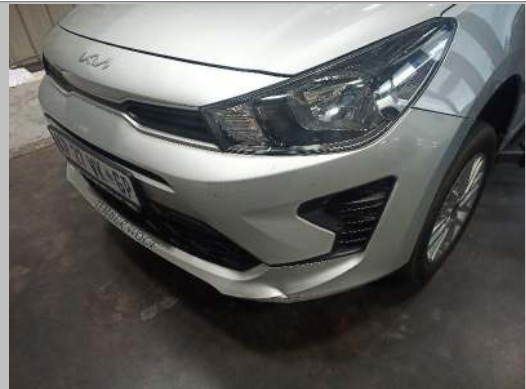
Damage	Repair Way
Tail Light Left Damaged	Replace
Front Bumper Damaged	Repair
Bonnet Damaged	Repair
Front Fender Left Damaged	Repair
Front Fender Right Damaged	Repair
Door Front Left Damaged	Repair
Door Front Right Damaged	Repair
Door Rear Left Damaged	Repair
Door Rear Right Damaged	Repair
Rear bumper Damaged	Repair
Tyre Front Left Worn	Replace
Belly plates Damaged	Replace
Radiator Cradle Damaged	Replace

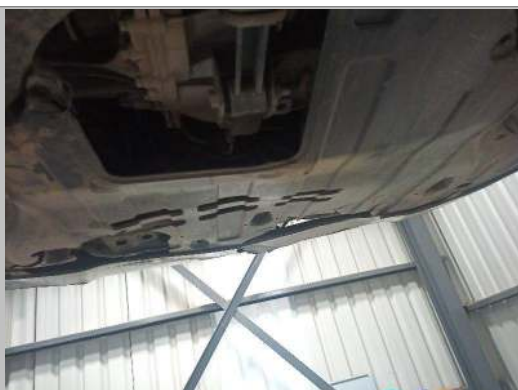
Belly plates

General Comments: ACCORDING TO AGE AND MILEAGE OF VEHICLE NORMAL WEAR AND TEAR ON INTERIOR, EXTERIOR, ELECTRICAL AND MECHANICAL PARTS. SHOCK ABSORBER TEST NOT PERFORMED.
Body • Exterior: Minor dents and scratches and stone chips to some body panels. Signs of repair work done to some body panels. Poor alignment to some body panels.
Undercarriage: Signs of impact damage to front of vehicle.
