CONDITION REPORT

Report No:
2017002557
DATE
04/09/2025

| Manufacturer | KIA | Registration Number | FS90MHGP |
| Model | RIO 1.4 TEC AT [2015-2017] | Register Number | |

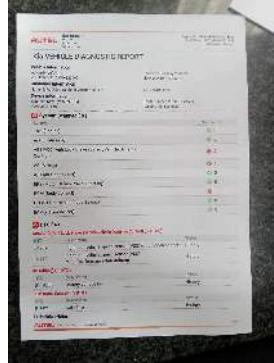
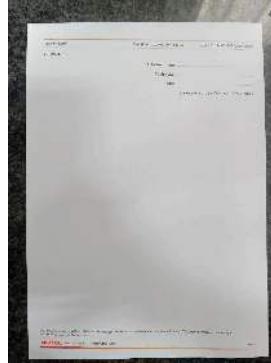
Diagnostic test

| No | System | Code | Description | Status |
|---|---|---|--|---|
| 1 | ABS | C1209 | RIGHT REAR VEHICLE SPEED SENSOR VSS CIRCUIT OPEN O | |

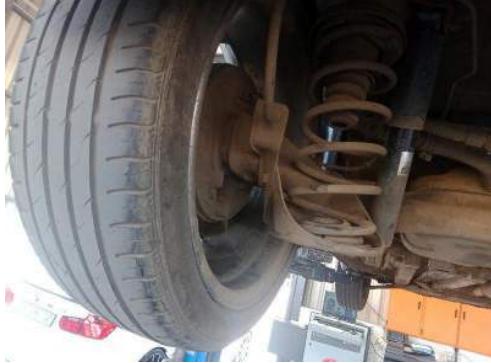
LR TYRE TREAD

| | Size | Load/Speed Index | Manufacture | Model | Type* | Production Date | Tread Depth (mm) |
|---|---|---|---|---|---|---|---|
| Rear Left | 205/40R17 | 84W | Nexen | Nfera | V | 0224 | 3 mm |

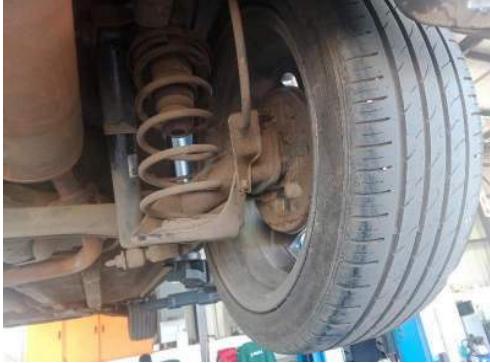
RR TYRE TREAD

| | Size | Load/Speed Index | Manufacture | Model | Type* | Production Date | Tread Depth (mm) |
|---|---|---|---|---|---|---|---|
| Rear Right | 205/40R17 | 84W | Nexen | Nfera | V | 4424 | 3 mm |

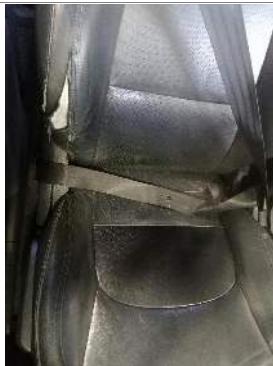
| Damage | Repair Way |
|---|--|
| Seat Front Right Torn / Cut | Repair |

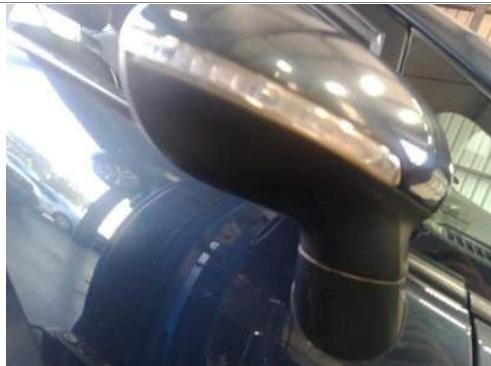
| Damage | Repair Way |
|---|--|
| Indicator Light Front Right Cracked | Replace |

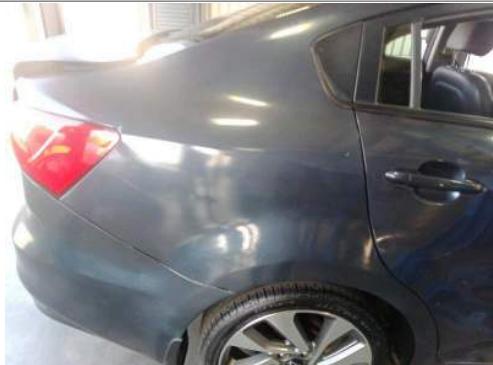
| Damage | Repair Way |
|---|--|
| Rear Fender Right Residual Traces of Repair | Repair |

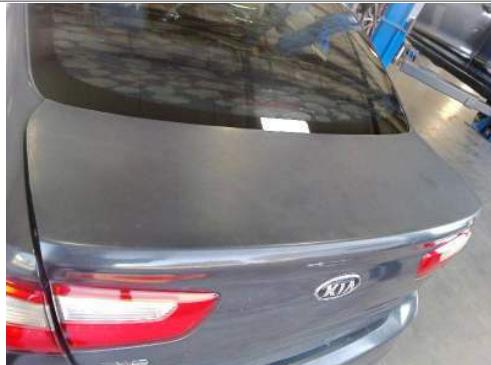
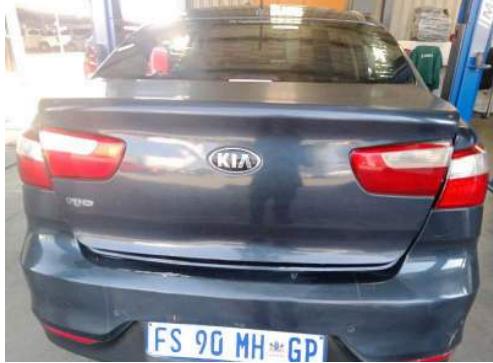
| Damage | Repair Way |
|---|--|
| Boot Lid / Hatch door Residual Traces of Repair | Repair |

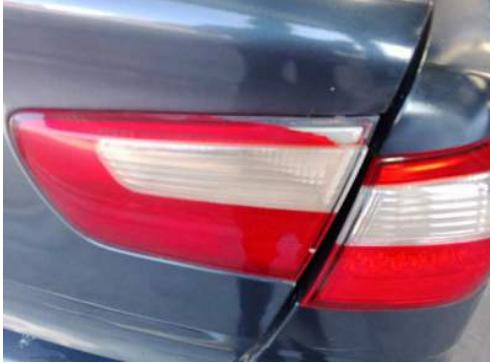
| Damage | Repair Way |
|---|--|
| Tail Light Right Broken | Replace |

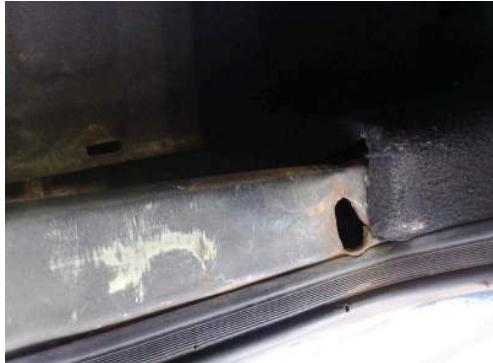
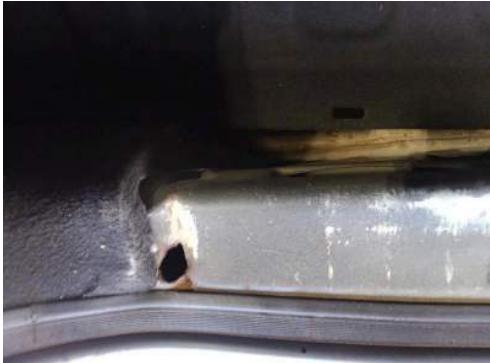
| Damage | Repair Way |
|---|--|
| Rear Upper Valance Damaged | Repair |

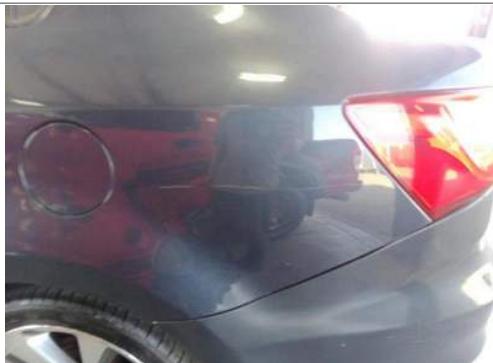
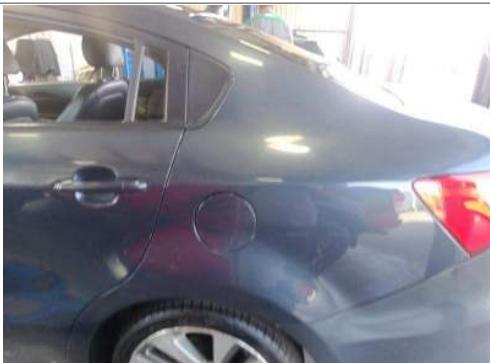
| Damage | Repair Way |
|---|--|
| Rear Fender Left Paintwork • Scratched | Repair |

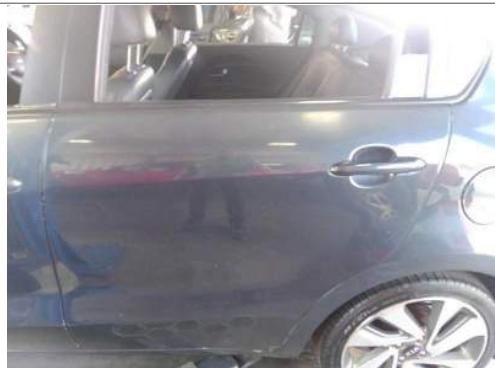
| Damage | Repair Way |
|---|--|
| Door Rear Left Paintwork • Dull | Repair |

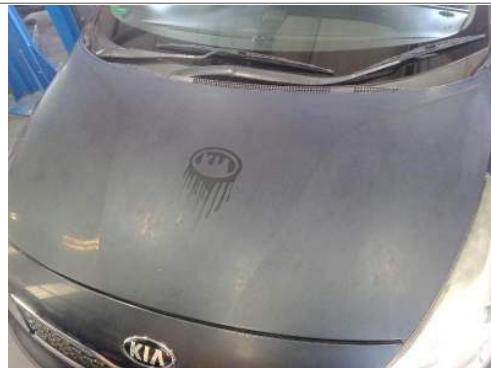
| Damage | Repair Way |
|---|--|
| Bonnet Paintwork • Dull | Repair |

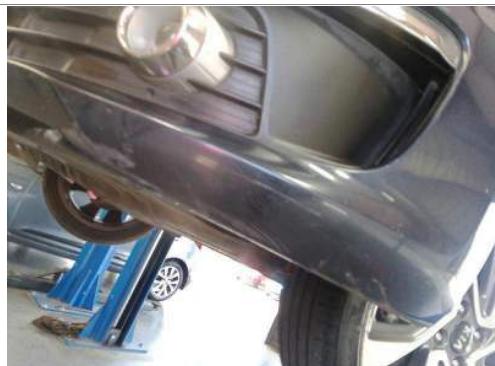
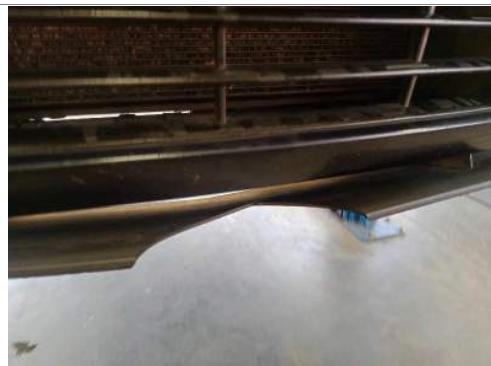
| Damage | Repair Way |
|---|--|
| Front Bumper Paintwork • Scratched | Repair |

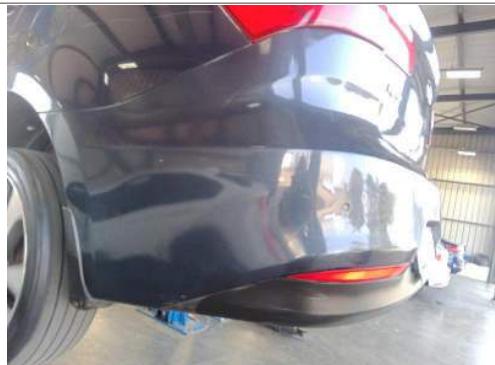
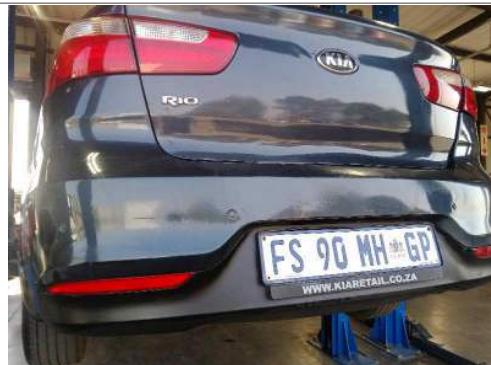
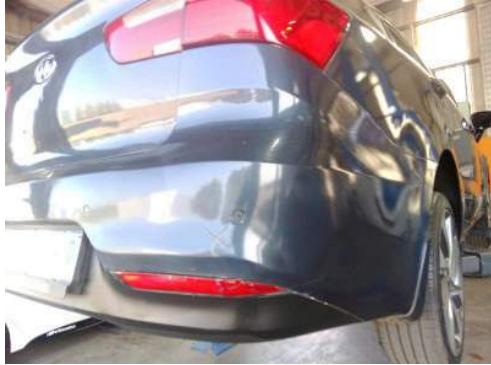
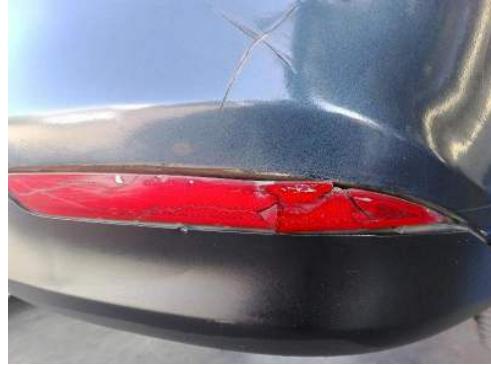
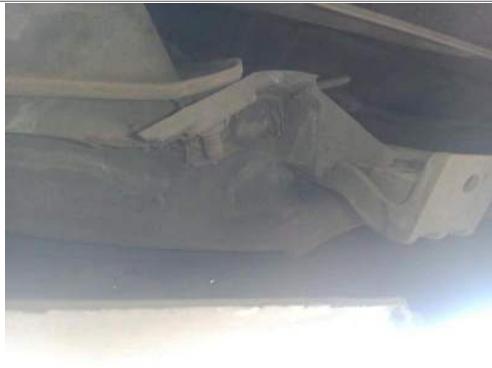
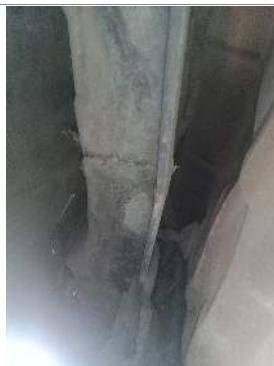
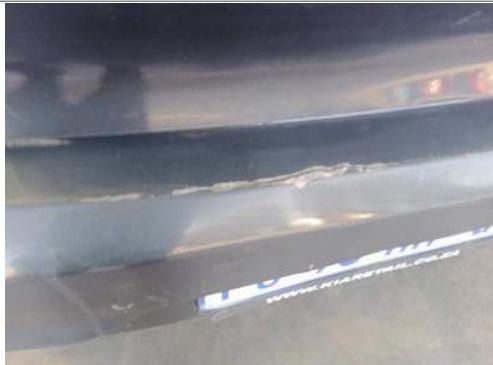
| Damage | Repair Way |
|---|--|
| Rear bumper Residual Traces of Repair | Repair |

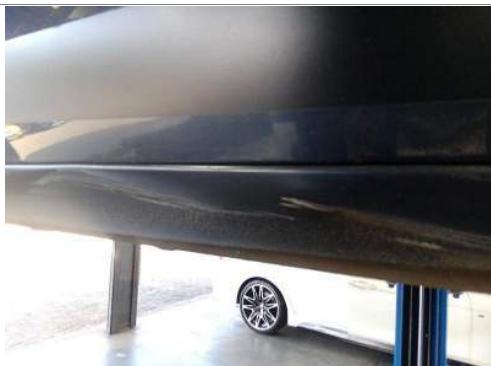
| Damage | Repair Way |
|---|--|
| Sill Panel Right Paintwork • Scratched | Repair |

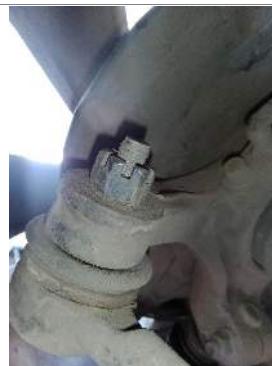
| Damage | Repair Way |
|---|--|
| Split Pin Left Missing | Replace |

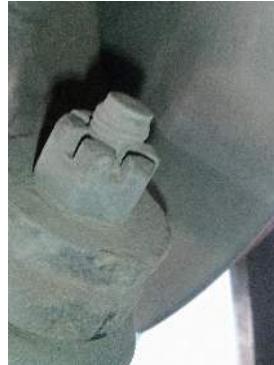
| Damage | Repair Way |
|---|--|
| Split Pin Right Missing | Replace |

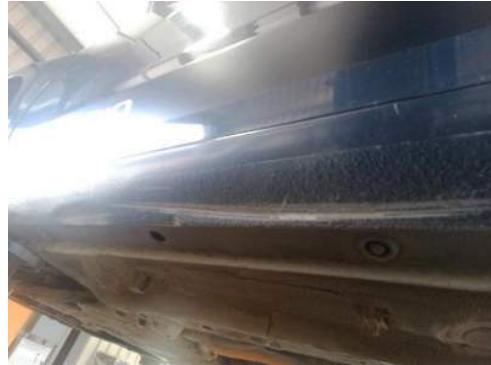
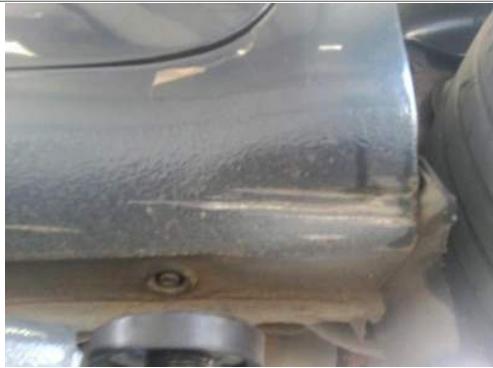
| Damage | Repair Way |
|---|--|
| Sill Panel Left Paintwork • Scratched | Repair |

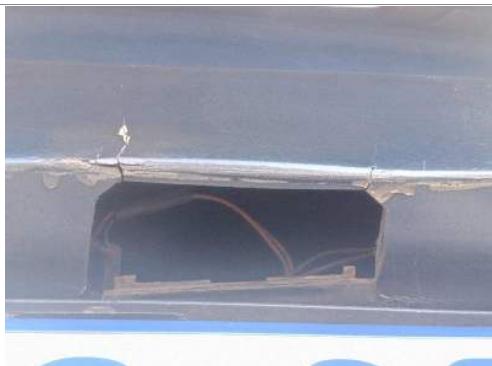
| Damage | Repair Way |
|---|--|
| Number Plate Light Left Missing | Replace |
